SERVICE BULLETIN

SERVICE BULLETIN		No.: MSB-99E23-002	
		Date: 1999-12-15	
Subject: CHANGE IN TRANSFER DRIVE GEAR DISASSEMBLY/REASSEMBLY PROCEDURE		<Model>	<M/Y>
Group: AUTOMATIC TRANSAXLE		(EC) COLT (CJ0A)	98-10
		(EC) LANCER (CK0A)	98-10
		(EC) CARISMA	98-10
		(EC) GALANTE (EA0)	98-10
		(EC) SPACE RUNNER	98-10
		(N61W)	98-10
		(EC) SPACE WAGON	
		(N84W)	
INFORMATION	INTERNATIONAL CAR ADMINISTRATION OFFICE	  T.NITTA - PROJECT LEADER AFTER SALES SERVICE & CS PROMOTION

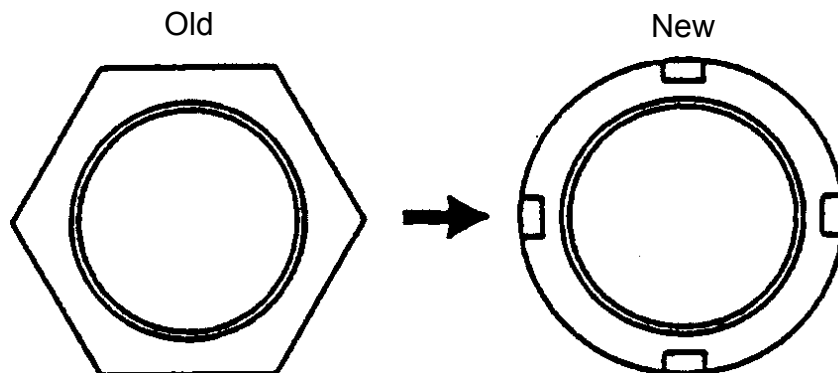
Shape of lock nut

With change in shape of the lock nut, the transfer drive gear has been changed to that which cannot be disassembled. Accordingly, the applicable transfer drive gear service procedure has been added.
