Faults and Fixes - ACE "Amber Light"

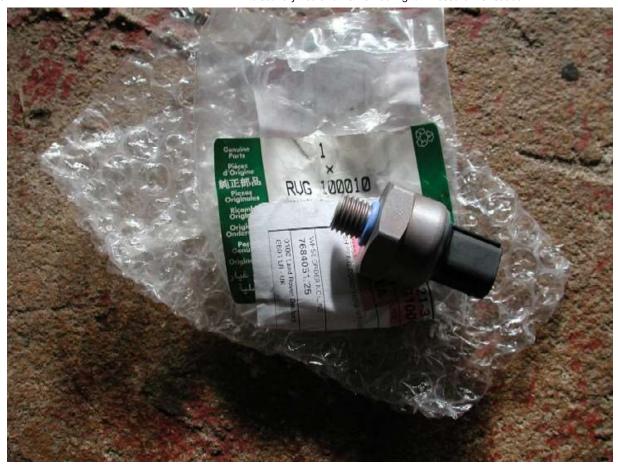
The only other info I could find was one ref to the pressure transducer fitted in the front of the valve block, this however was a lot more money than the accelerometers, the pressure transducer is about £75 + VAT. After a bit more studying of the ACE system, I came to the conclusion that it was "highly" likely the pressure transducer had died as it was only an "amber" light, so the day before I went for the diagnostic session I ordered one from the dealer to have ready if I needed it. The test session confirmed a fault of 0023 "no pressure signal", so my "hunch" was correct as nothing else would give this particular code / fault. So off to the dealer I went and bought the new transducer, some new ACE fluid (if needed) and went home to replace it.

Here is the little culprit!! not a lot for £80 +

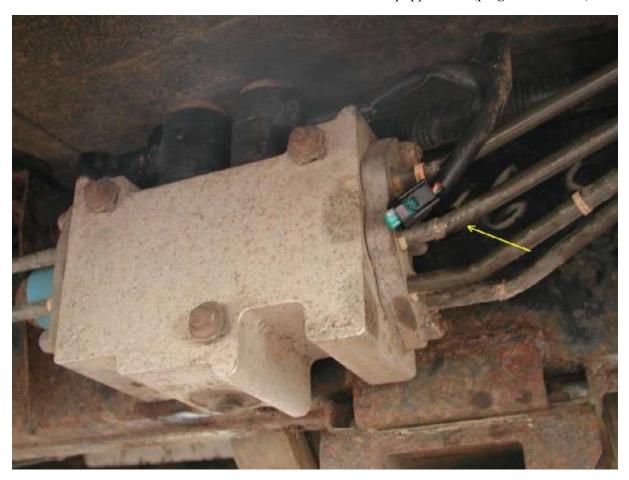
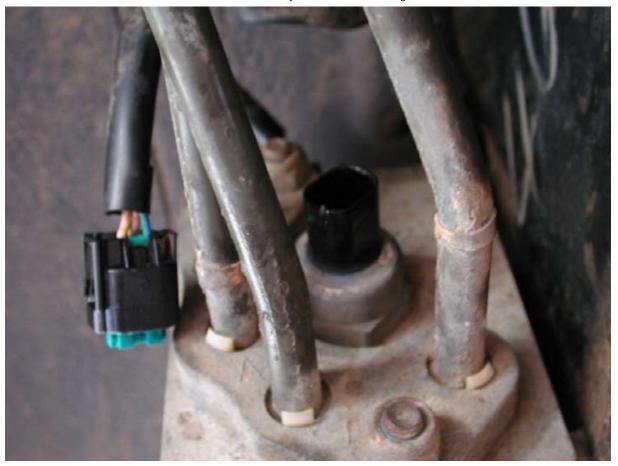
And here is where it is located on the Valve block on ACE equipped cars (plug disconnected)
