www.discovery2.co.uk

Rear Axle "Watts" Linkage Bush / Bearing Replacement

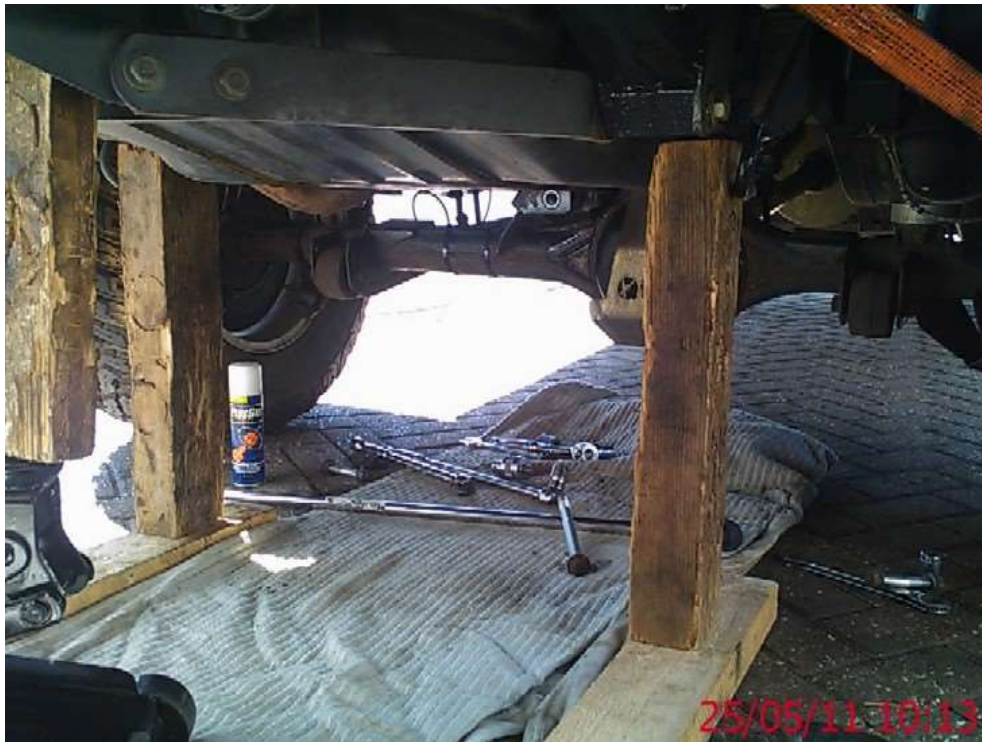
To do this job you need to support the chassis on flat and level ground, I jacked the vehicle slightly to get a little more room underneath and used some large blocks of wood to support the chassis / body by the rear tie down points.

NoteI also left a trolley jack and bit of wood under load under the tow bar assy.

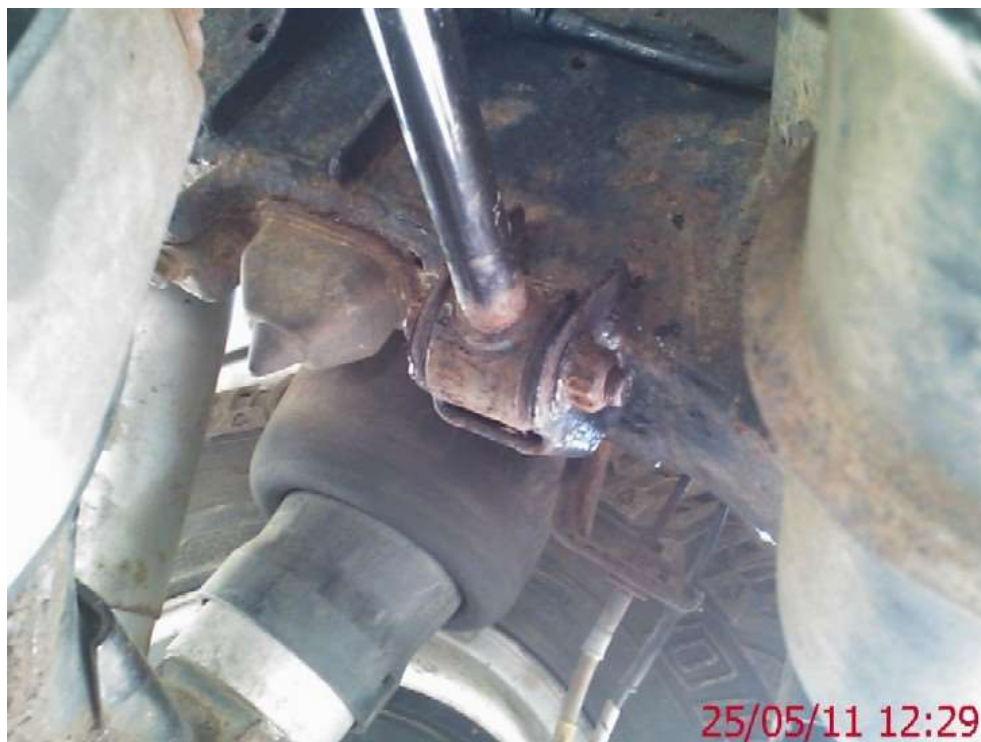
First of all you need to undo the bolts and remove the "link arms" from the chassis mountings, right hand side shown below, left hand side similar.

NOTE :- These are what keeps the axle and the body central to each other, once you remove the bolts from these if the vehicle is not on level ground it can move sideways !!

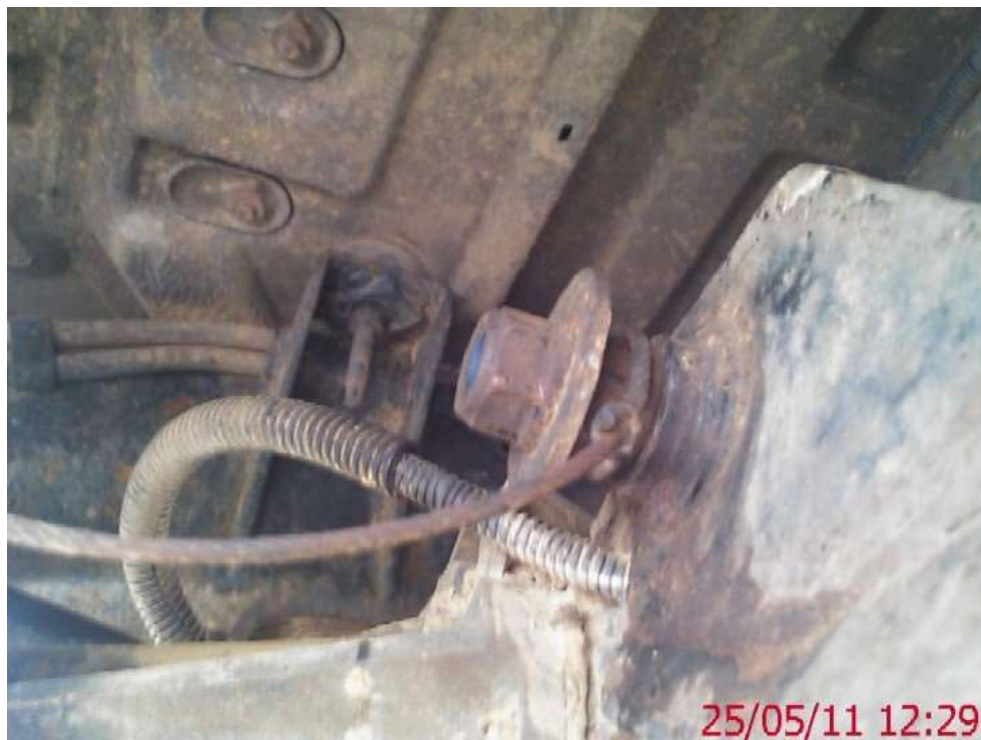
So after the link arms are done, you have to undo the central pivot bolt, this bolt goes all the way through the axle mounting and protrudes out the back with a nut on it, BUT also on top of that nut is a large Nylock nut and washer used to keep the lanyard for the rear axle damper in position....Pictured below.

So remove the 24mm nut, then the washer and lanyard and you can then access the central pivot bolt nut. This bolt is torque'd to 170lbs ft, so its quite tight to undo. Once that's undone, remove what is probably the longest bolt on the car!!!

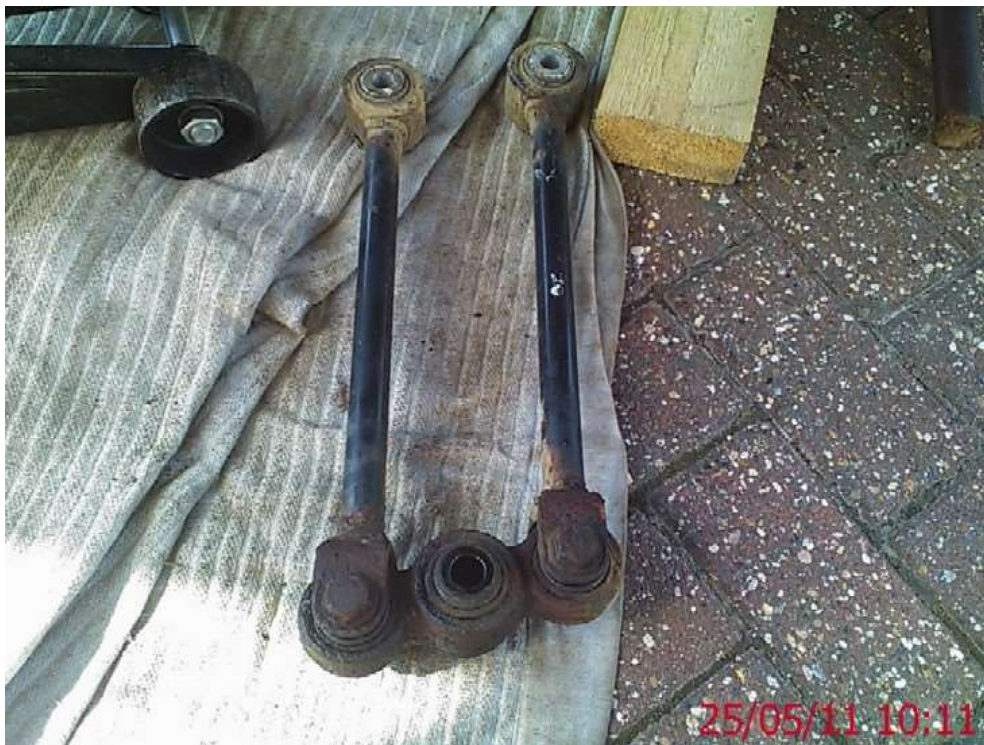
After the central bolt is out, you can then pivot / wiggle the watts linkage to remove the assy from the car..

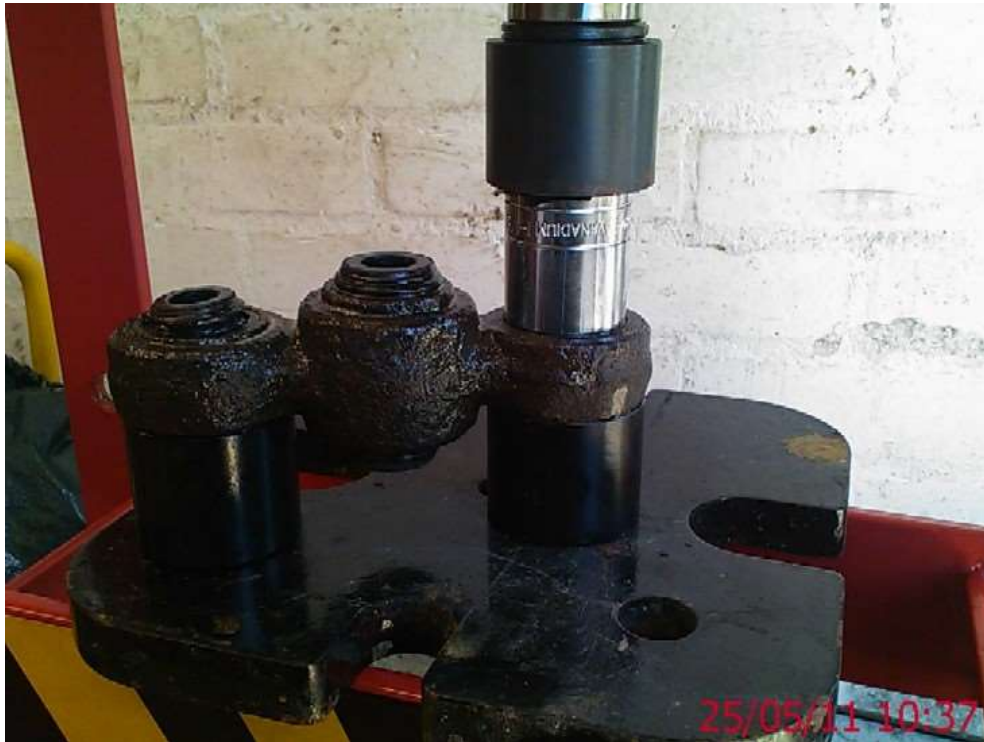
I started on the outer bushes, for info a 1-1/8" socket is pretty much a prefect size to use to push the bush out, I also used 2 steel tube receivers underneath to support the pivot piece...

The first outer bush took only 2 Tons of pressure and away she went.....The other side followed not to long after with only 1.5 Tons of pressure.....So as mentioned earlier, you "may" have been able to do these with out a press.....but for simplicity I suggest a press is used.

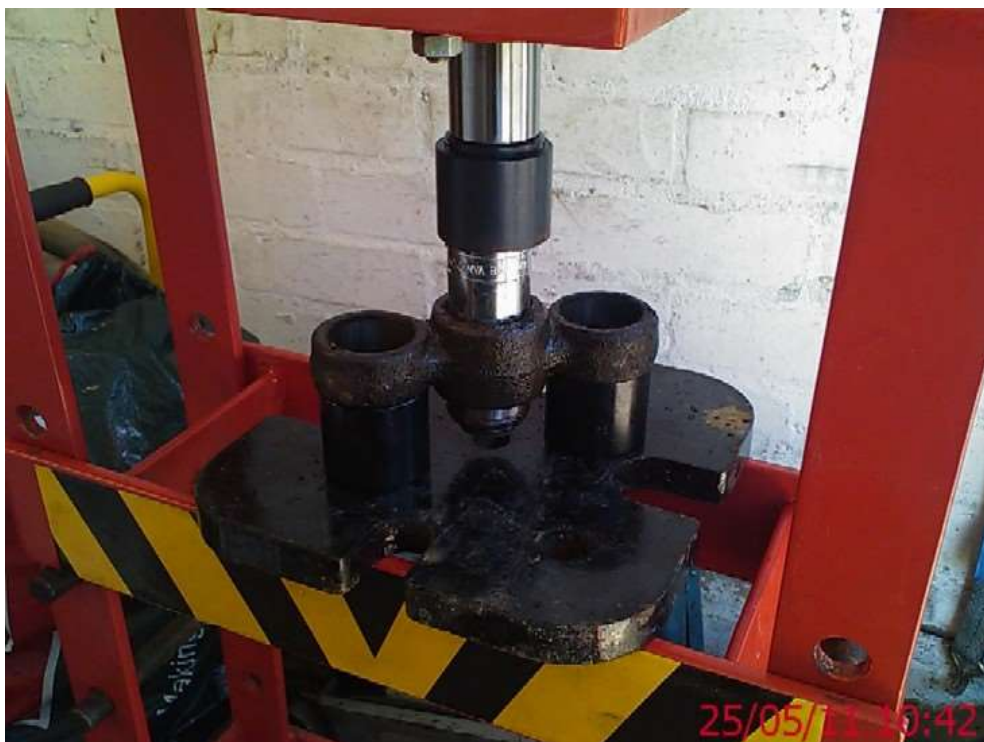
The same socket also fits the middle bearing as well.....

Now this is where I believe you would have struggled to remove this without a press, this bearing took nearly 6 Tons before she went, and took a continual 3 tons to push it out, I simply don't think this could have been done "on the bench".

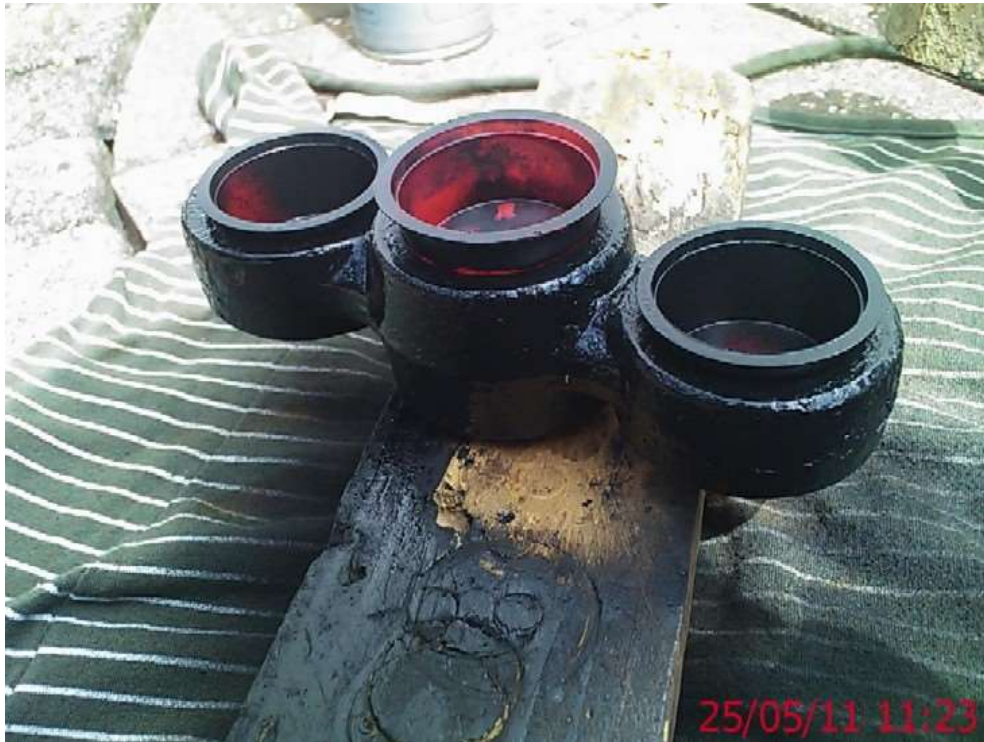
Bush apertures "blacked" for painting below.....

With the old bushes and bearing out, I took the opportunity to "clean" up the pivot and also made it pretty again with a lick of new spray paint.....

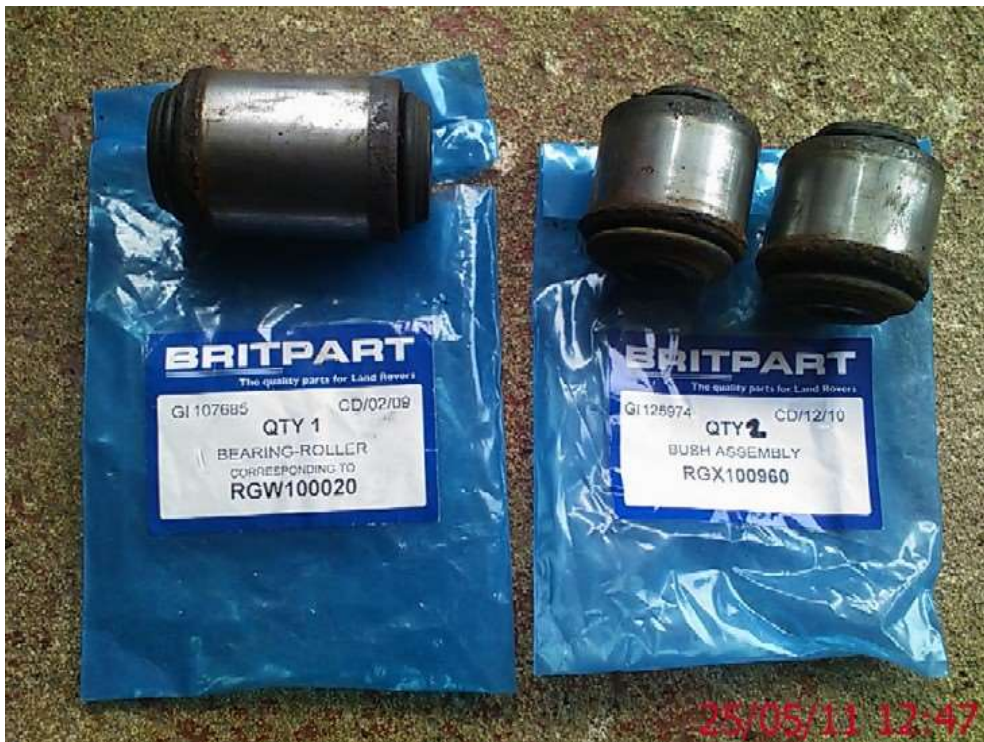
Below is the new bushes and central bearing showing the part numbers,

NOTE:- *I changed the quantity to "2" on the bush bag because that's how many you need.....(they are sold singularly)I know its obvious, but its the old bushes shown below.....*

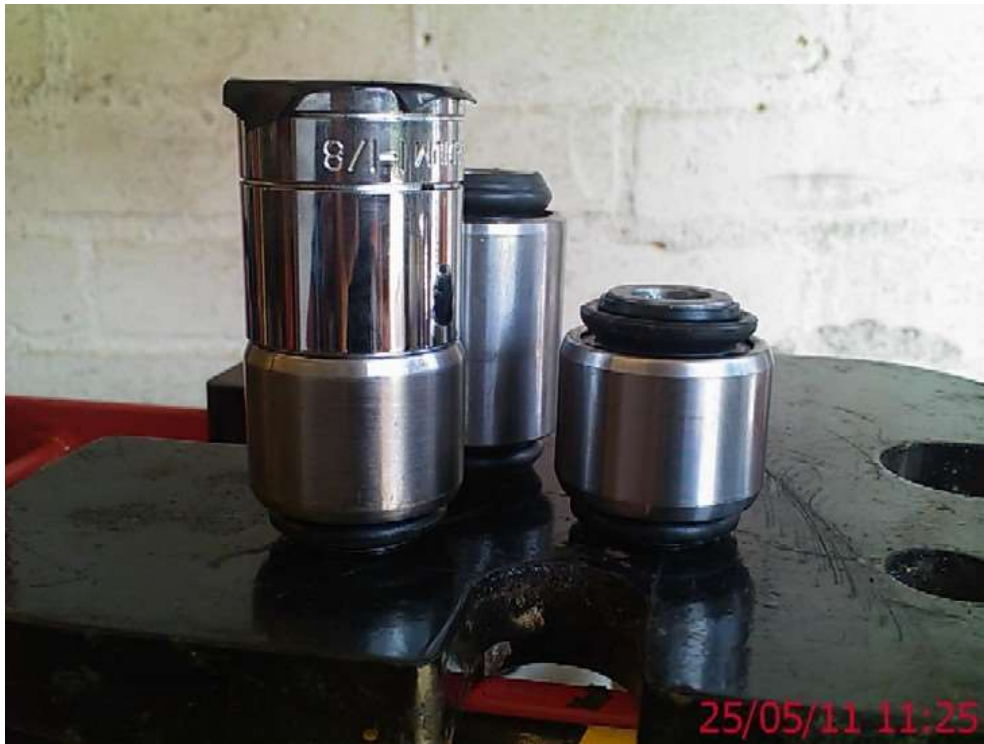
Now you can use the same socket for fitting as removal, just "feed" the socket over / around the rubber on the new bush carefully first...

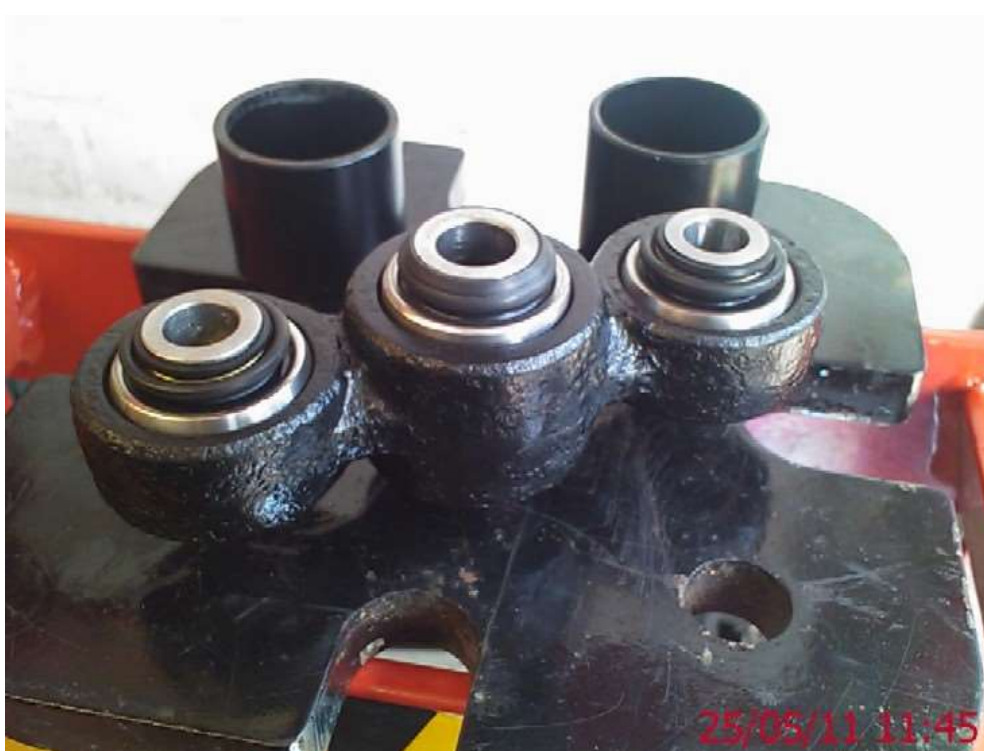
*Push the new central bearing and outer bushes into the pivot link so they protrude equally out each side.
Picture below of new bushes fitted in the nicely painted watts pivot....*

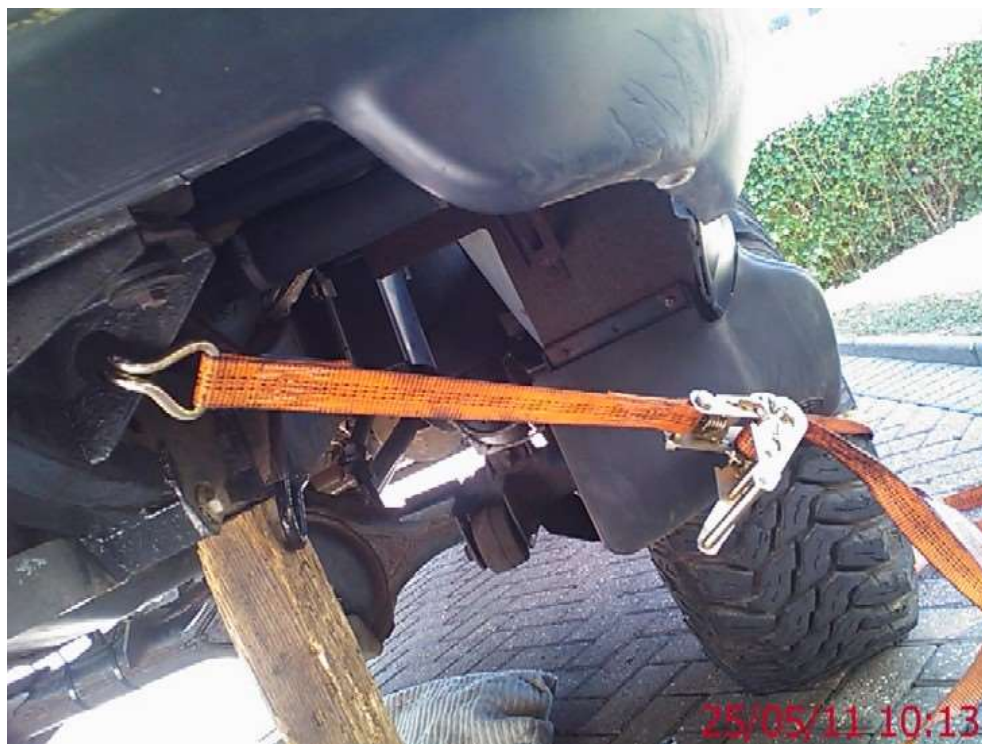
Now my drive way is relatively level, however the body had still moved slightly to the left meaning I could not get both link arms in where they bolt to the chassis.....

To combat this, I used a ratchet strap hooked onto one of the rear body mounts and the rear wheel and "carefully" ratcheted away until the body moved across so I could fit both the outer bolts....
