Faults and Fixes - Gearbox Oil Cooler Pipes

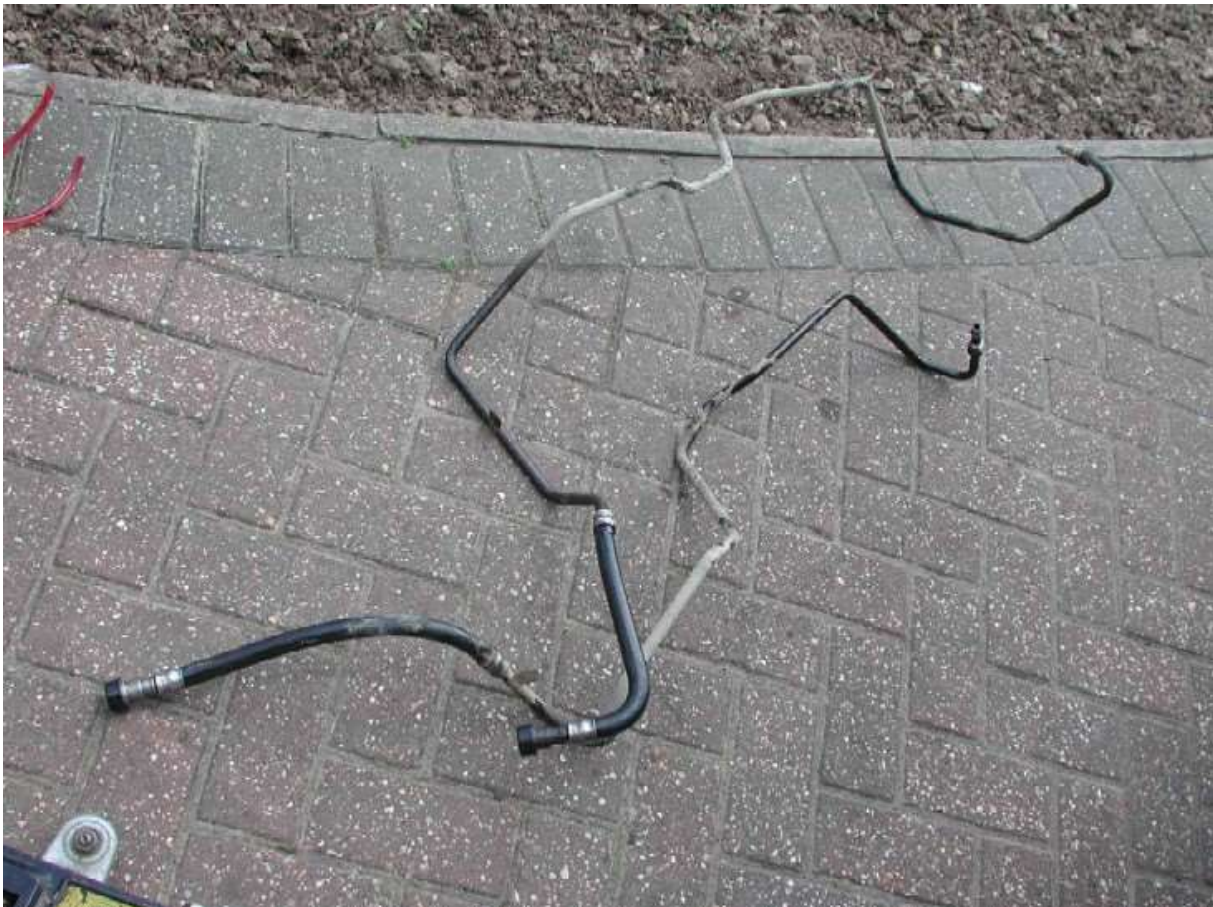
Above is the cooler pipes for the Auto box, there is 2, they run from the gearbox where they are solid rigid pipes, and just in front of the engine they change to flexible pipes that are swaged onto the metal ones.

You can see them here by the gearbox sump.

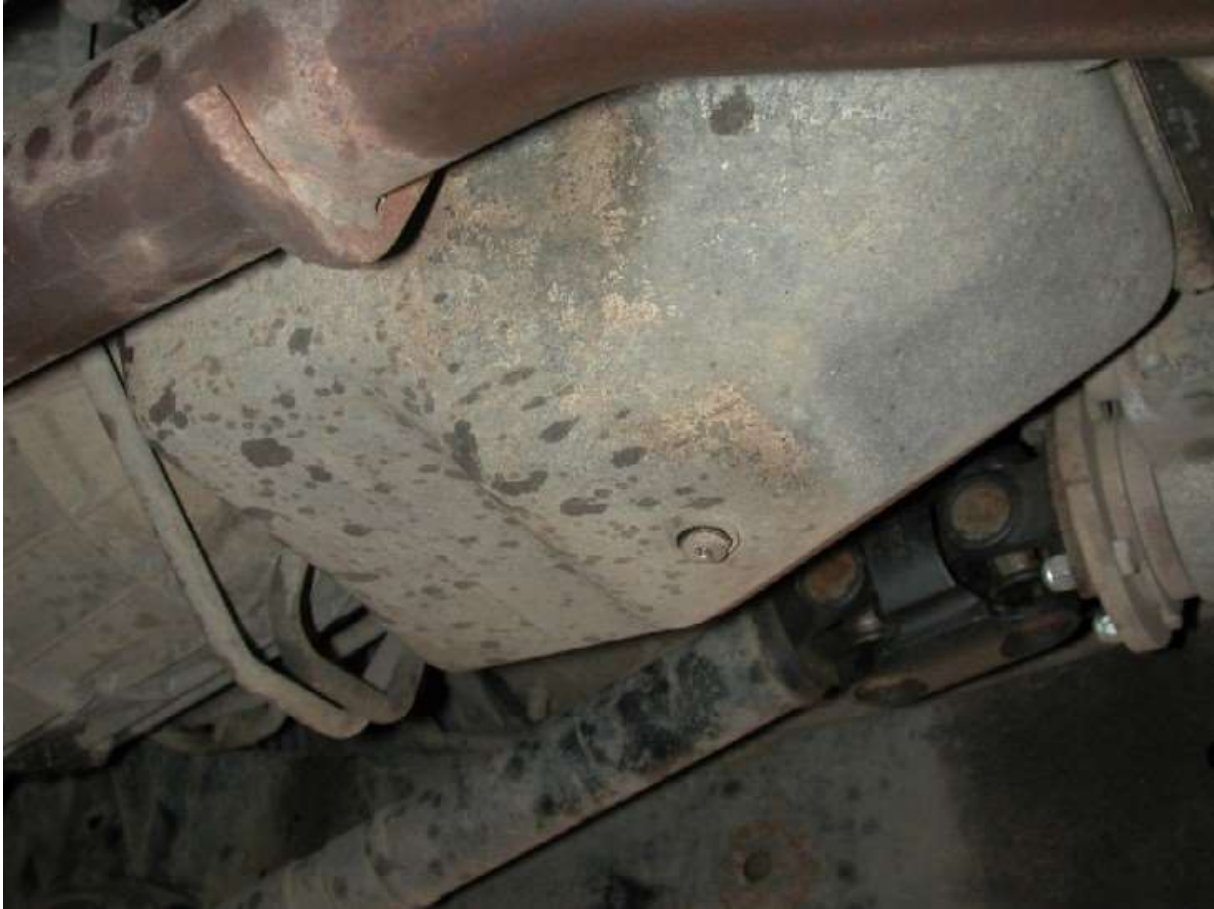
They then run down the drivers side of the engine in rigid clips and up to the oil cooler. Below is the 2 "quick" release couplings at the oil cooler end....

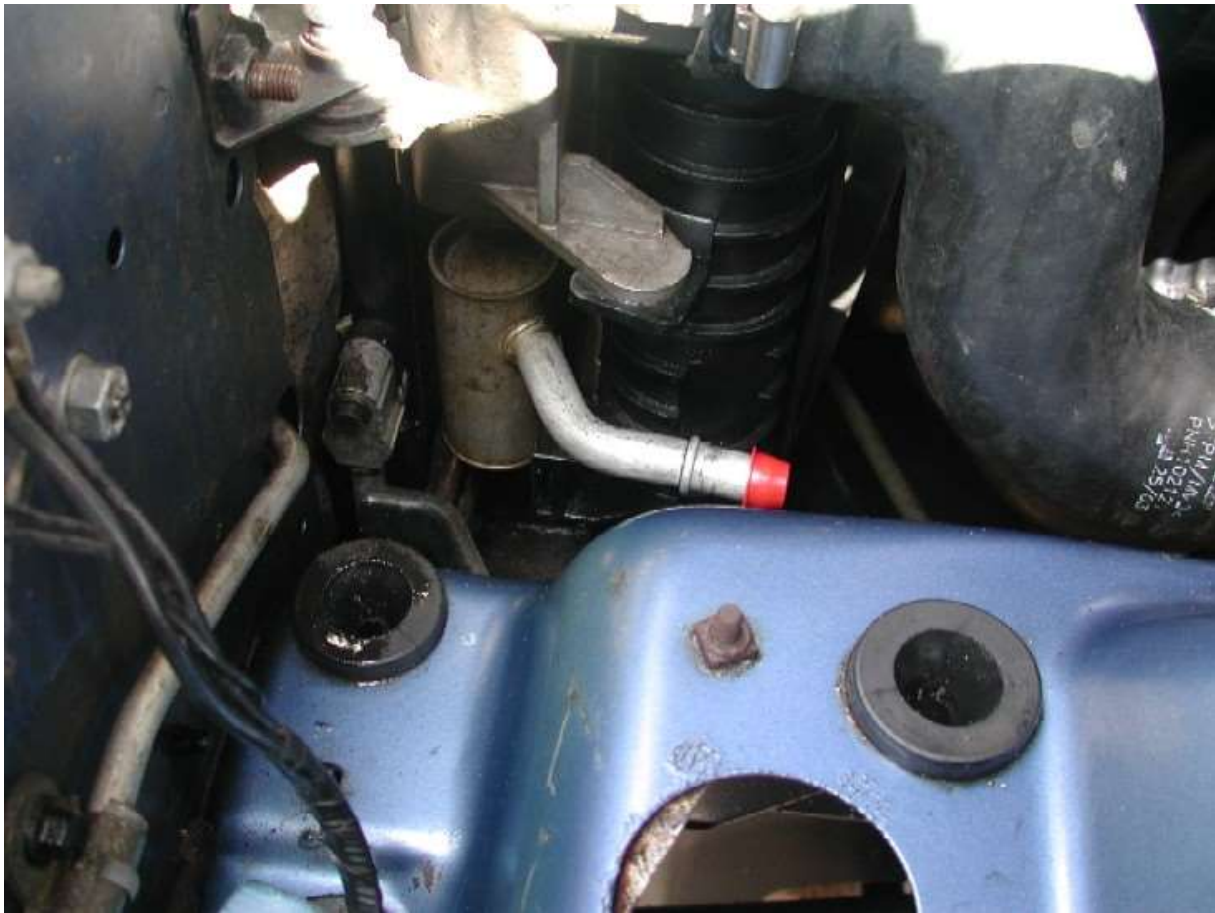
below is the passenger side (UK car), the Air filter housing is removed for clarity

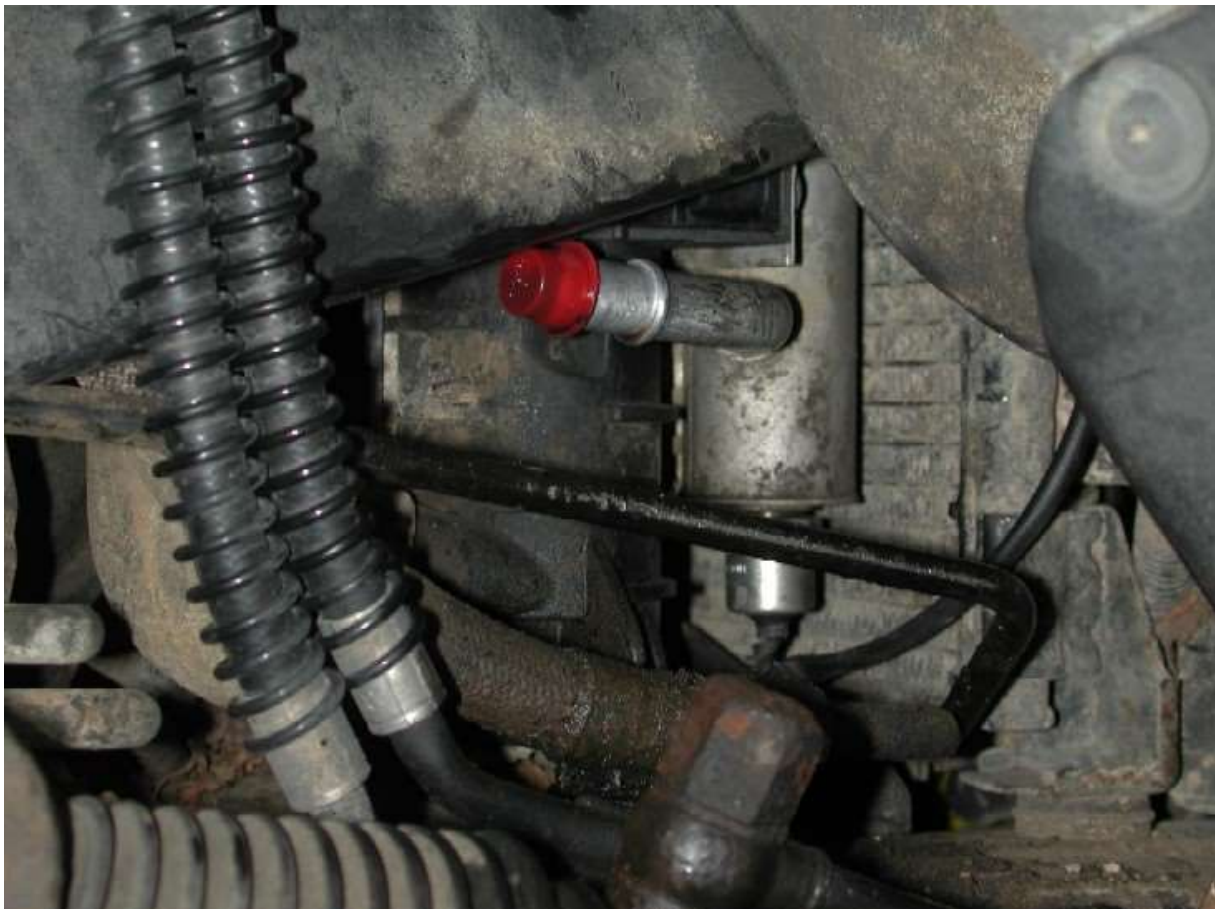
And the drivers side, there is a small plastic panel in the inner wheel arch behind the ACE actuator which is removed.....

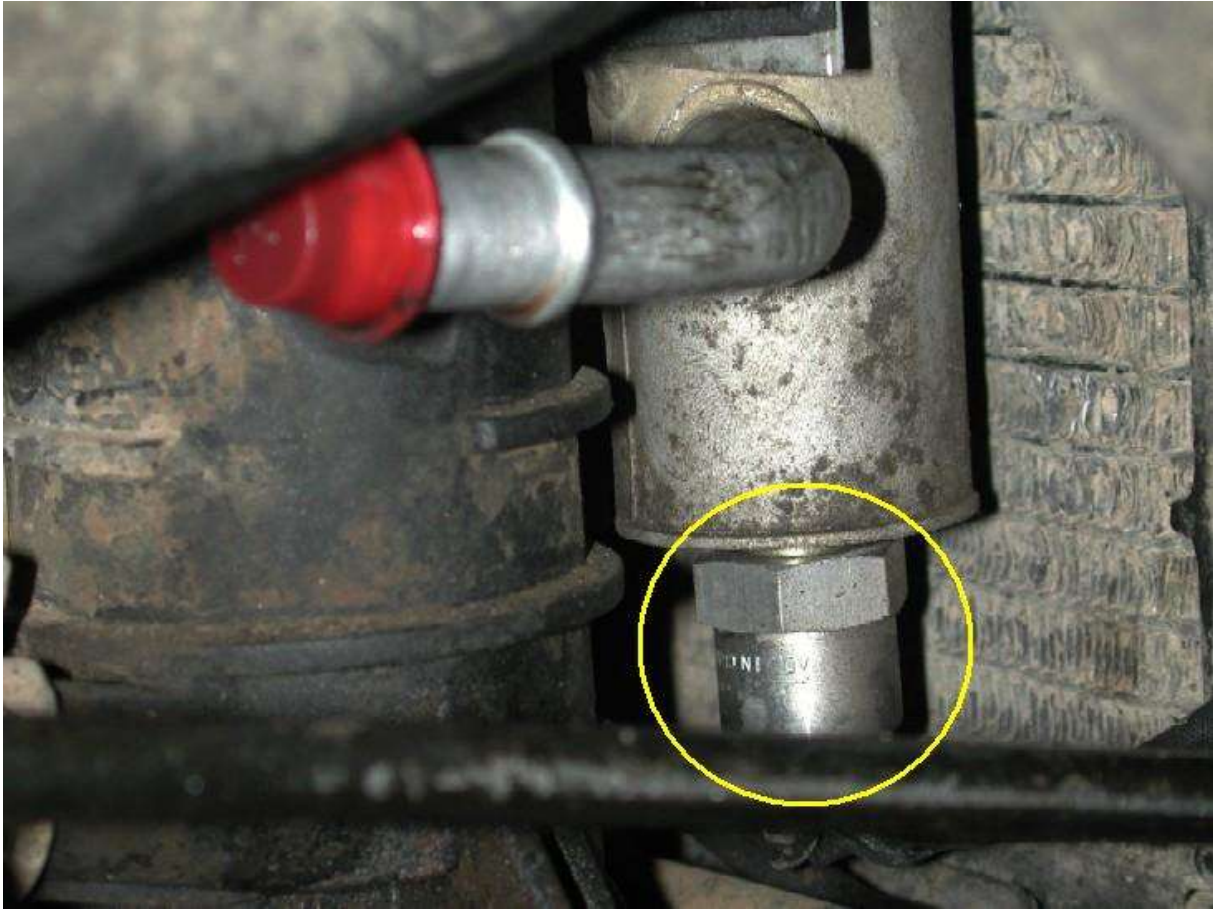
NOTE!!!!.....Also, in this picture below you can also see the gearbox Oil Temp Sensor (circled). These are also known to be a little "iffy", replacement normally involves removal of the intercooler and oil cooler etc to get to this part. I even changed mine this way, that was before I had even noticed this little access panel.

I personally think you could change this sensor in situ through this access panel, that would mean the time and amount of parts you have to remove would be significantly reduced!!!

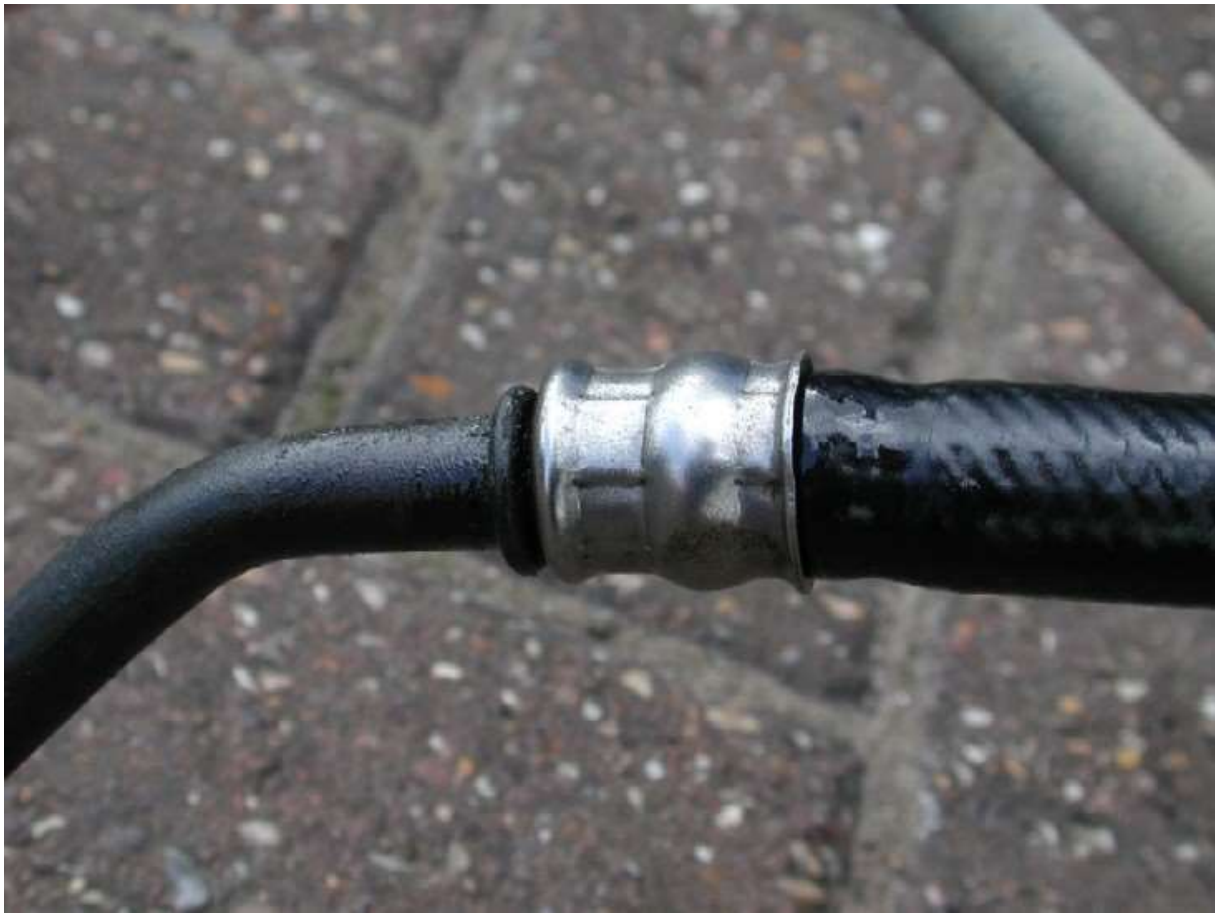
Here's the pipe, the left hand side cooling pipe, you can see what it SHOULD look like, a swage that should last the LIFETIME of the car.....

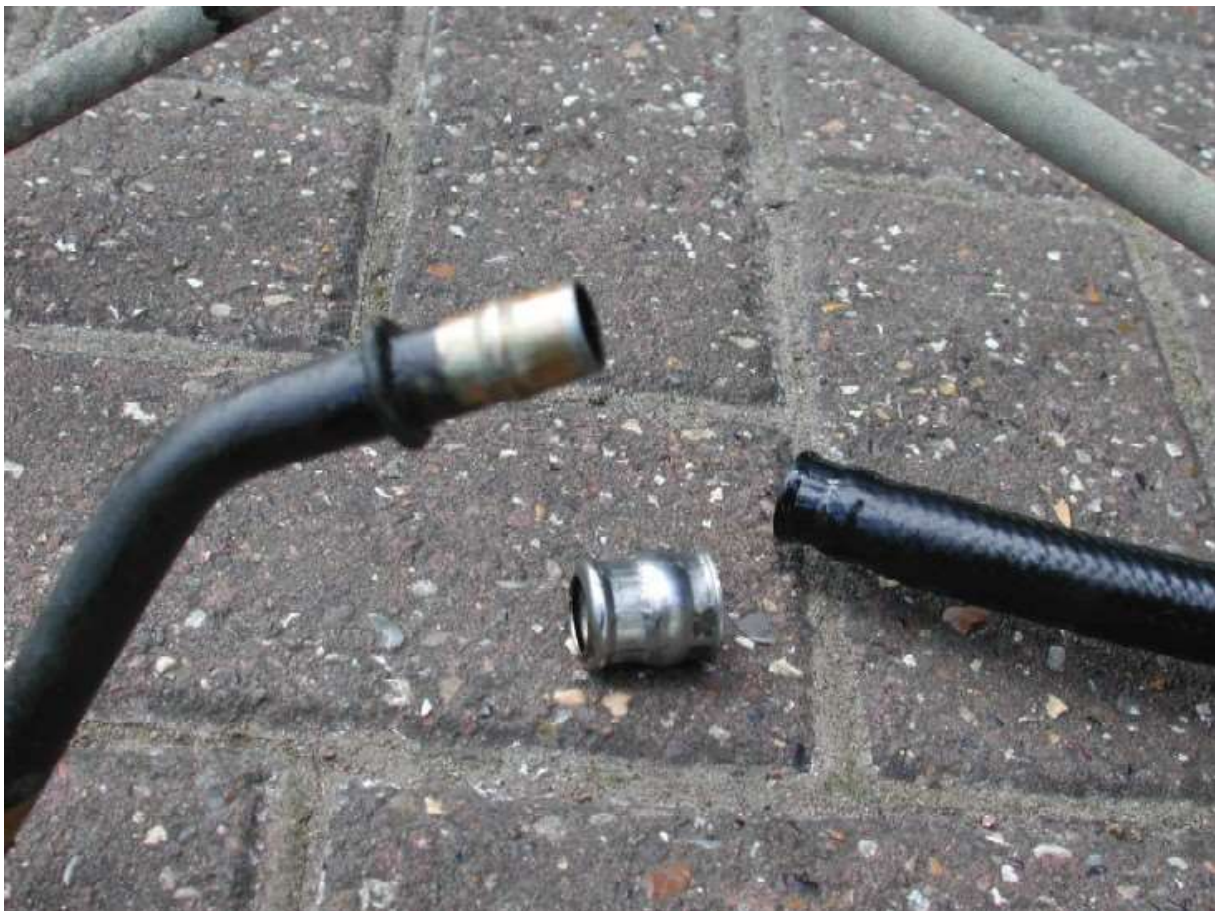
Ok, back to the pipe failure, well did it split ?? or chafe through on something ? no.....!! the pipe literally come apart at the swage, not an issue I would EVER suspect, but clearly a manufacturing fault and if the vehicle was under warranty I have NO doubt you would have a claim. I did even consider contacting Land Rover to show them how bad this is!!!.....maybe I will.....to see what they say.....

However, the gear box oil pressure, or a simple tug and this is what happened.....

Not good is it!!!!very disappointing to be honest.....

Anyway, I have not done a full write up on this issue, but I would recommend that at some point you check out the pipes on your vehicle to ensure they are secure / not leaking etc. The new pipes are approx £50 a side, I replaced both to be safe and hopefully they will now last longer than the failed one. Both pipes run together and its pretty straightforward to see where and how they go.

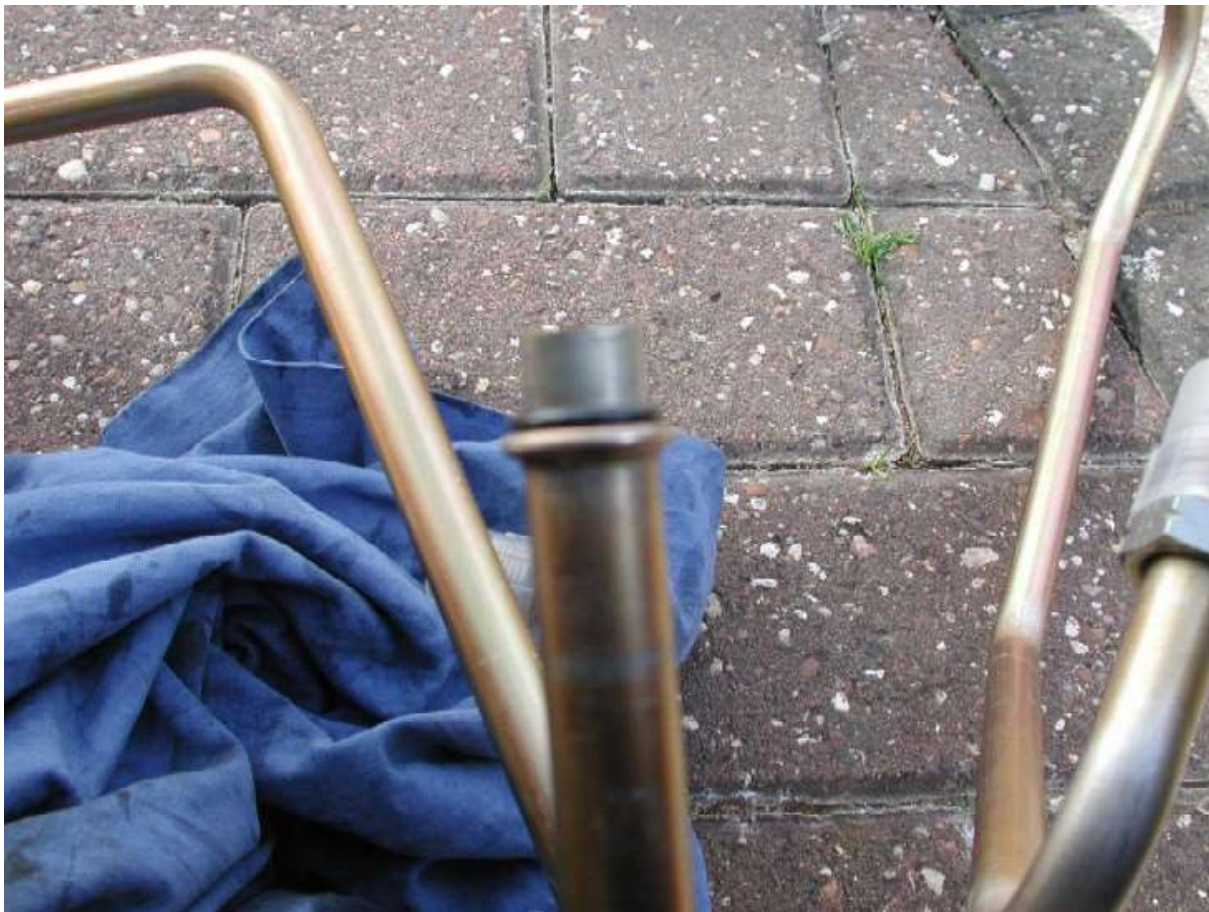
They are a little "fiddly" to remove them over the cross member purely on the fact there is lots of twists and turn in them. The New pipes come ready fitted with "o" rings for the Gearbox end

The top pipe at the gearbox end is in a "tight" spot, and you will require a 19mm crows foot spanner to undo it.

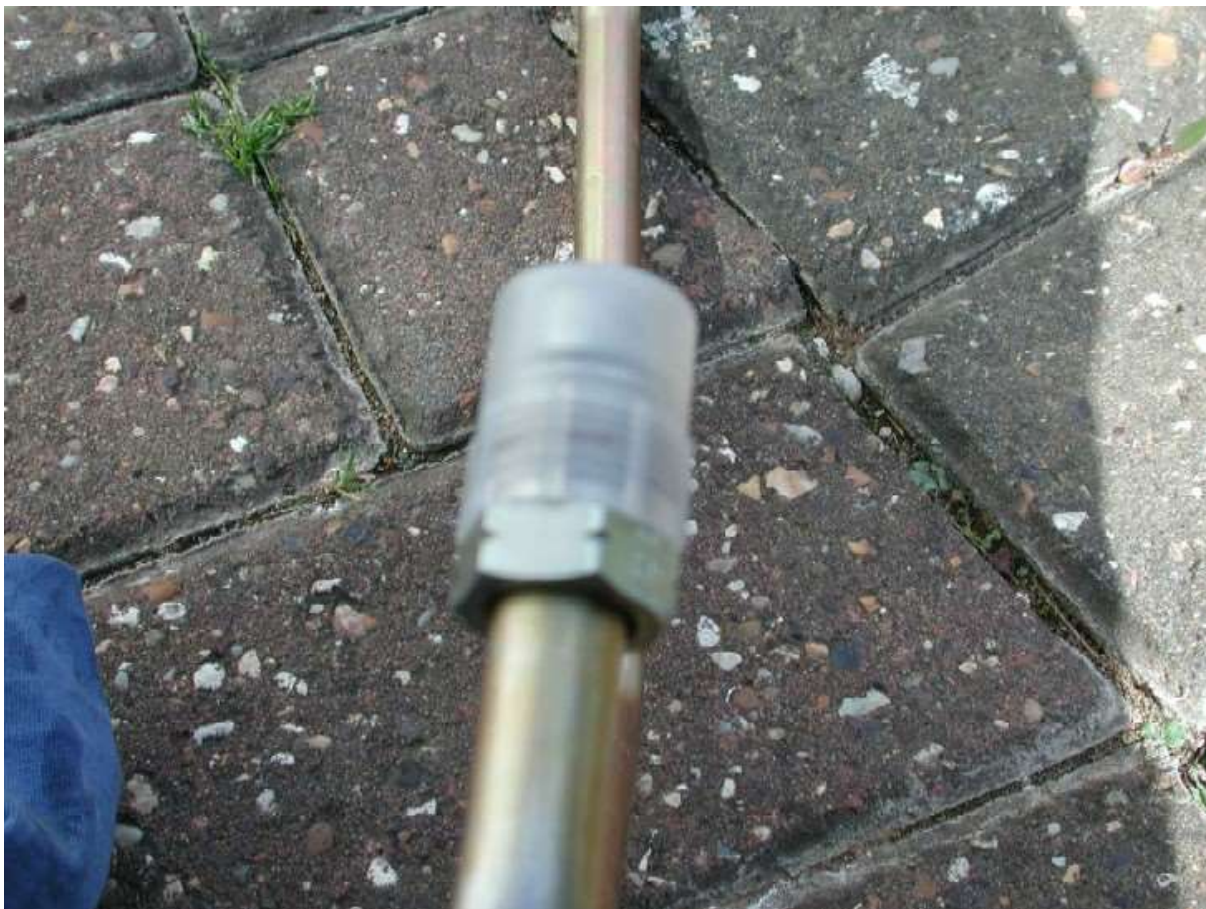
The pipes come with plastic blanks on either end and I STRONGLY advise you leave these on until you have fed them into position over the cross member to eliminate any risk of getting dirt etc into

them...
