Rear Passenger Door lock Assy / Motor

Here's another of the "common" faults or failures on the Disco 2, the door locks. These can be slow to operate, operate intermittently, or pack up all together......it also seems to be worse when the outside temperature is colder, and that's usually when they finally give up. There is no "quick" fix to be honest, if your door locks are playing up, its time for a new one. They retail around £60 a door and are all handed due to the fact the motor / lock assy is all contained in one unit.

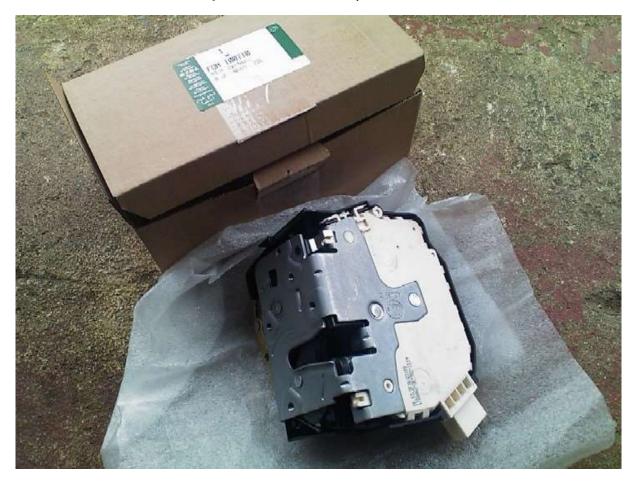
Above is what they look like, all 4 doors have similar assy's, but the drivers is slightly more complex as it has the key / switch assy on it as well.

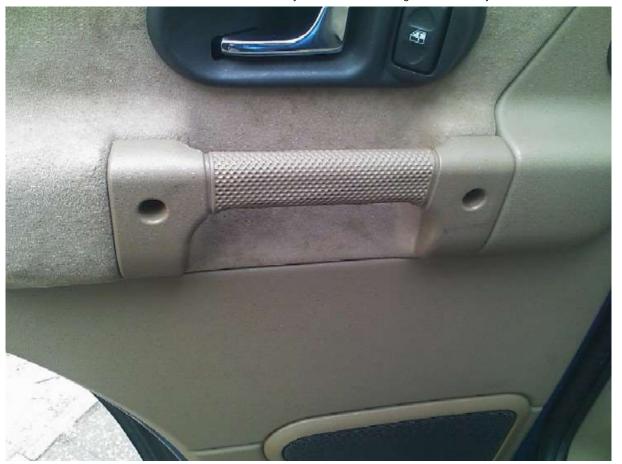
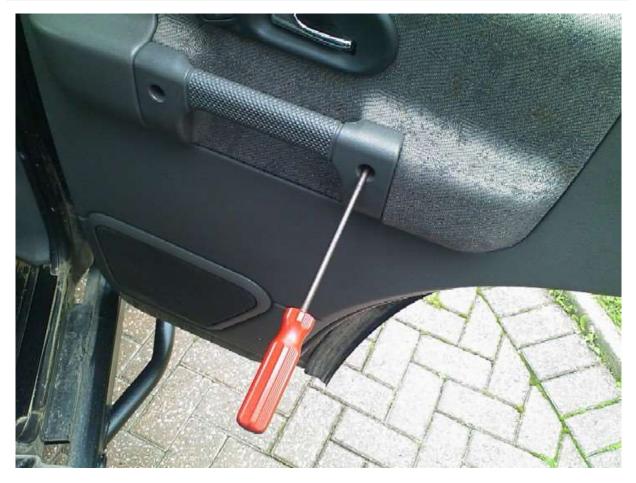
To start with you have to remove the door card / interior trim, to do this start with the 2 screws located in the door handle.

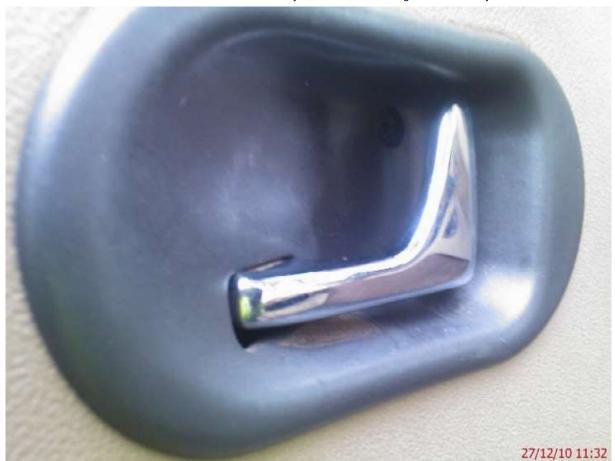
Next you need to remove the screw that holds the inner handle finisher on.

NOTE:- Front door shown, ALL doors similar.

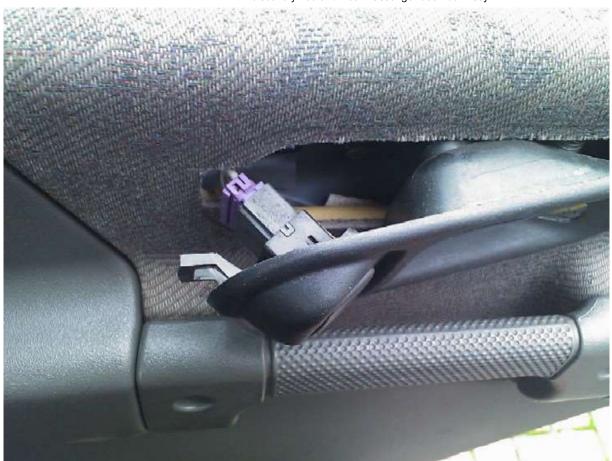
Once the screw is out, carefully lever out the trim and then disconnect the electrical plug to the window switch.

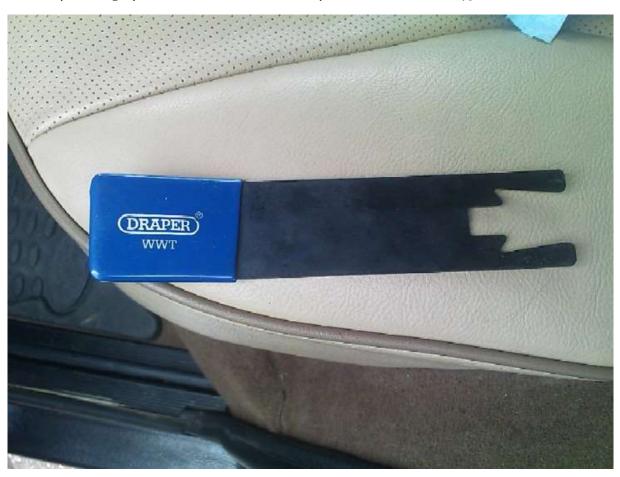
Next using a trim removal tool, or wide bladed screw driver, "carefully" lever the door trim away so you can get your trim tool etc underneath by about an inch or so. (typical tool below)

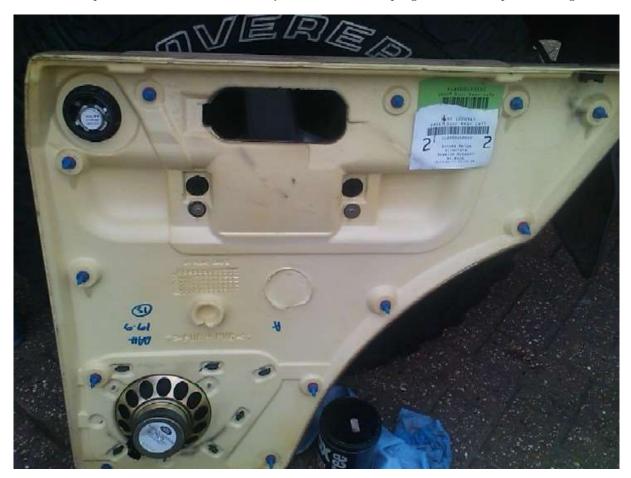
Use the picture below to see where they are located, Trim plugs are the blue plastic things.

It is highly likely you "may" break one or two, or even more, depending if the door trim has been removed in the past and how carefully it was done. The trim plugs are only cheap and can be bought in packs of 10 from Ebay and all land rover parts places. Good idea to have some new ones before you do this job. Link below as an example

Some of the trim plugs may pull out of the door retainers and remain on the door, these are the ones that will need replacing, simply remove them from the door and clip the new ones back onto the trim panel. Its pretty self explanatory when you see them.

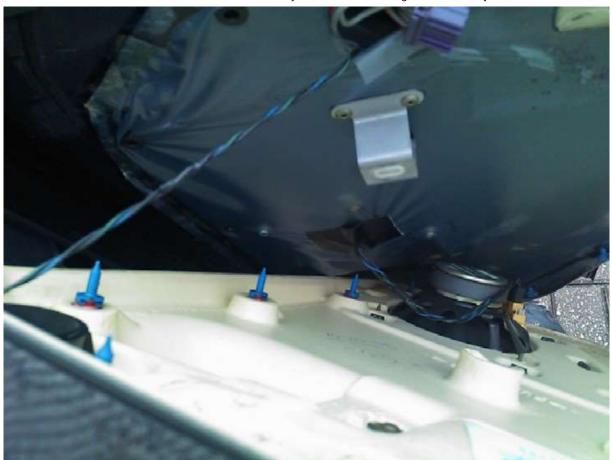
DO NOT pull it away to far as you still have to disconnect the 2 sets of wires running to the door speakers (shown below)

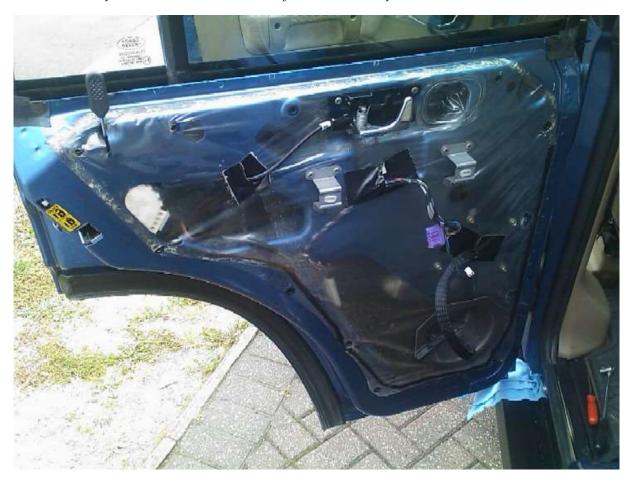
Once they are disconnected the trim is free to come away and this is what it looks like....

The door lock assy / motor can be seen in the top left of the door (white plastic item). The door is covered internally by the dust sheet / splash guard and as with all cars I have messed with over the years it is very difficult to remove / peel away this plastic liner without it tearing!!!.....take your time and slowly peel it back, if it tears don't worry to much as it can be re-taped together when the job is complete. You need to peel it back enough so the liner is back to where you see the steel bracket in the picture above that mounts the interior handle, it will most likely tear as it comes around where the trim plugs go.

If your splash guard was torn when removing it, then use a good quality duct tape or similar (not insulation or masking tape) to repair it. Where the splash guard is on the outer edges, it will still be able to be stuck back down with the factory "putty" used.

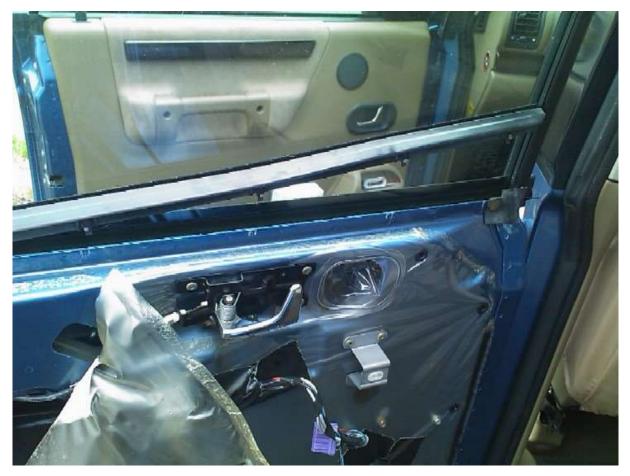
Next is the interior weather strip, that is simply a "push fit" and is clipped to the metal on the top of the door, it contain a metal "inner" which will bend out of shape if you are to aggressive with it, simply pull it directly up the door to remove it....

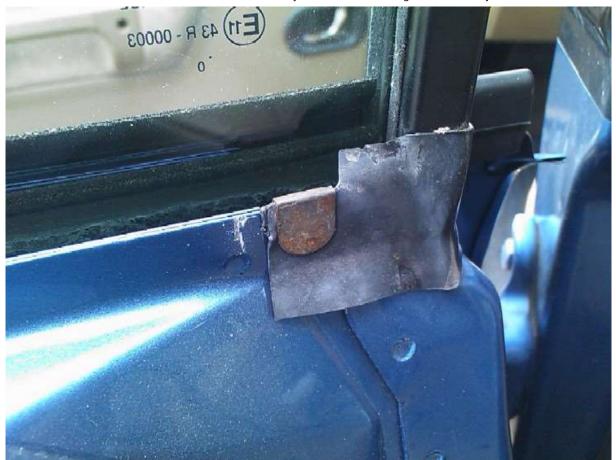
The next part is to remove the outer weather strip, that is held on the inside by 2 spring clips just exposed be removing the interior weather strip...... one at either end....fwd one here......

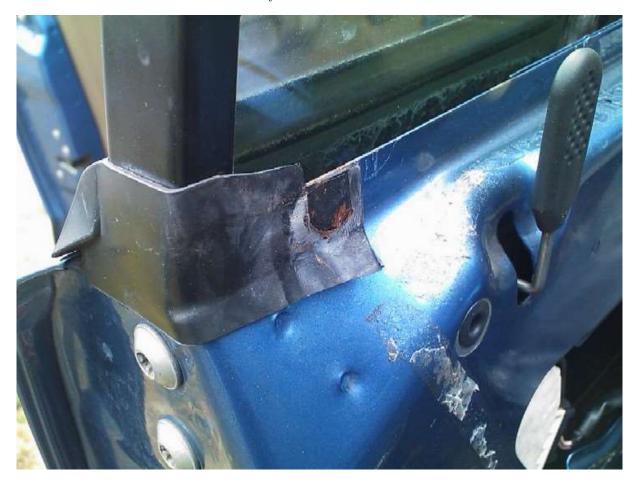
Aft one here.....

Carefully prize them up with a small screw driver to release the trim, then once they are both off, you can CAREFULLY remove the weather seal by lifting it directly up the window glass, DO NOT use to much force as the strips contain a metal insert that will bend and go out of shape if you are to forceful with it.

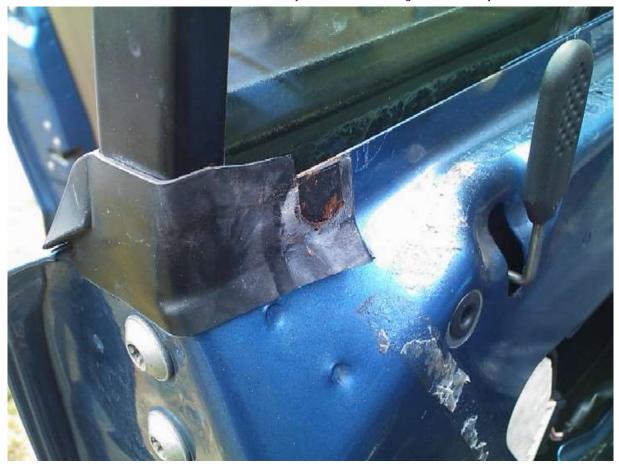
Once that is removed we now need to start releasing the door window frame (black part). That is held by 5 Torx bolts (silver) on the outer edges and 1 bolt between the quarter window and main window......

2 Torx here....

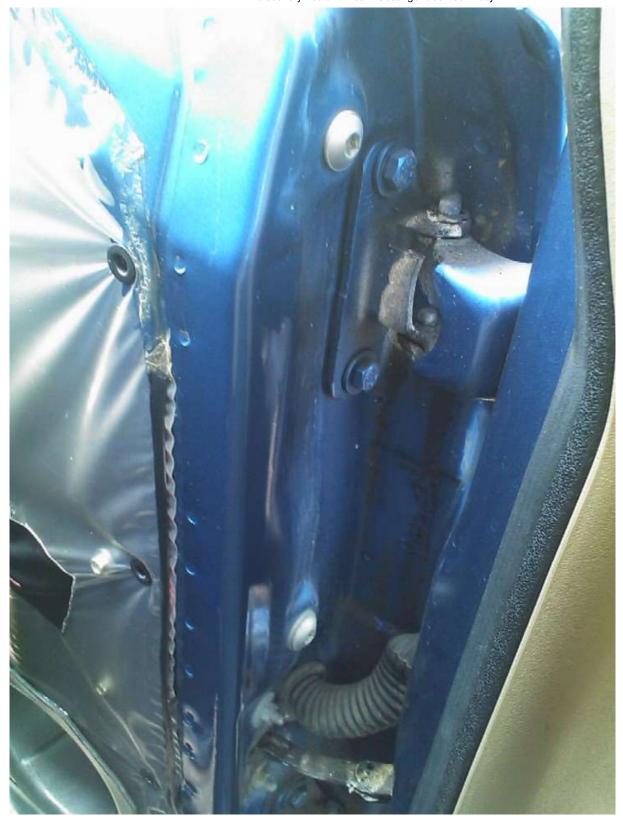
2 more on the front face by the hinges here

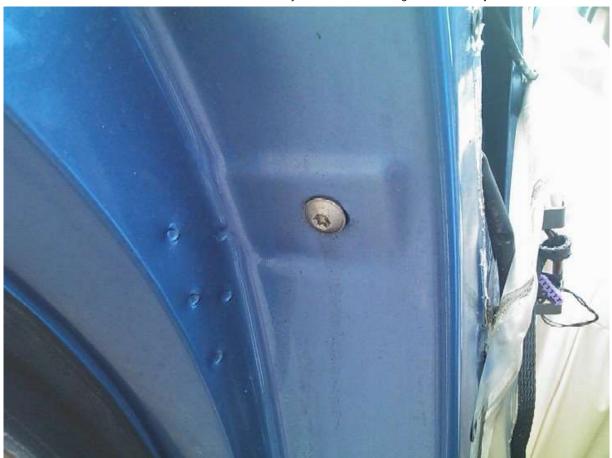
And the central "pillar" under the wheel arch section......here...

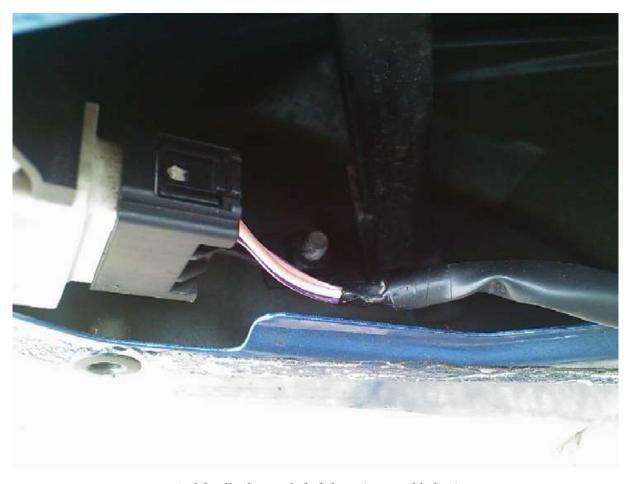
and the inside view of the above bolt....

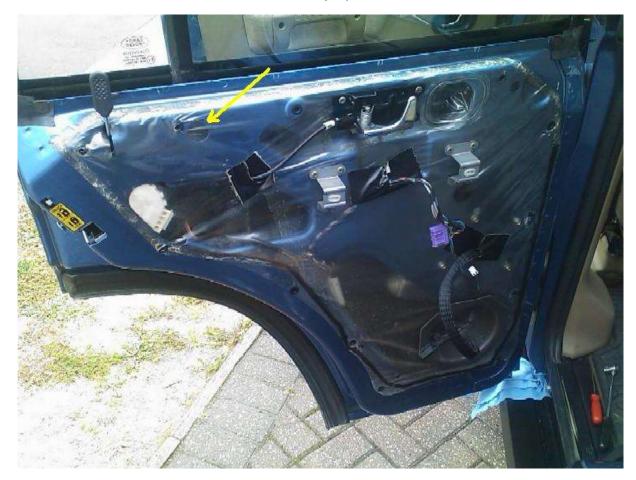
And finally the single bolt here (arrowed below)

Pierce the water shield carefully to access the bolt....

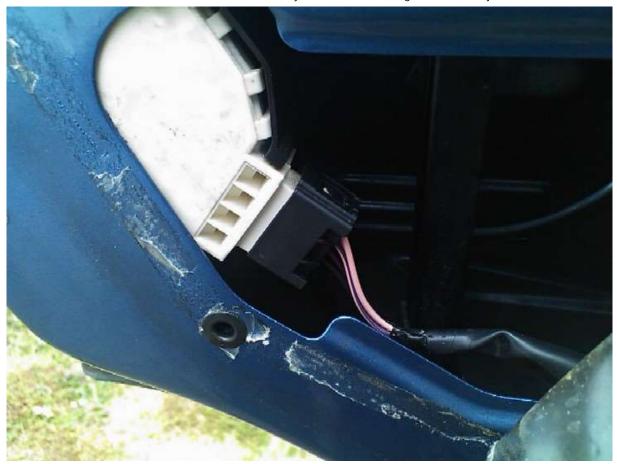
Now the door frame is "released" we can when needed lift it up to gain enough clearance to remove the door lock motor assy. So now disconnect the door lock electrical plug (below)

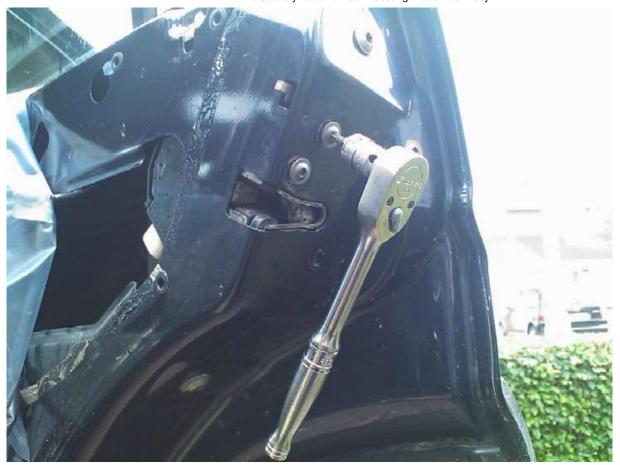
Now we need to undo the retaining bolts for the motor itself, these 3 are in the wheel arch face of the door.

Remove 2 completely and leave one finger tight to stop the motor dropping into the door.

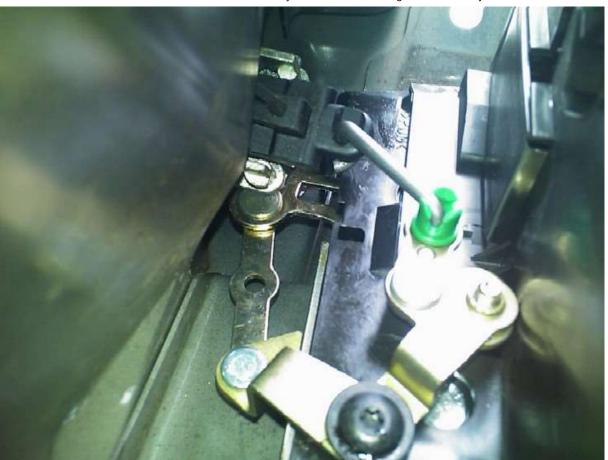
Now the fiddly bit, you have to disconnect the rod from the lock assy that connects it to the outer door handle, its VERY difficult to even get your hand in there let alone a camera, but I tried to show it below....

You can see its "clipped" into the green retainer, does not take much to unclip it and leave it connected to the outer handle. It pulls "out" of the <u>retainer towards the door hinges</u>.....

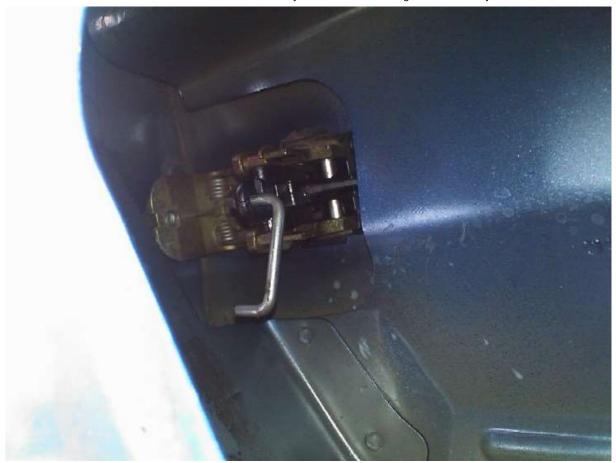
Picture below with motor removed......

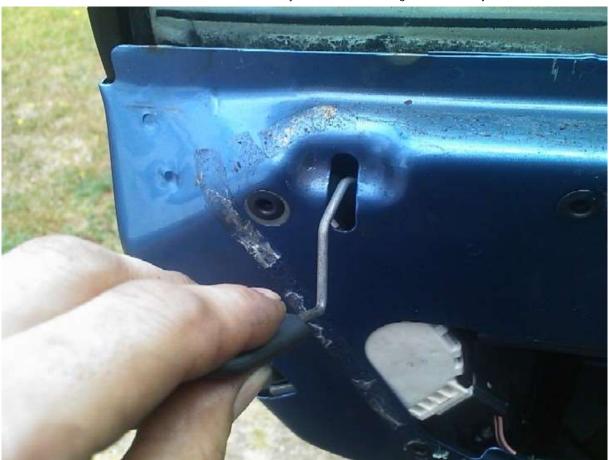
Once that's done, you also need to unclip the door lock button, that is held in exactly the same way and if you put your hand in and unclip it towards the outer door handle, you can then completely remove that out the way.....

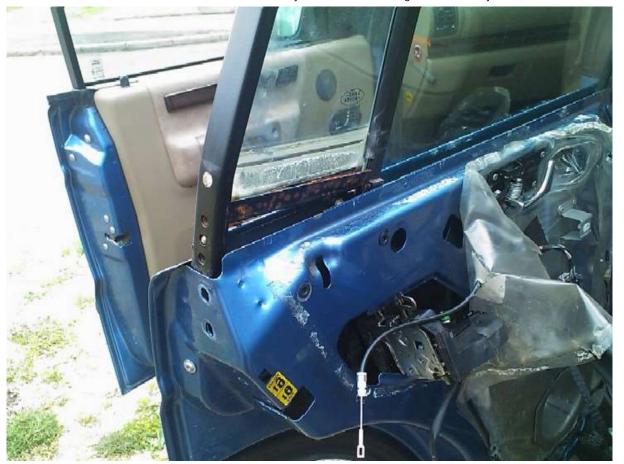
Now we are pretty much ready to get the motor out, it is still connected to the interior handle release cable, but that can be disconnected once the motor is out, once you have done 1 door you would be able to disconnect that from memory before removing the motor assy. So carefully lift the door frame assy up about 3- 4 inches at the back end, having a second person here to help support it would be advisable......

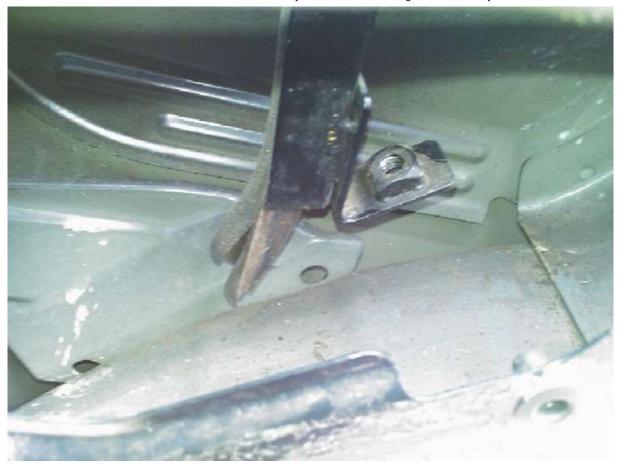
The amount you lift it is up to you, but you only need to give your self enough clearance to get the motor past the middle part of the frame that is bolted to the wheel arch section of the door.....so remove the last finger tight bolt in the motor, and with assistance ideally, lift the frame and tilt the top of it towards the back of the car, this will move the lower part of the frame towards the outer skin of the door....

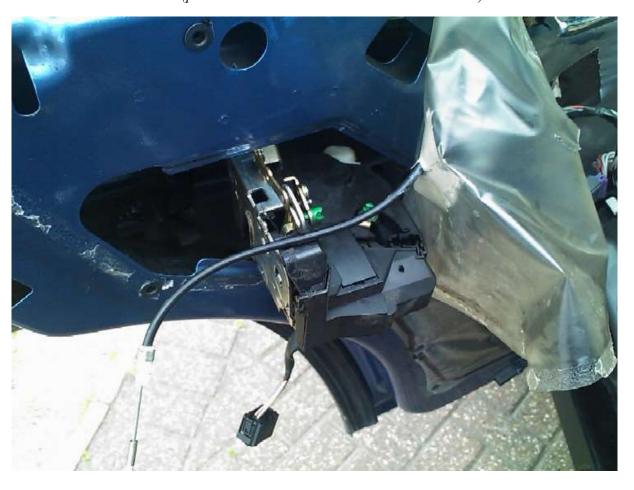
This now gives you enough room to squeeze the lock assy past the frame and out of the hole in the door...(picture shows interior handle cable disconnected)

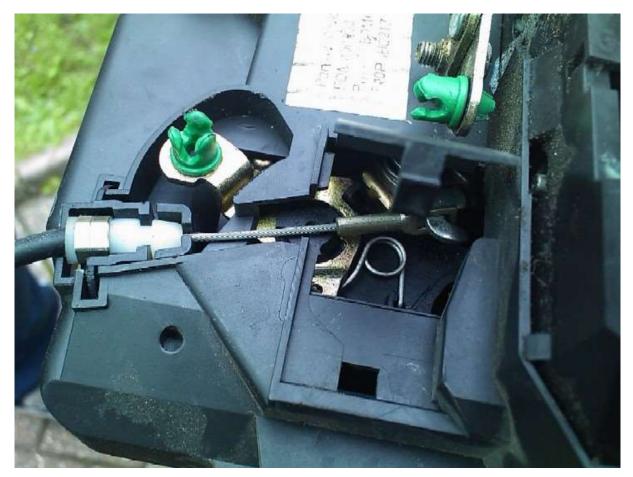
Below shows how the interior handle cable is connected to the lock assy, you lift / unclip the little flap, and remove the cable and un-hook it from the latch assy.....

By all means do this with the motor still in the door (as I did), but if you have not seen or done it before then looking at the picture above will hopefully show you how its connected, there is enough slack to remove the motor and unclip it when its outside the door assy.
