Faults and Fixes - Rear Transfer Box Output Shaft Seal / Hand Brake Shoe Replacement

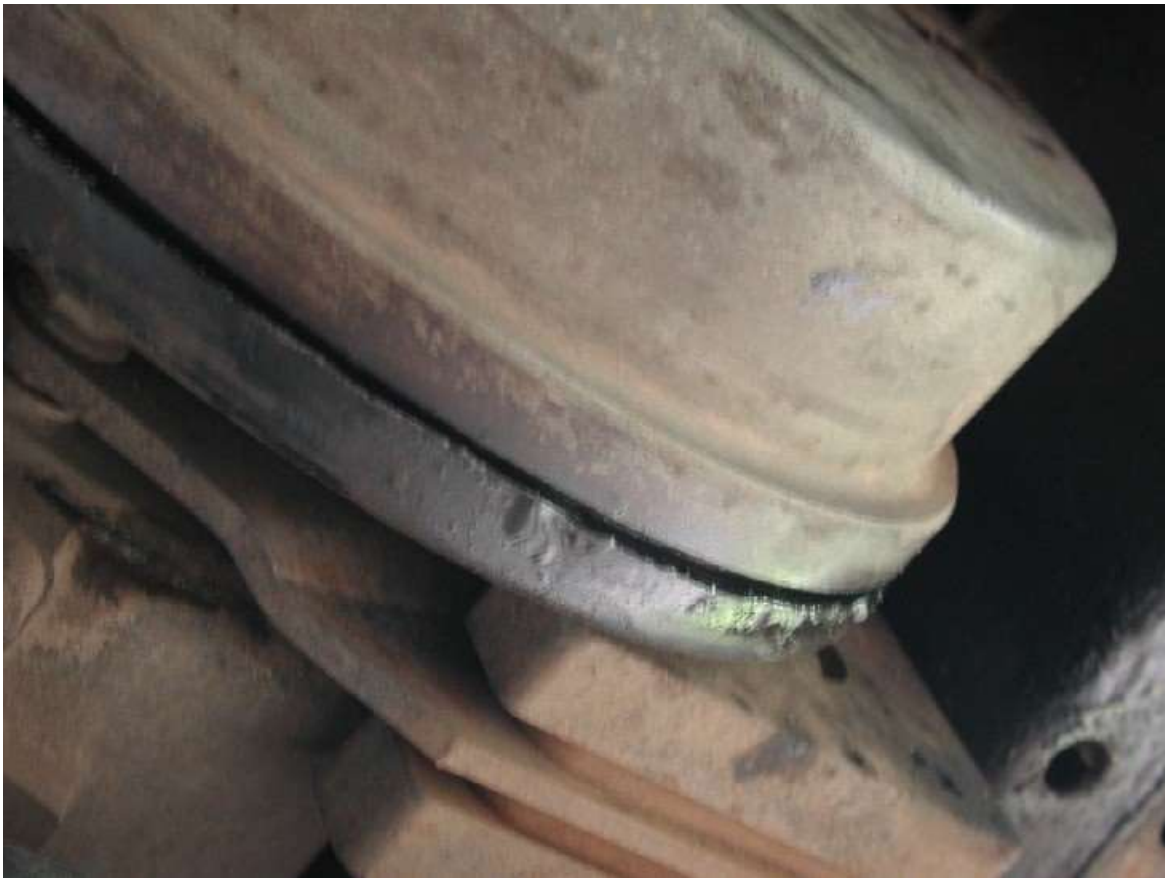
Below you can see the evidence clearly on the bottom handbrake drum, and also on the adjacent chassis rail, so with oil leaking in this area it could only be one thing, and that's the Rear Output shaft oil seal on the transfer box.

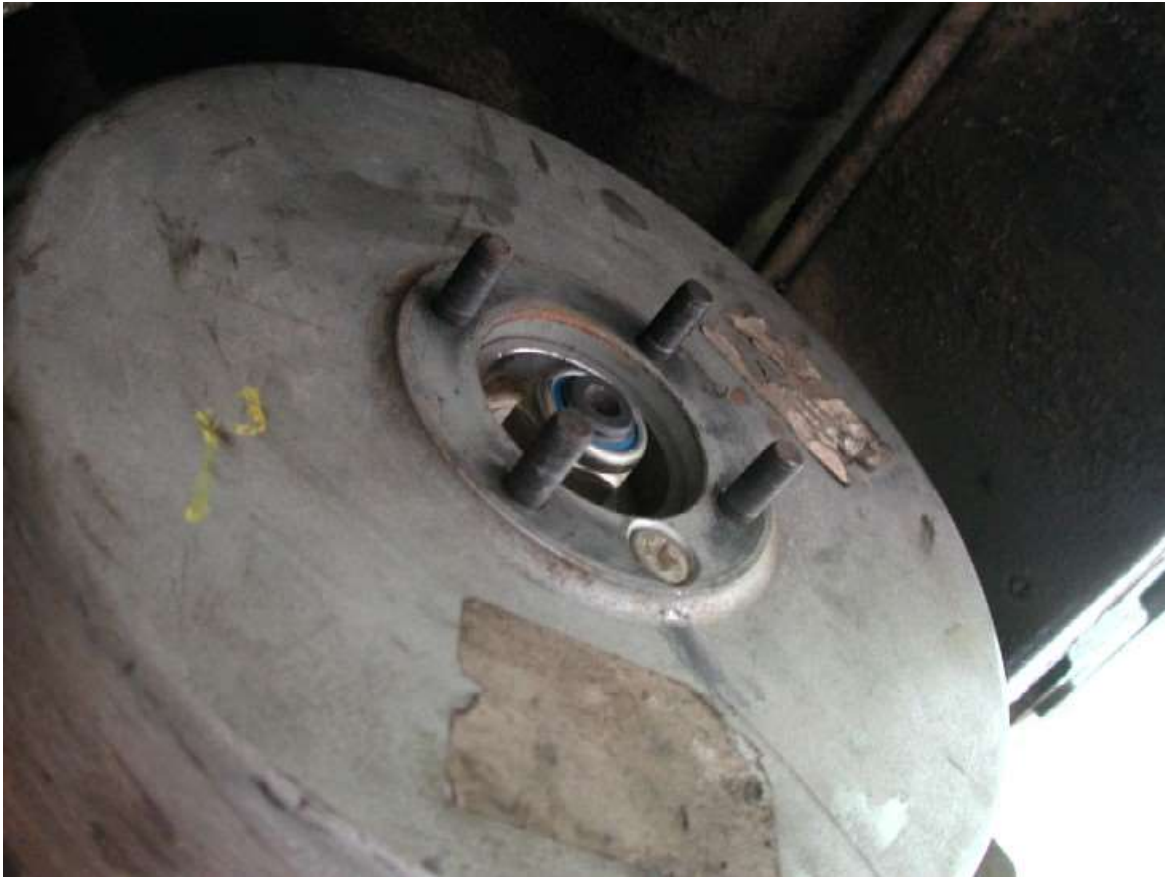
Once its off, that will reveal the brake drum securing screw

Now you need to first remove the rear propshaft, to remove the shaft, simply undo the 4 nuts at the brake drum end, and the nuts and bolts x 3 at the rear Differential end, and it will simply come away once you compress it together.

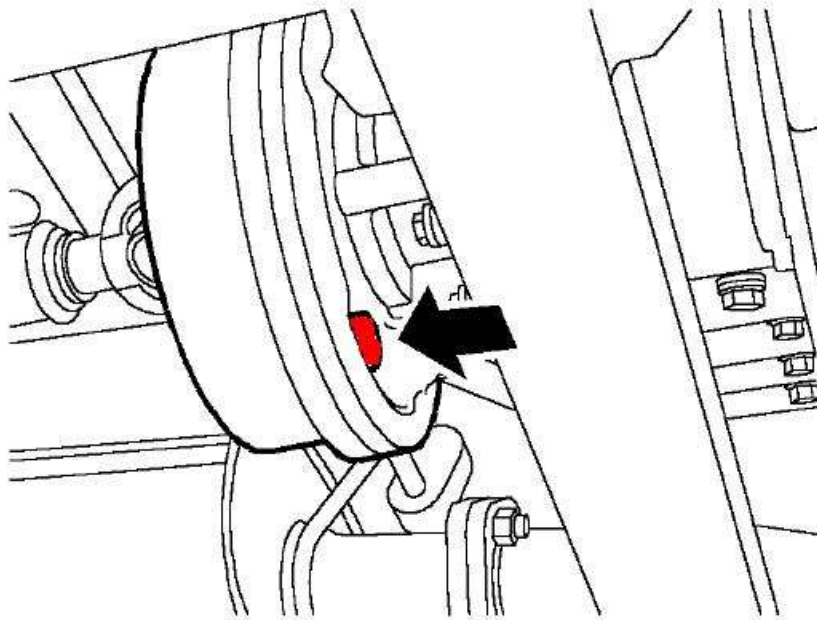
To make it easy to get the drum off, undo the handbrake adjuster bolt several turns to wind the internal shoes in together. Its located on the front face, at the bottom of the hand brake drum back plate and is 17 mm in size

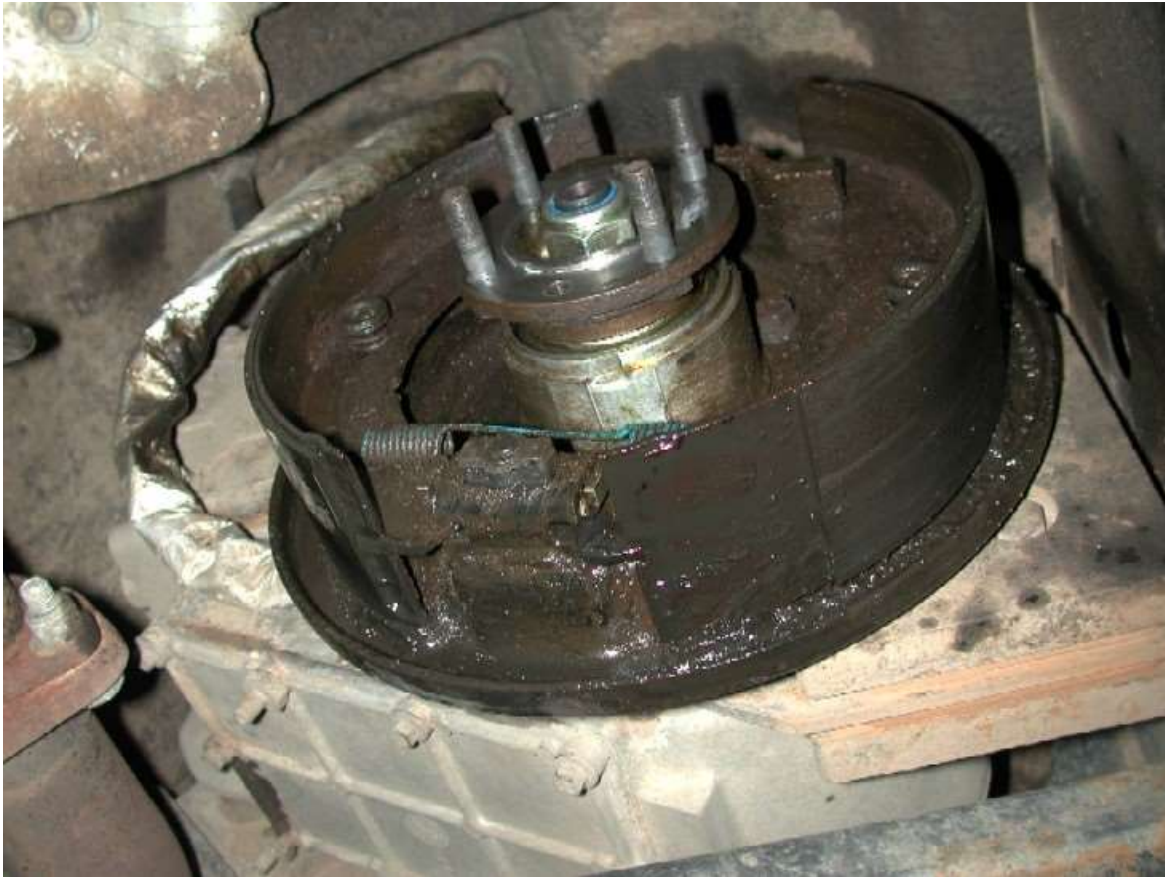
I was confronted with this!!!...

It seems it has been leaking for a "little" longer than originally thought, the brake pads etc were completely contaminated with transfer box oil (hence poor efficiency) , in "anticipation" of this and because the handbrake was becoming less efficient I had bought a new handbrake shoe kit ready to fit just incase...

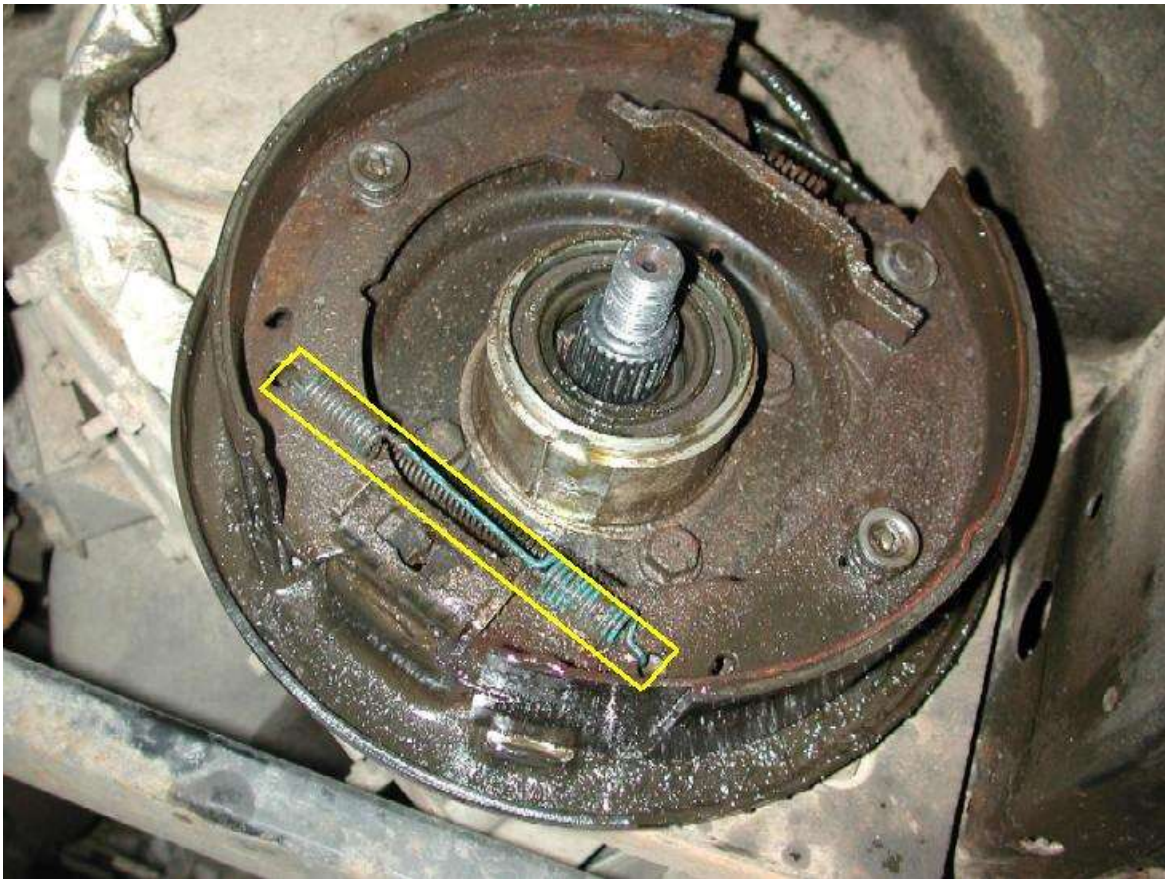
To get the shoes out, first off, remove / unclip the lower spring which holds the 2 shoes together.

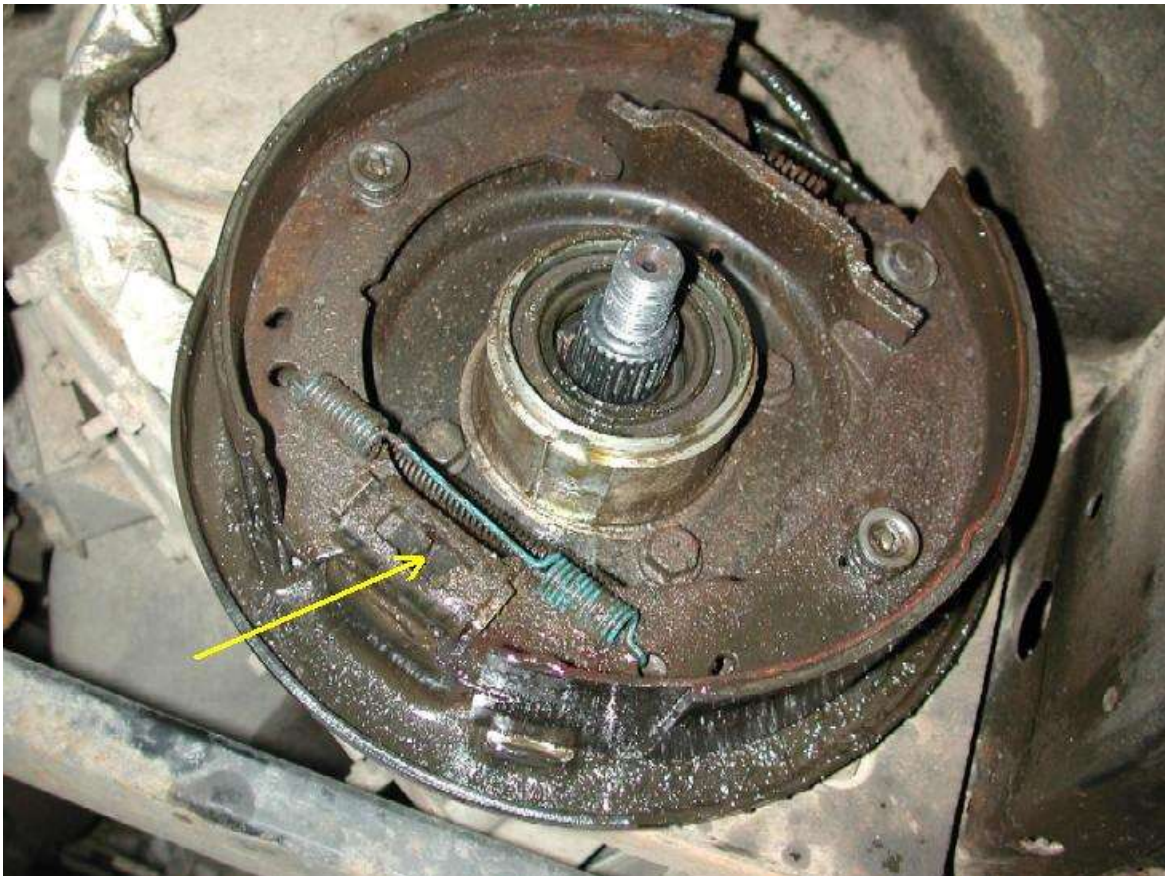
*Then undo a fully remove the adjuster bolt from the shoe adjustment clams (arrowed below) and discard it, the new shoe kit comes with a new thread locked bolt and **MUST** used!! to avoid any rattle in the shoe adjustment assembly.*

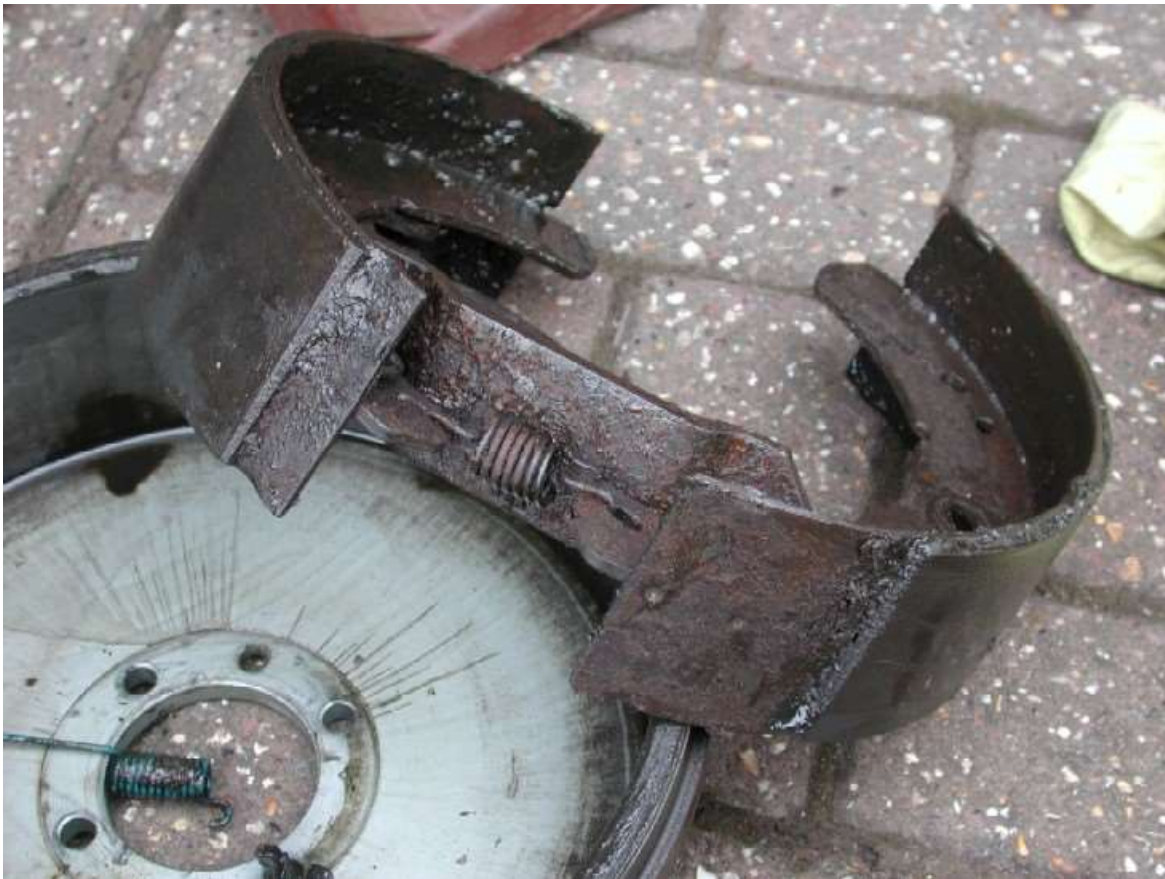
Here you can see the oil contamination on the shoes.....

Now I cleaned up all the brake parts using some solvent cleaner ready for refit after the output seal is replaced.

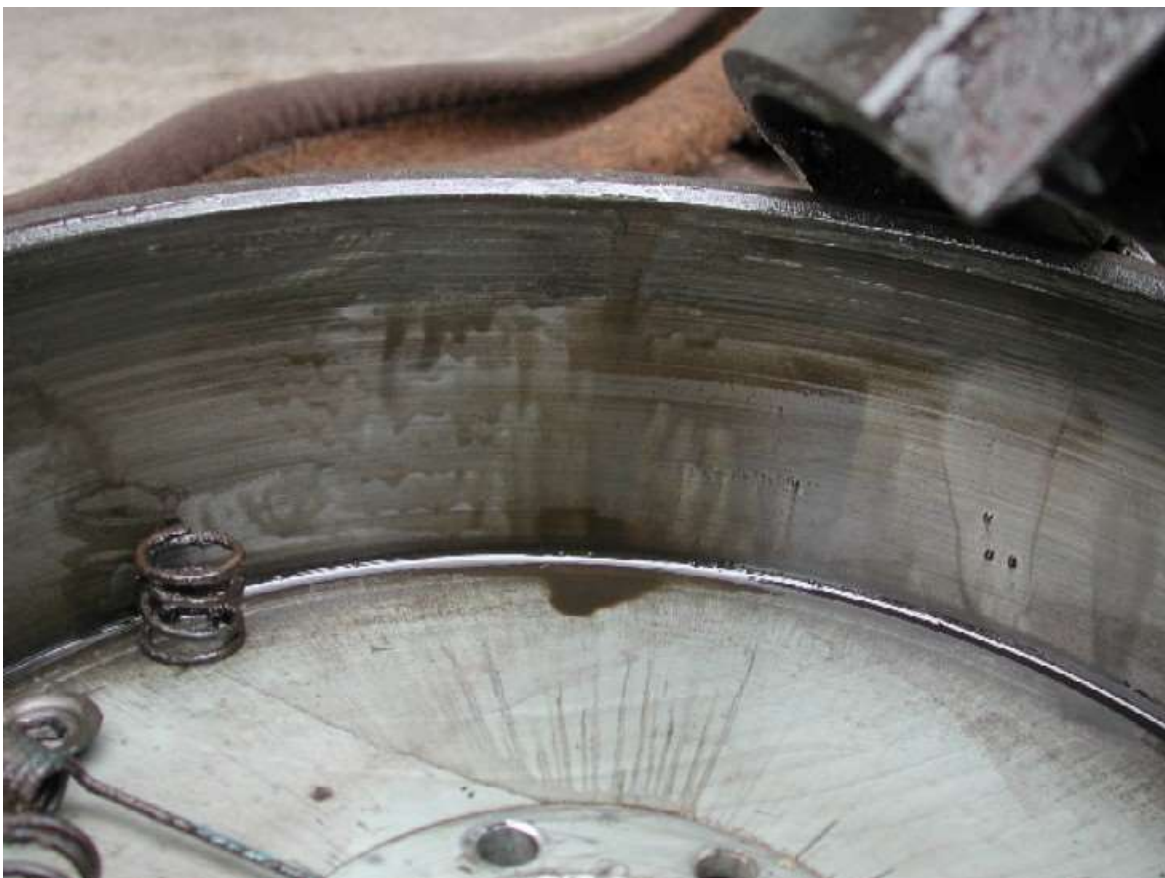
And the oil in the brake drum itself.....

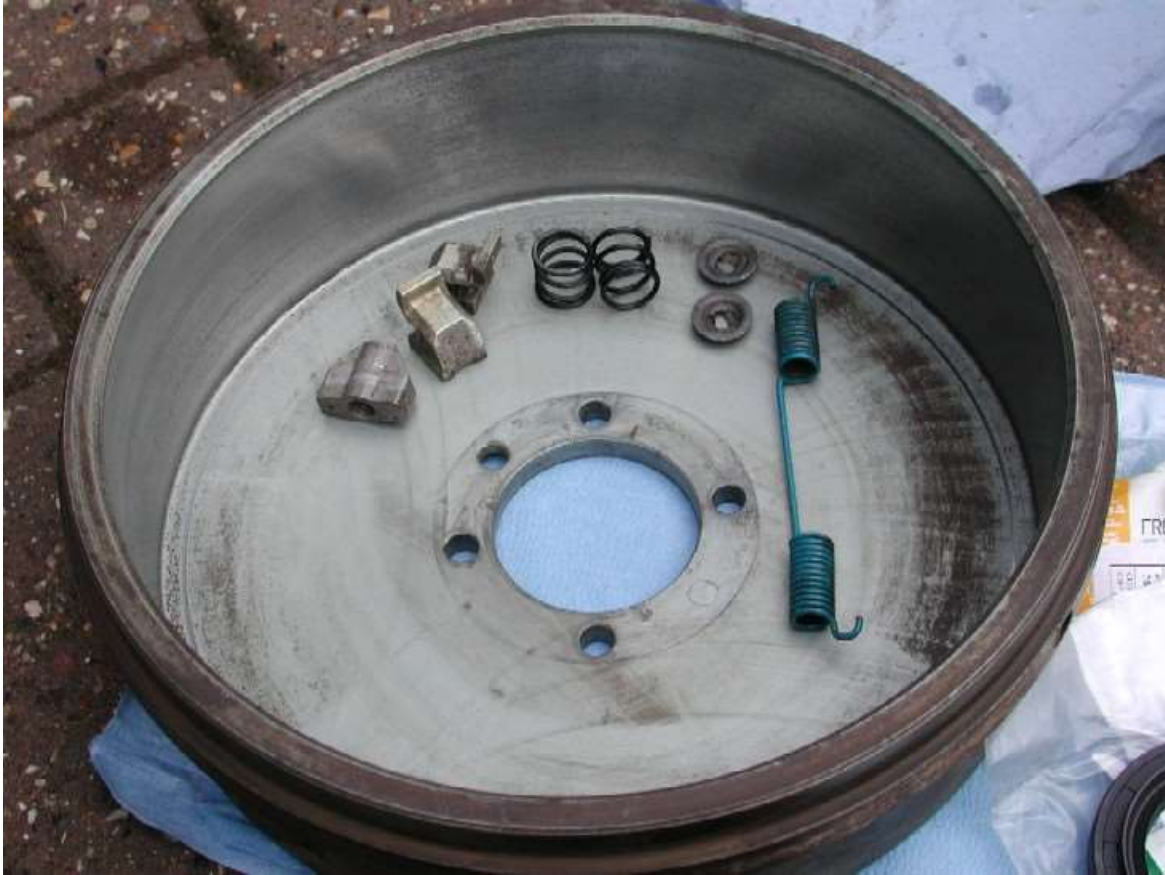
NOTE the only bit you need to discard is the adjuster bolt, everything else is re-used INCLUDING the top spring and plate, and hand brake lever, this has to be swapped over to the new shoes as it does not come with the kit. It is held on by the top spring and a circlip / pin.

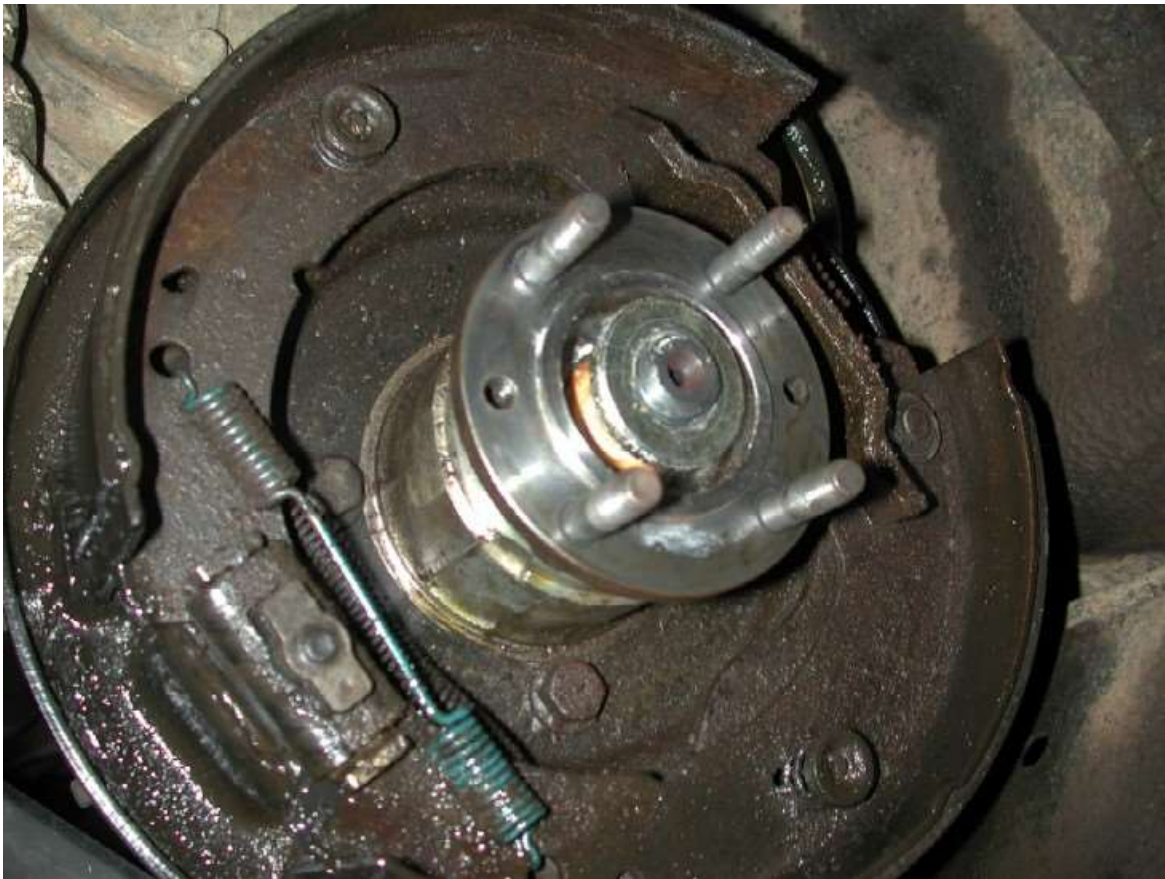
Now onto the seal itself, the rear flange is held on by the central nut, its 30mm in size and is quite tight at around 109 Lbs ft. NOTE, it is a lock nut and SHOULD be renewed!! For info, its an M20 Nylock nut. I engaged the CDL to hold it in position, if you have a Discovery 2 without a CDL, then a tool can be bought to hold the flange whilst undoing the nut, its pricey at around £100, but you may have no choice, or possibly borrow / hire one from an independent or local dealer. or make something up to hold the flange from rotating while you undo the M20 nut.

Under the lock nut is a large washer / spacer

(note pictures still show handbrake shoes in place as they would be if you was only replacing the seal and not the handbrake shoes)

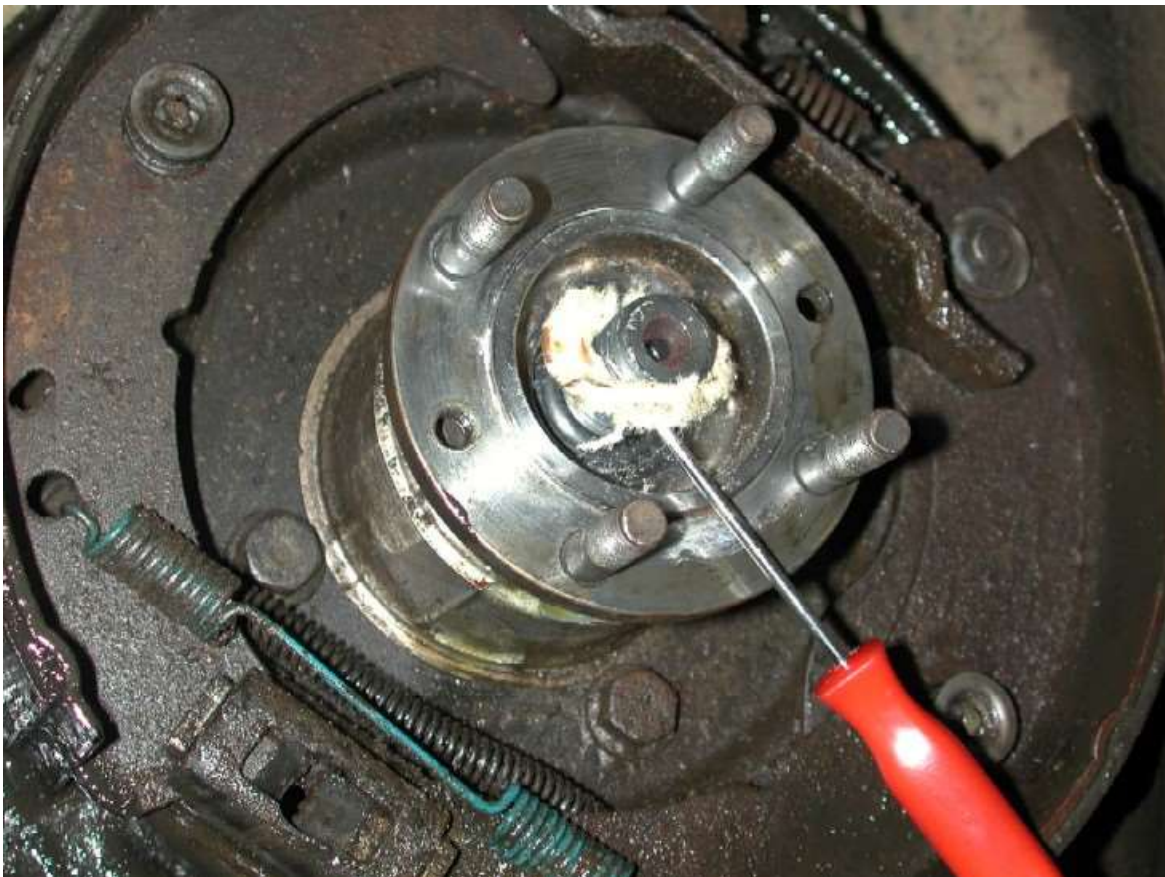
Under the washer / spacer is a fiber washer, use a small tool to dig this out.....again a new one will be required!!.

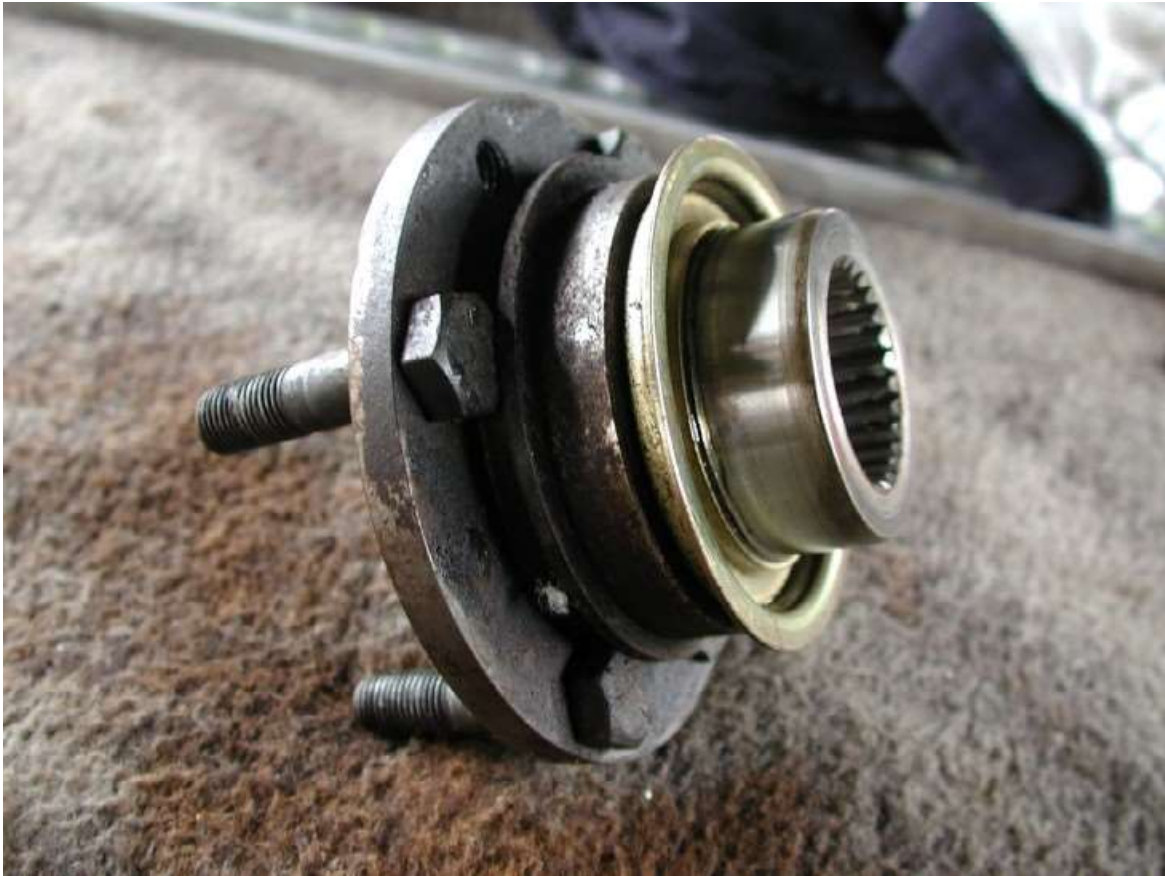
Above you can see the mud shield on the flange, and the circlip that retains the 4 prop bolts, I had bought all new ones to fit to the flange before re-fitting it. Now its time to remove the seal, I used a small 3 legged puller to go inside the seal and wiggle / lever it out.

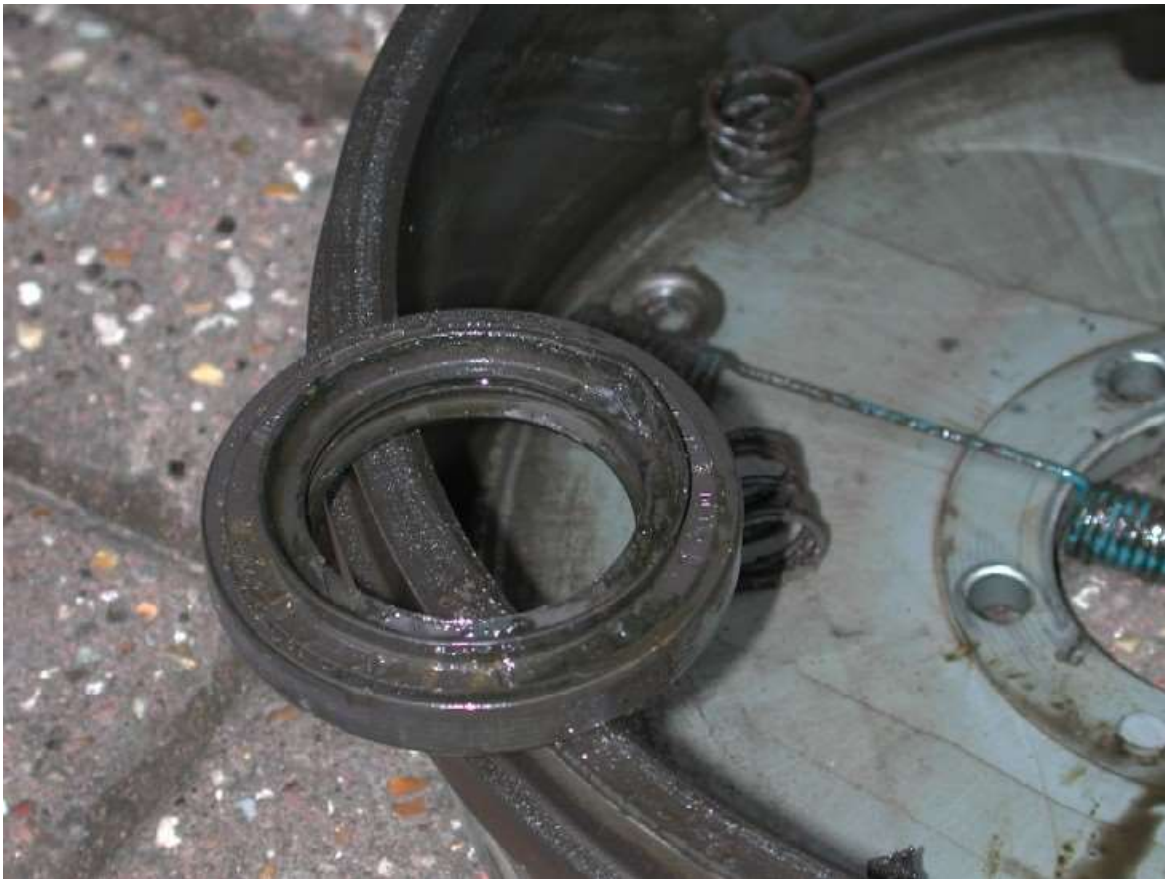
You can use anything you like but take care NOT to damage the seal face on the transfer box, use "blunt" instruments, my seal came out pretty easily. Once out, it was very hard to the touch, which probably relates to the fact it was leaking.

here's the guilty item!!!!

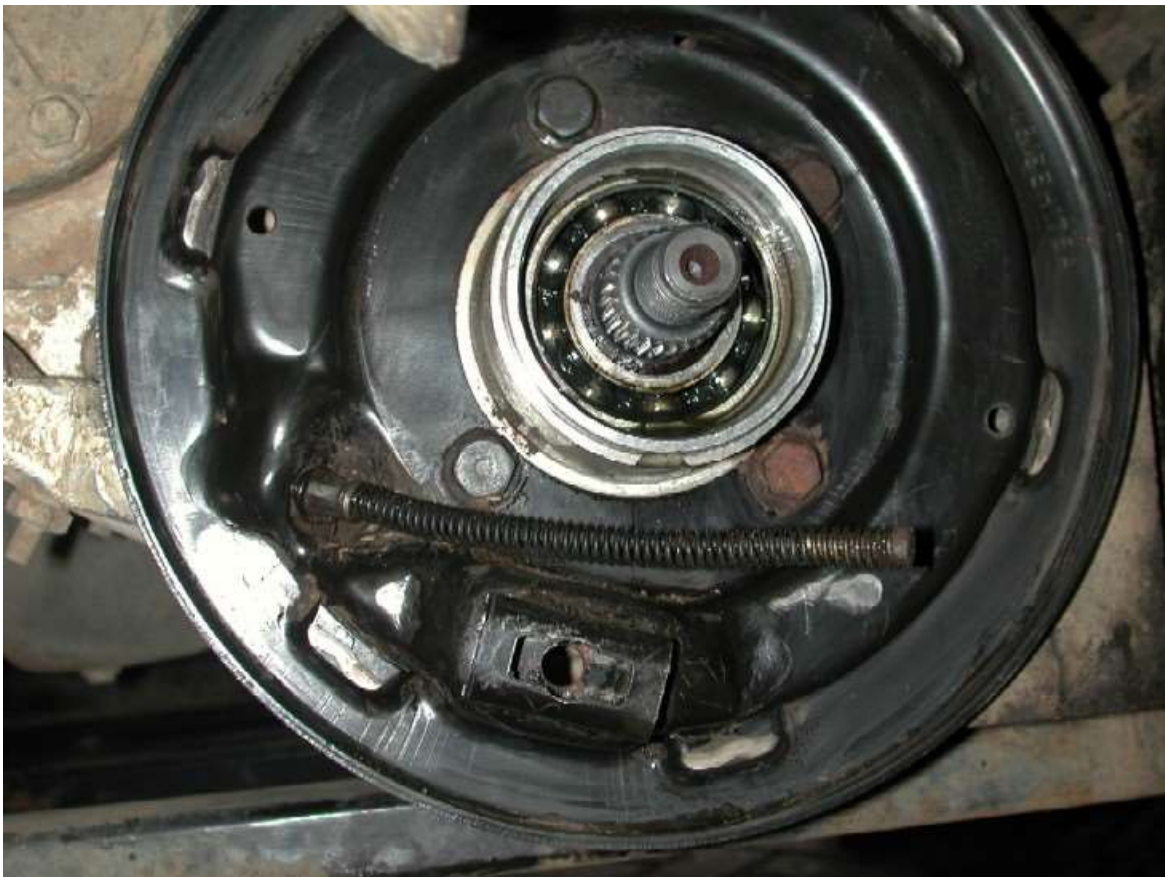
Here below is the seal removed and the handbrake cable is also visible (shoe replacement only), the back plate is all cleaned up of old oil and muck and care was taken to not get any dirt etc into the transfer box

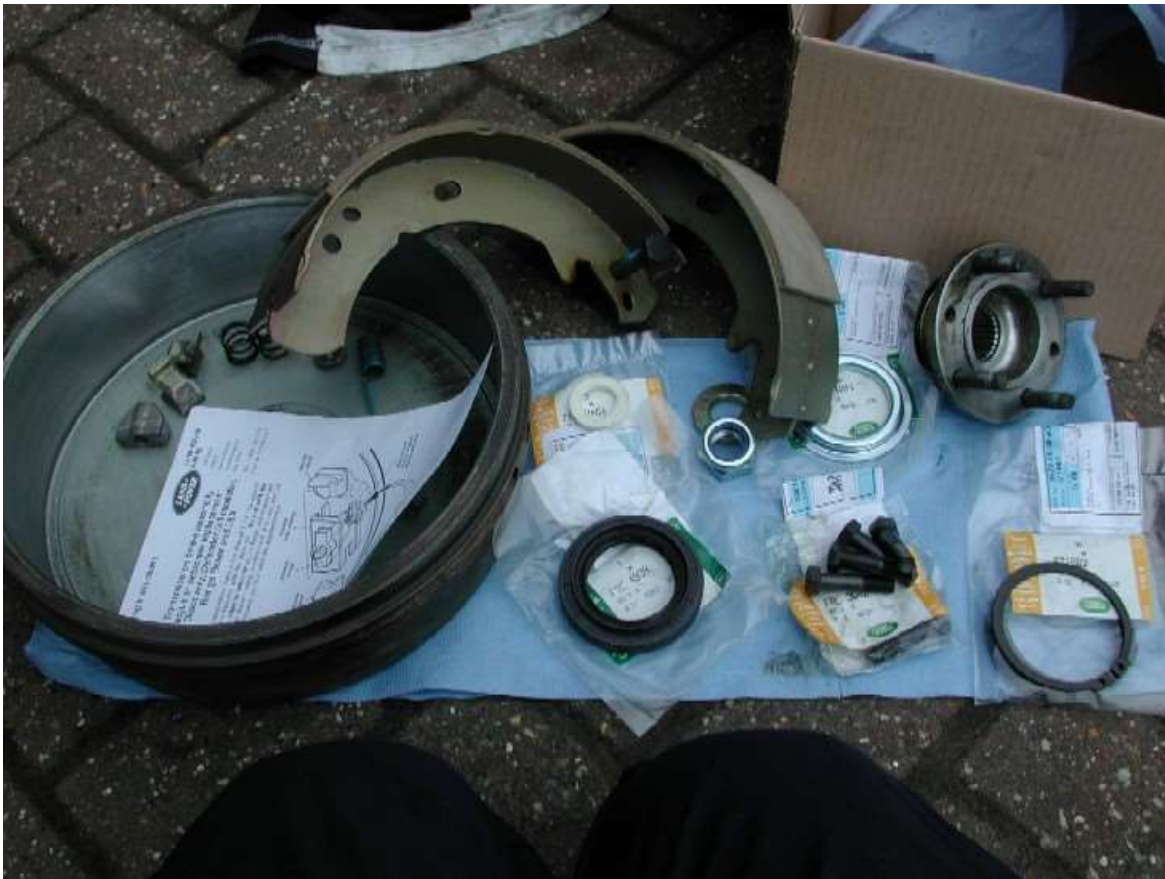
Here's a big pile of new bits!!! :o)

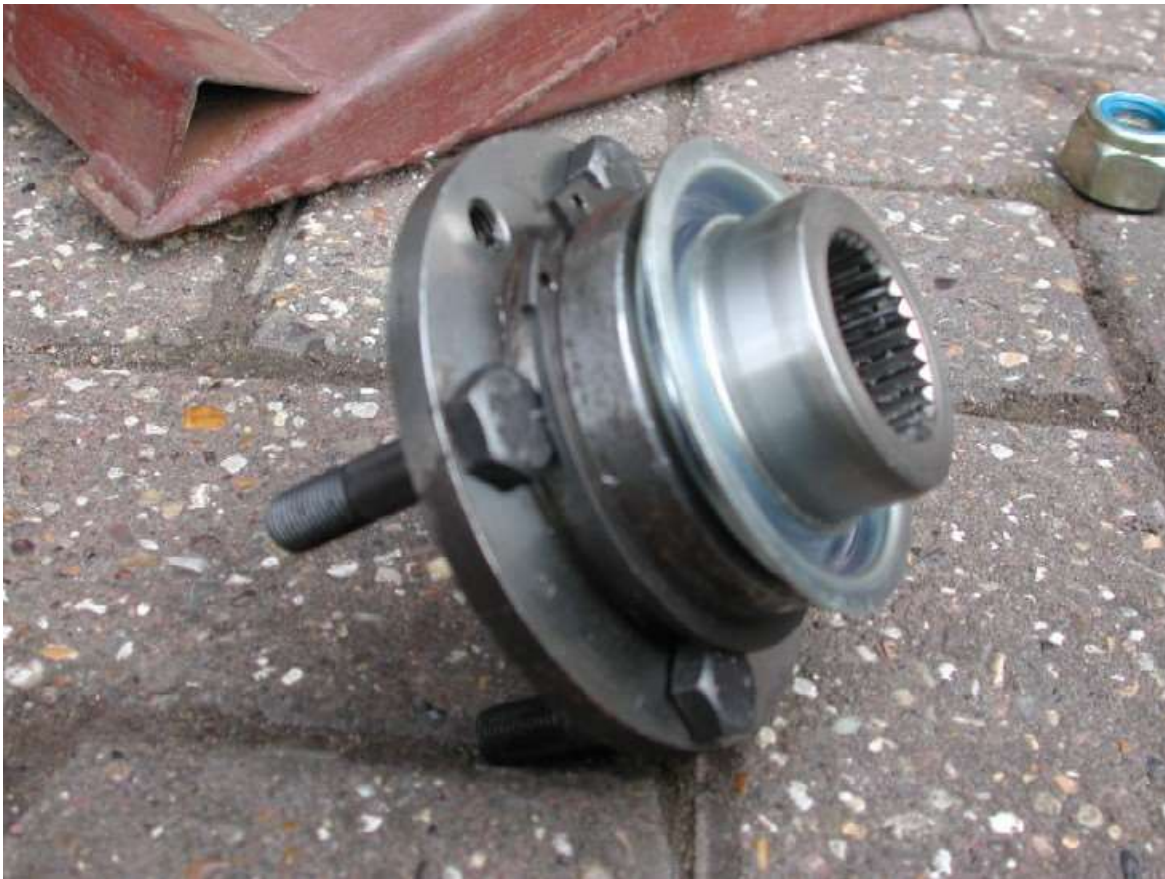
Output flange all cleaned up and new bits fitted....

As I stated earlier, while it was off, I chose to renew the prop shaft bolts, circlip and output flange mud shield. The Big circlip def puts up a fight, and you will need big circlip pliers to remove / install it, wear EYE protection when doing this!!! The mud shield is simply a push fit, I used a hammer to remove it and a large socket to drive the new one back on squarely...

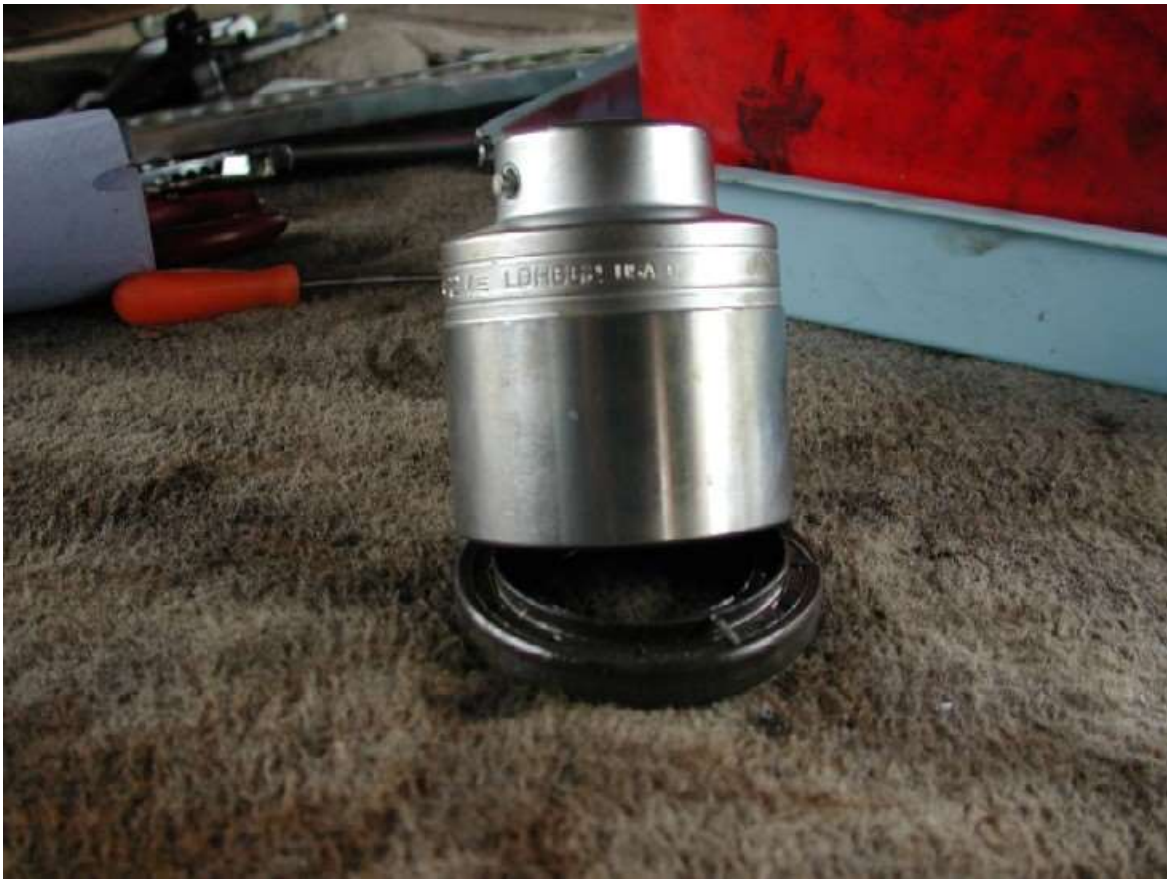
Fortunately I have a rather large socket that fitted it perfectly....2 1/16..

Make sure where the seal is fitted in the transfer box is clean and then smear some new oil on the new seal and push it into place. There is obviously a proper tool to drive the new seal in, but anything can be used as long as its BLUNT and will not damage the seal / seal seat.

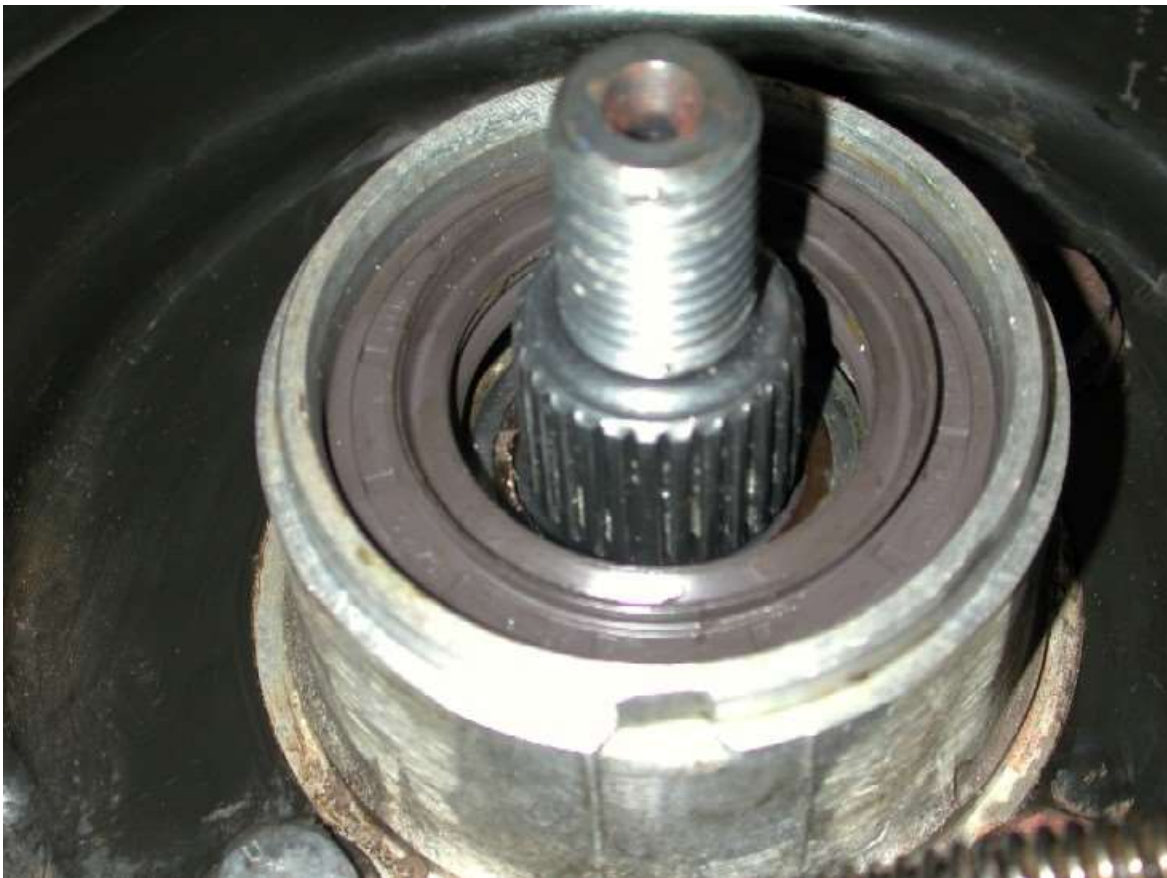
New seal driven into place CAREFULLY as not a lot of force is needed!!!!

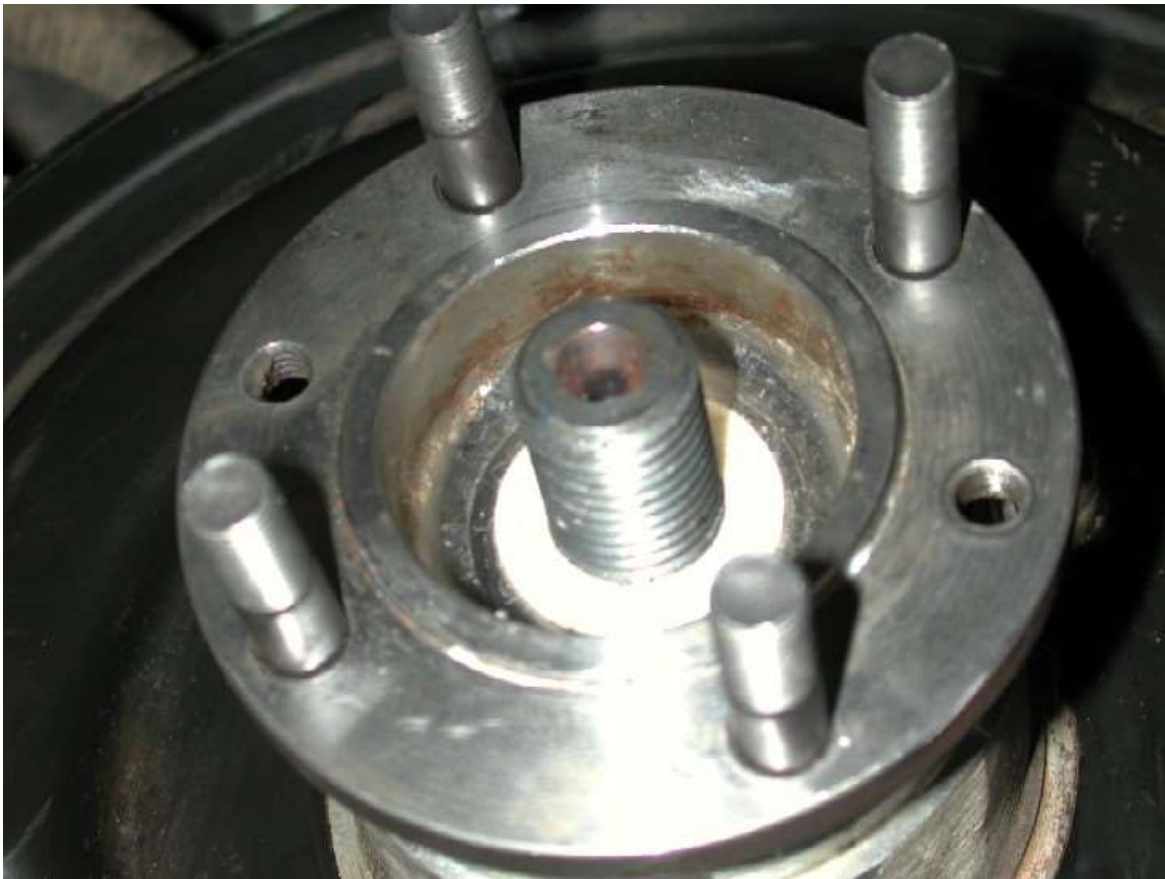
Now refit the output flange and ensure it goes fully home!! then pop in a new fibre washer and make sure that is fully pushed in so its flush with the inner surface.

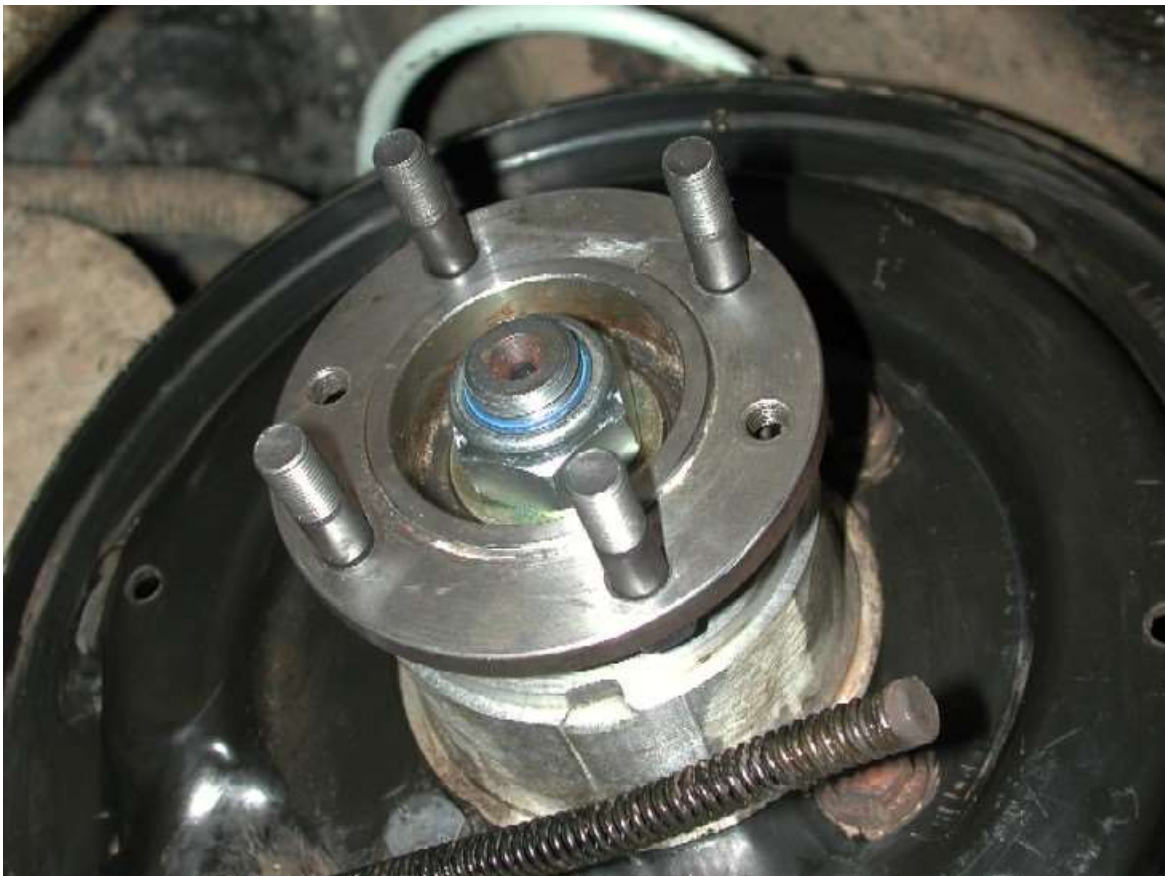
Refit a new spacer / washer and NEW locknut and tighten to 109 Lbs ft

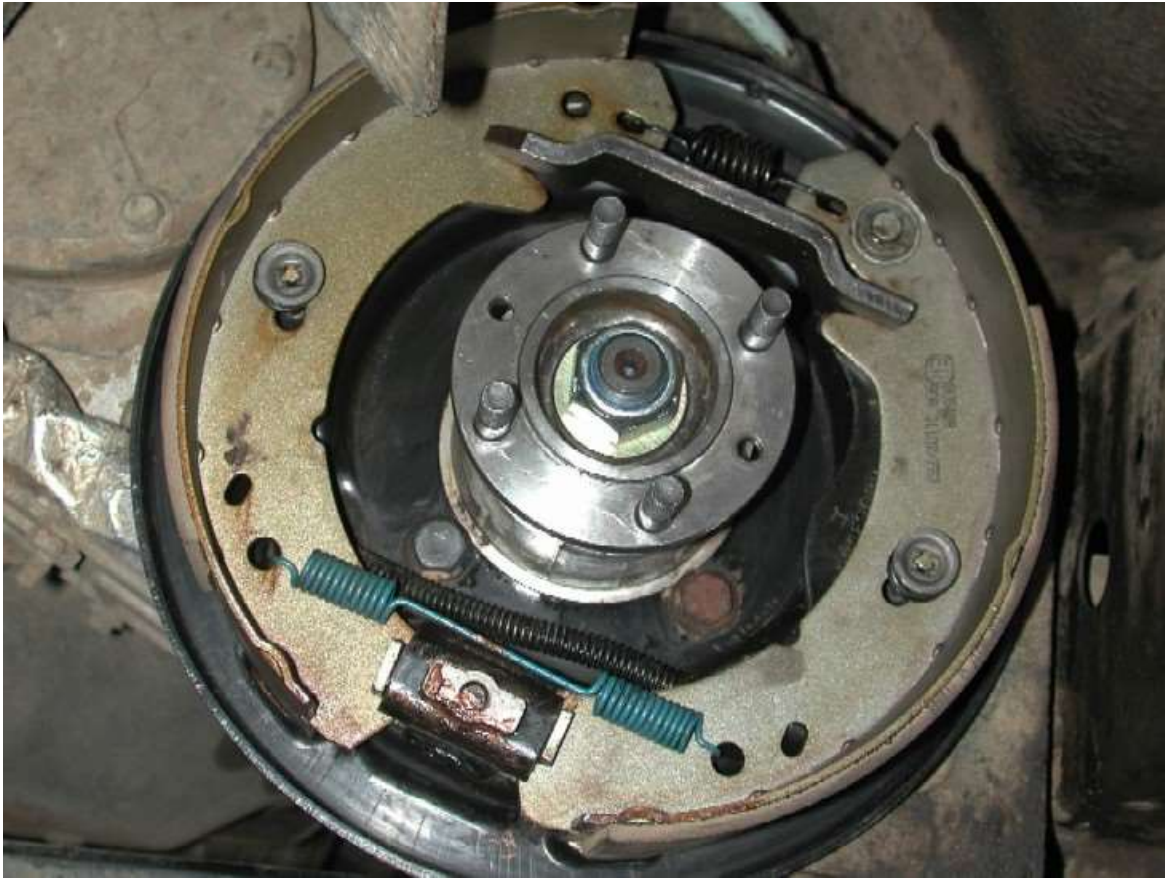
below is all the new handbrake components installed

Put some copper grease onto the adjuster clams, where the shoes sit on the back plate and where the handbrake lever pivots on the outer shoe. Install the NEW adjuster bolt just a few turns to start with. Once the handbrake drum is refitted, tighten the adjuster bolt until the drum is locked and then back it off 1 and a 1/2 turns. You may have to disengage the CDL and put the transfer box in neutral to allow you to spin the drum.
