"Leaking" - TD5 Fuel Cooler

16/12/2009

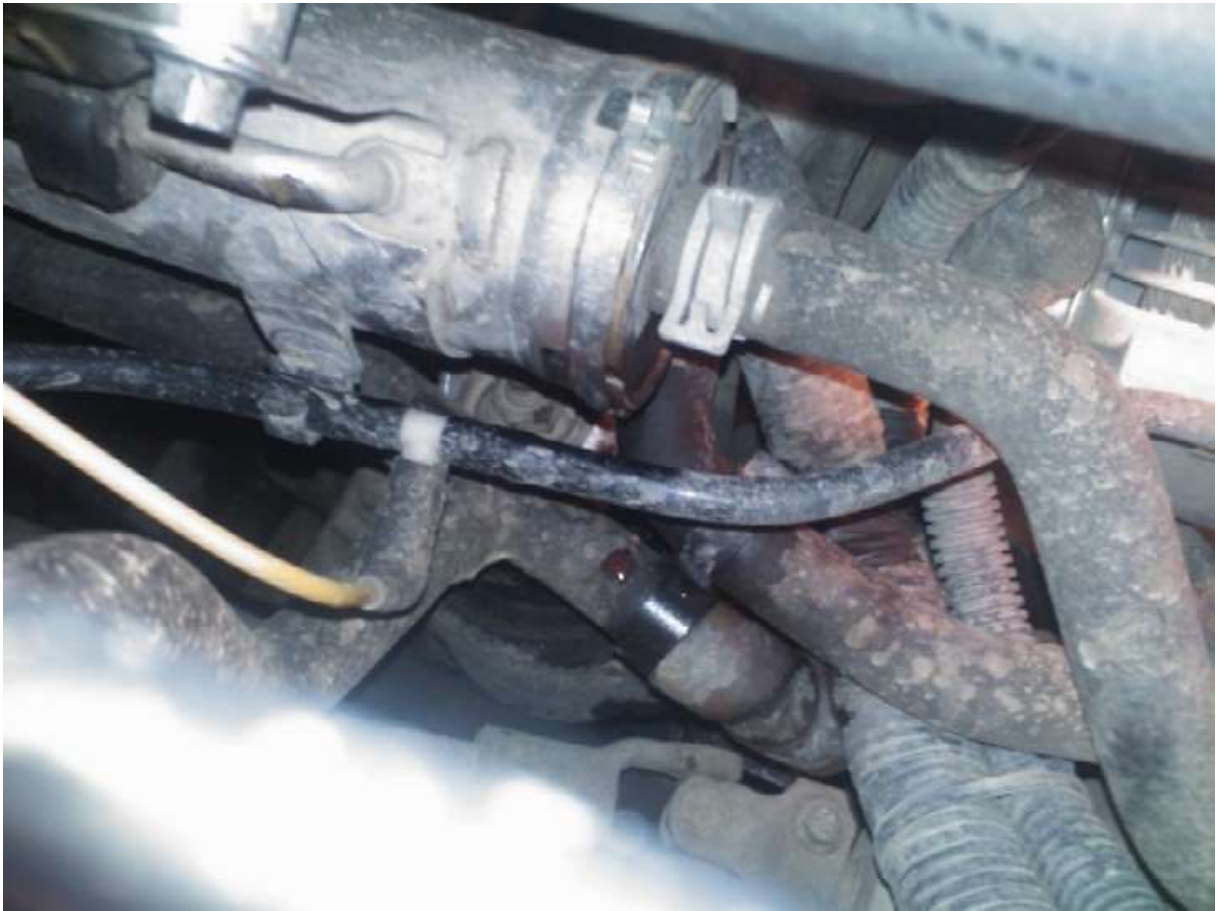
Upon looking underneath I saw what I had feared and that was pink OAT coolant dripping, I had an idea where it was coming from and upon removing the engine acoustic cover from the top, my assumption was confirmed. Below you can see the bottom of the front face of the cooler is wet, and the drip on the pipe below. The engine mount was also full of coolant.

This had literally just happened, as I had checked the water a day or so ago and the level was spot on, and after noticing this leak, I ran the engine up to temp to see how bad it was, but to my surprise it only leaked when the engine was off and cold.

Now if you took this car to a dealer, it is highly likely they would replace the whole unit, which at a cost of £250 + labour etc it would not be a nice bill to get, especially as its most likely just a seal that has gone and caused the leak. So after a little "googling" I found several references to it and it seems its more common than you think.

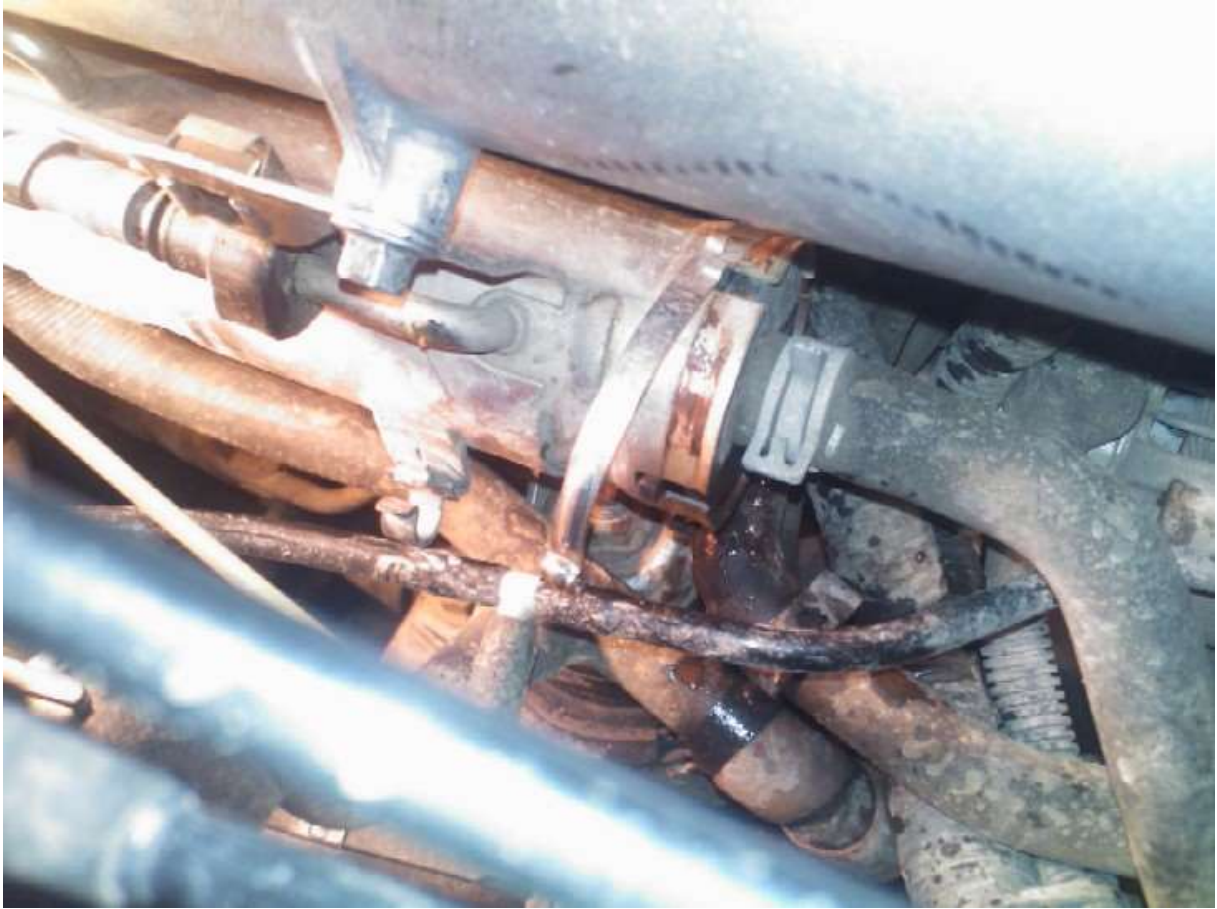
The housing of the cooler simply has 2 plastic ends that are held in by them awful "latching" spring clamps, now they are not easy to do when access is good, let alone down by the cooler. You can if you wish remove the cooler assy from the vehicle and fix it on the bench, but I chose not to disturb the other end and fix it in situ. To remove the clamp I simply used a flat bladed screw driver and tapped one side of the clamp to "unclip" it.....

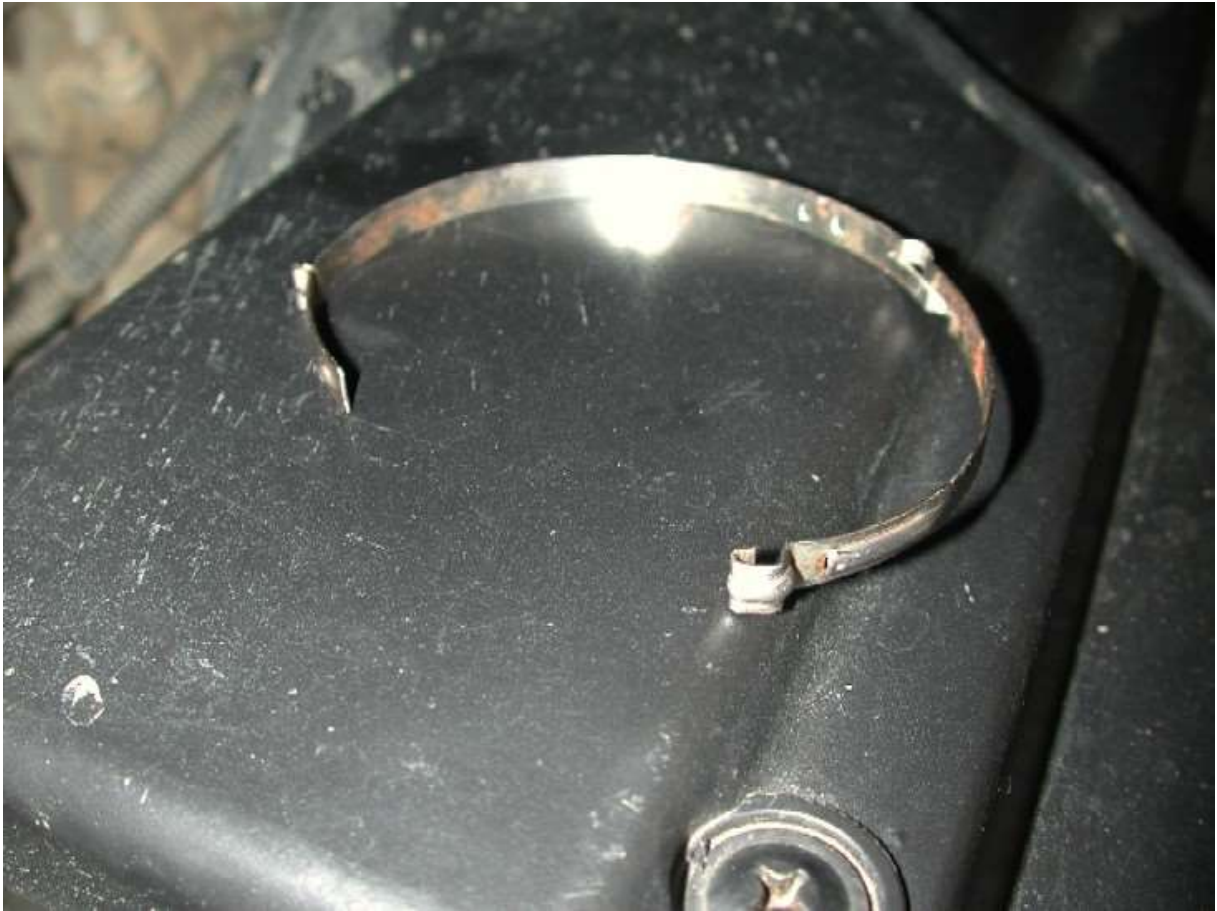
Below is the clamp, which I'm sure you have had "fun" with this type before!!!

The refit is the reverse of the removal, be CAREFUL when fitting the end cap back in, and then its a "fight" with that blasted clamp, what you use to refit that is up to you, But I normally use side cutters and small needle nose pliers to do it. Its fiddly and not easy, but be patient with it!!.

If you wish you could use standard jubilee clips, but you have to make sure they are "narrow" ones so they don't interfere with the "pegs" molded into the end cap. Once your successful with that, reconnect the hose to the end cap, and then top up the coolant as required.

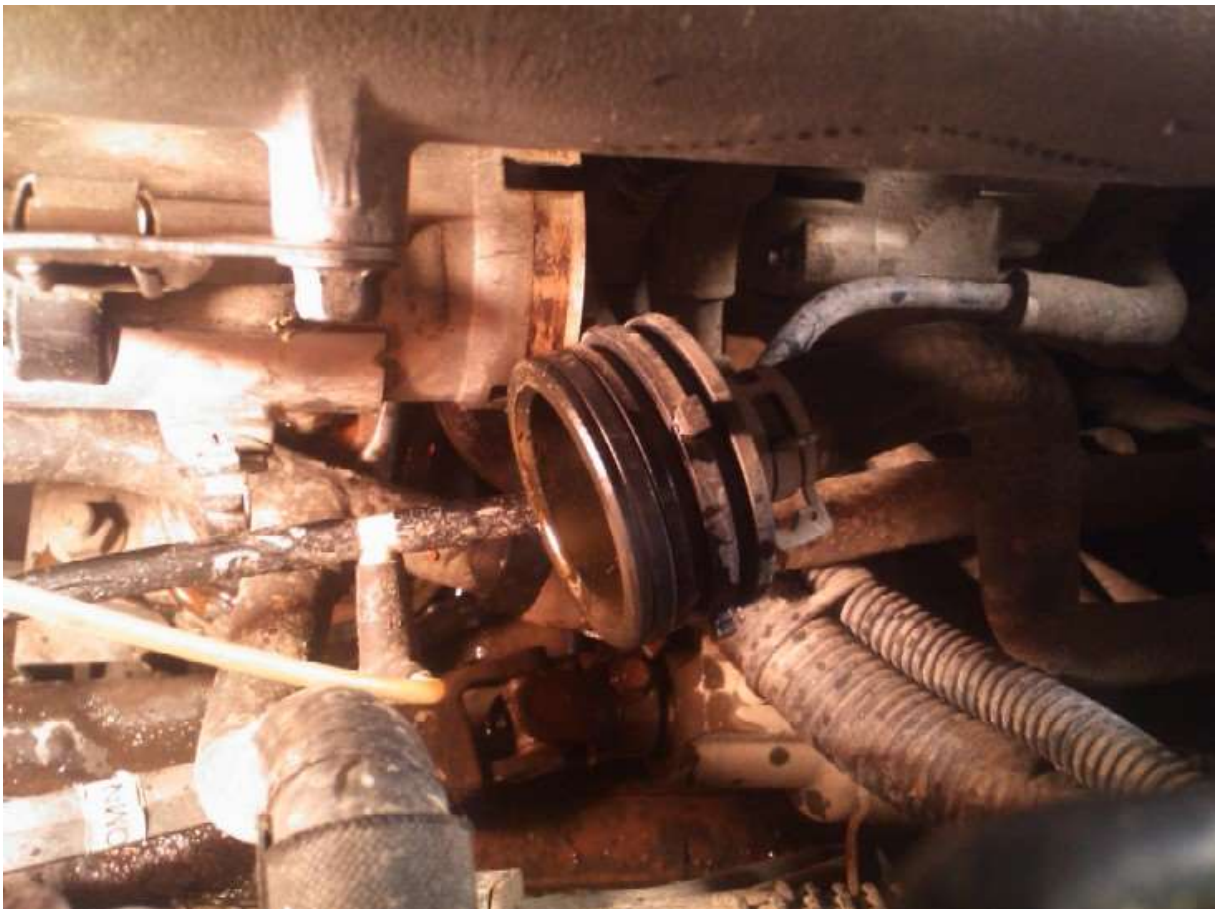
Now to "ease" removal of the end fitting, I left the hose connected for now and used that to "carefully" wiggle and tug the end cap out of the cooler.

The was very little coolant loss when the cap was removed, you can see the "o" ring in place on the end cap.

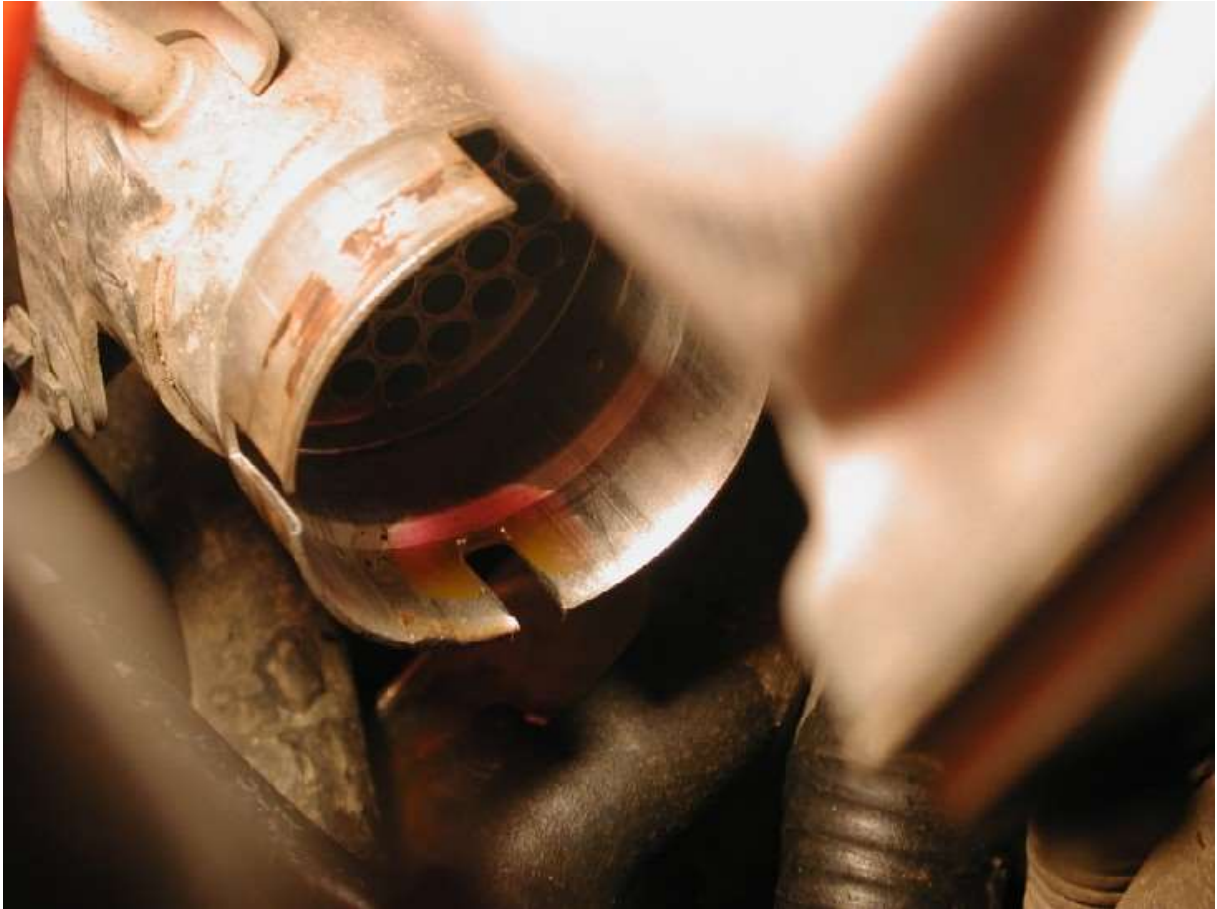
Next was the hose on the end cap, it's held by a simple spring hose clamp, I removed that and tied the hose back in a vertical position to retain as much coolant as possible and to be honest not a lot came out anyway. Below a view inside the cooler.....

Here below is the end cap, which it looks to me, that it was designed to have 2 "o" rings in place, but in the picture above you can see only the very bottom one would do anything due to the shape of the cooler body, maybe Land Rover changed their mind during design, who knows? but 2 "o" ring seals would have DEF been better.

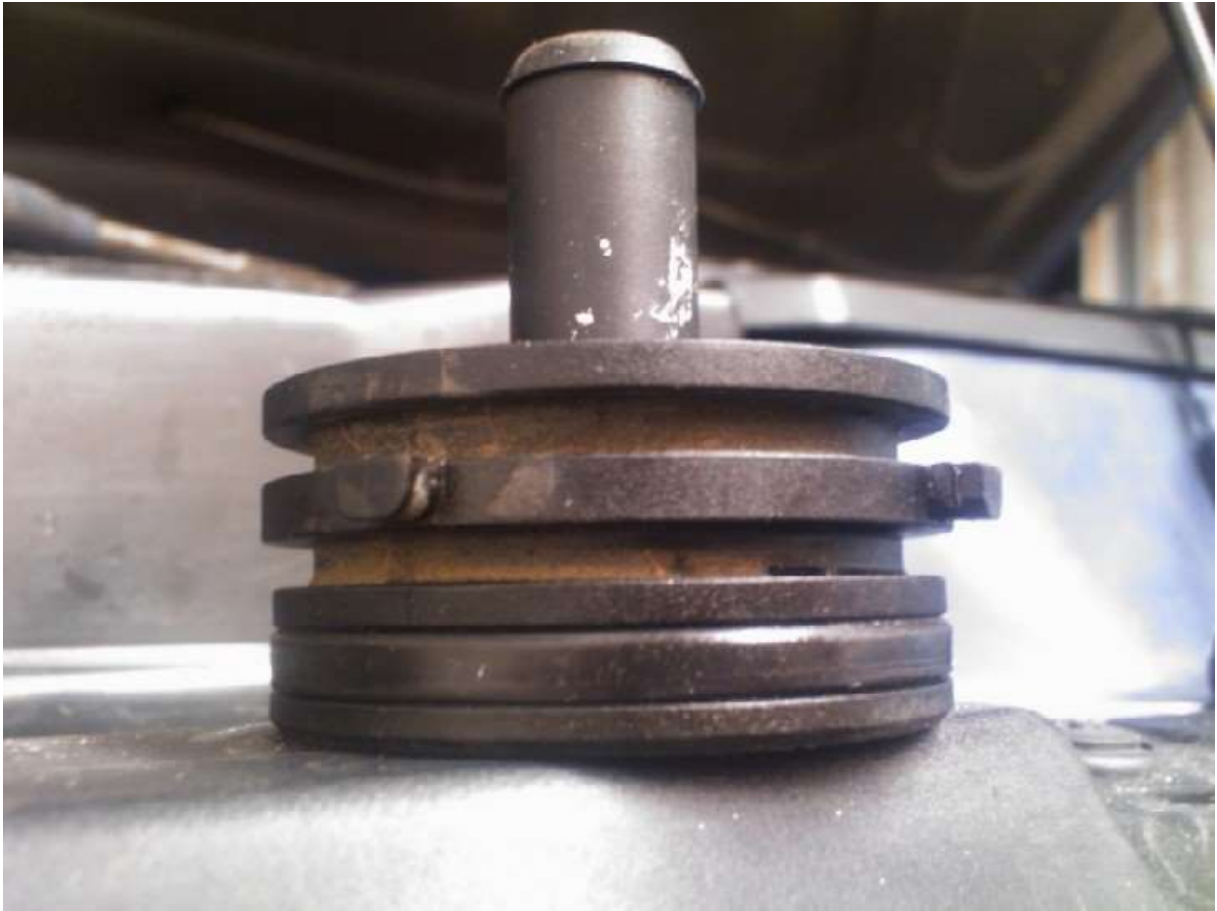
You can clearly see the "o" ring is VERY flat in cross section, and this is the obvious cause of the leaking end cap. After measuring the end cap "o" ring seat, and reading some of the stuff on the internet I was happy that the correct replacement seal would be BS225, and because of the environment its in, "o" rings made from Viton rubber would be the correct choice.

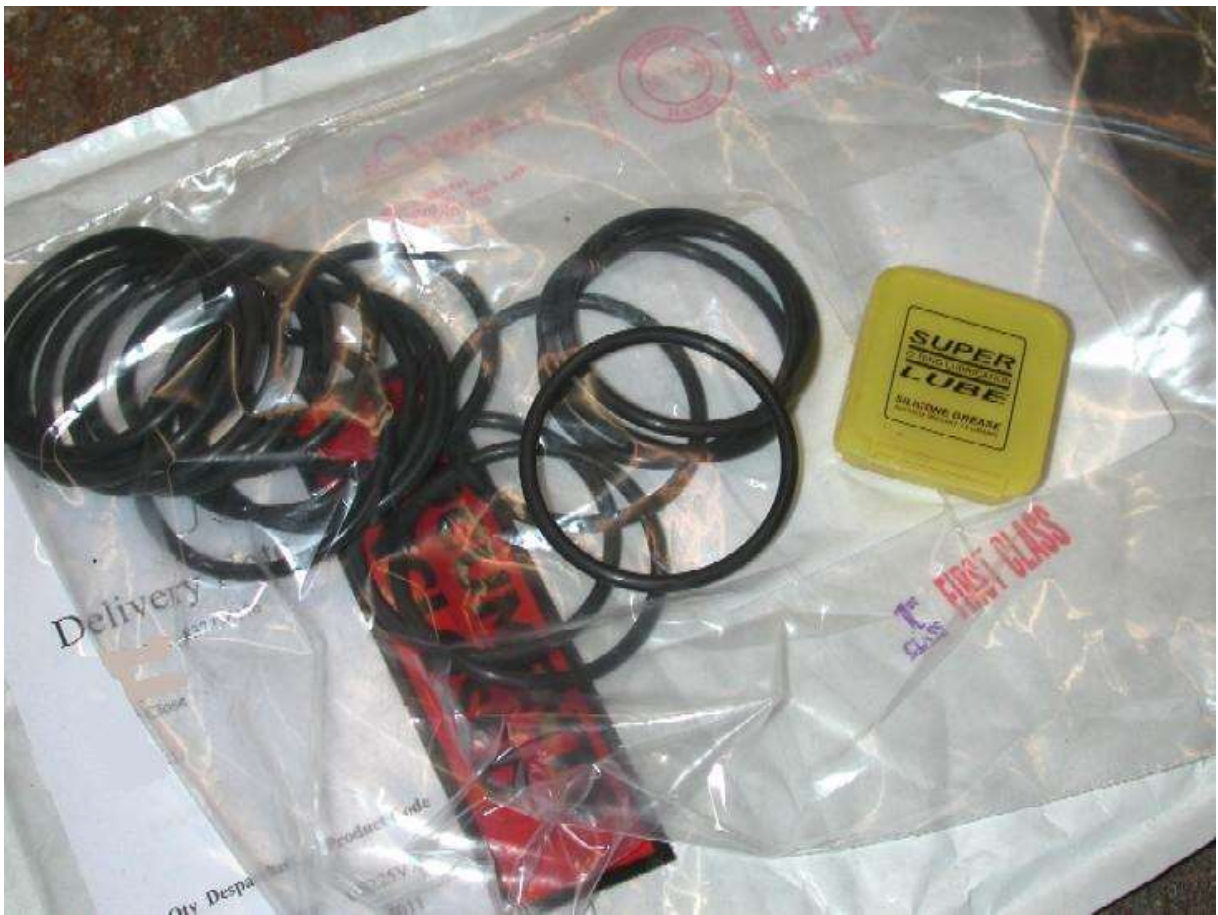
I ordered a "few" up (always good to have spares) a couple of days before, and also bought some proper "o" ring lube from the same place.

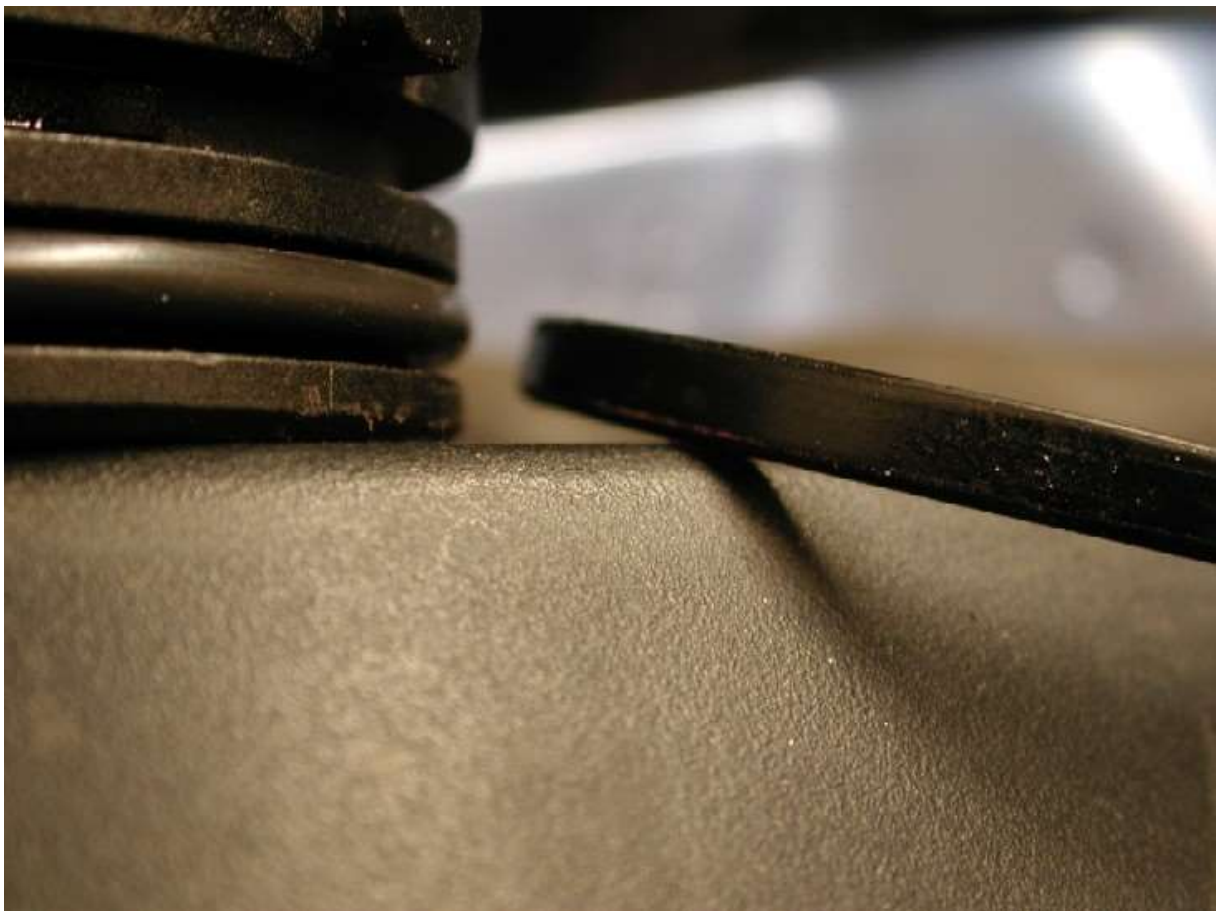
Here below you can see the new "o" ring in place on the end cap, and the old "flat" one next to it !!

I applied a very small amount of "o" ring lube to fit the new seal, and then a light smear around its edge to aid re-fitting the cooler end cap and to try and avoid "snagging" the seal in the process.

Run the engine up to temp to check for leaks, and also check it when the engine is COLD as well.
