## [www.discovery2.co.uk](http://www.discovery2.co.uk)

### WORKSHOP :- TD5 Fuel Injector Harness Replacement

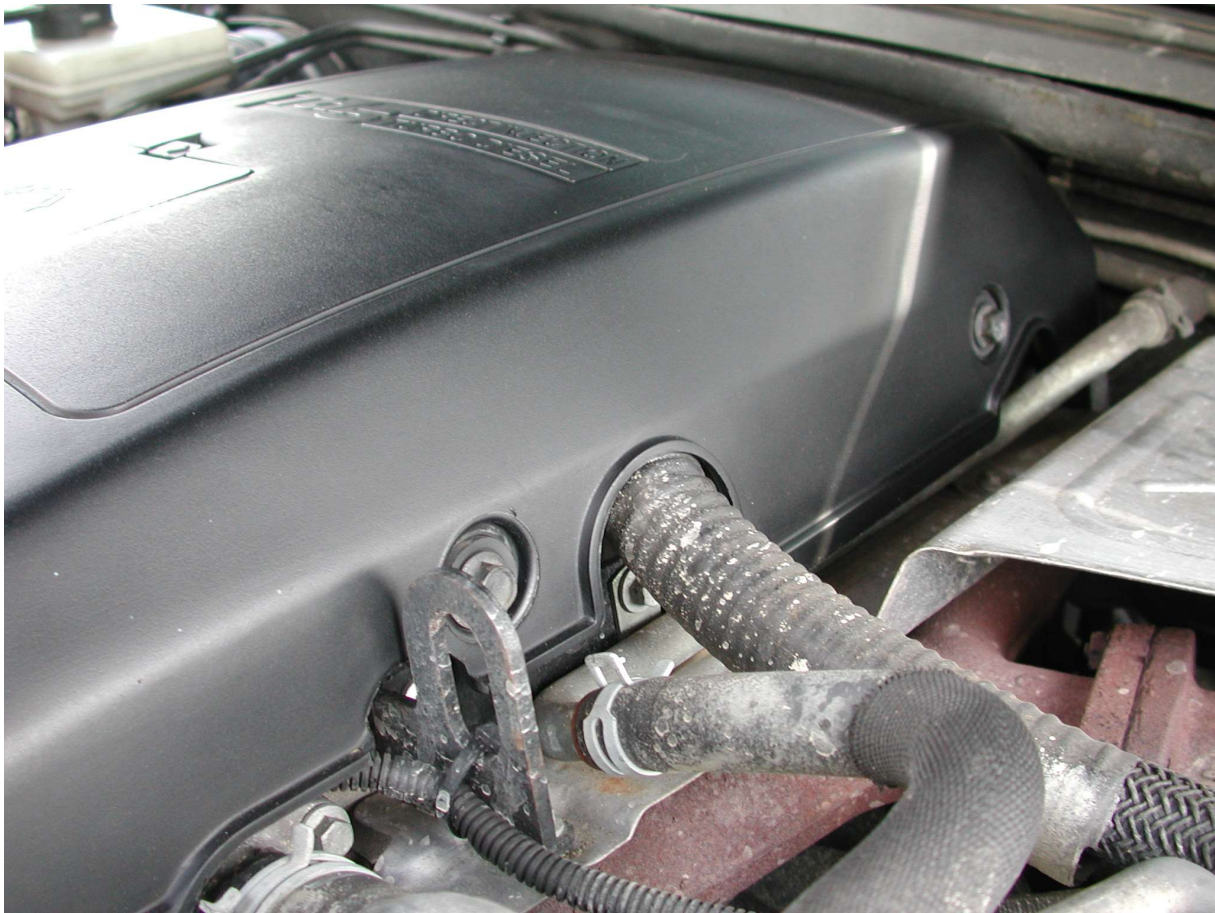
*So, first of all as with "most" jobs, remove the acoustic engine cover by removing the 3 x 13mm bolts, 1 on the drivers side and 2 on the passenger side*

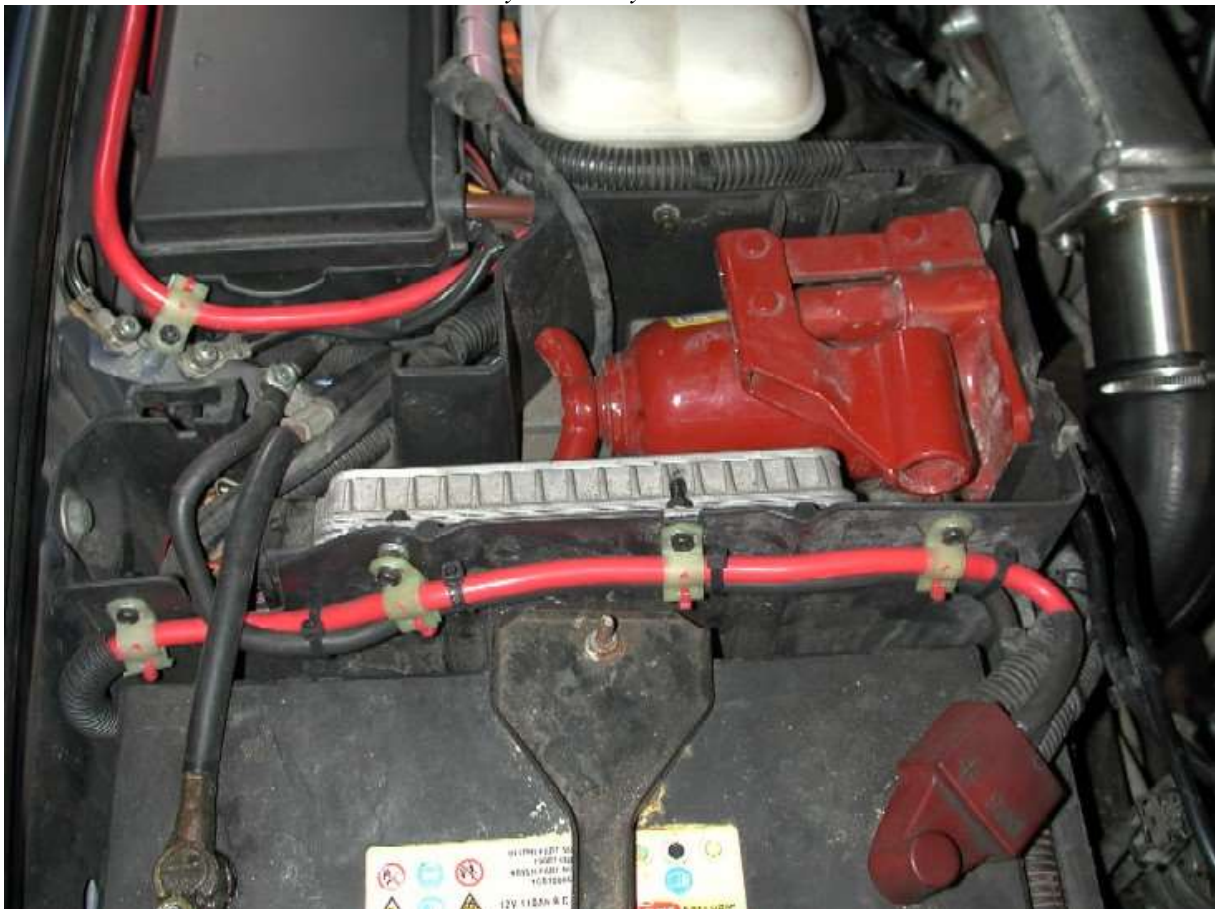
*Next remove the battery cover, and disconnect the battery earth lead as this will be needed to be moved out the way to allow you to remove the ECU.*

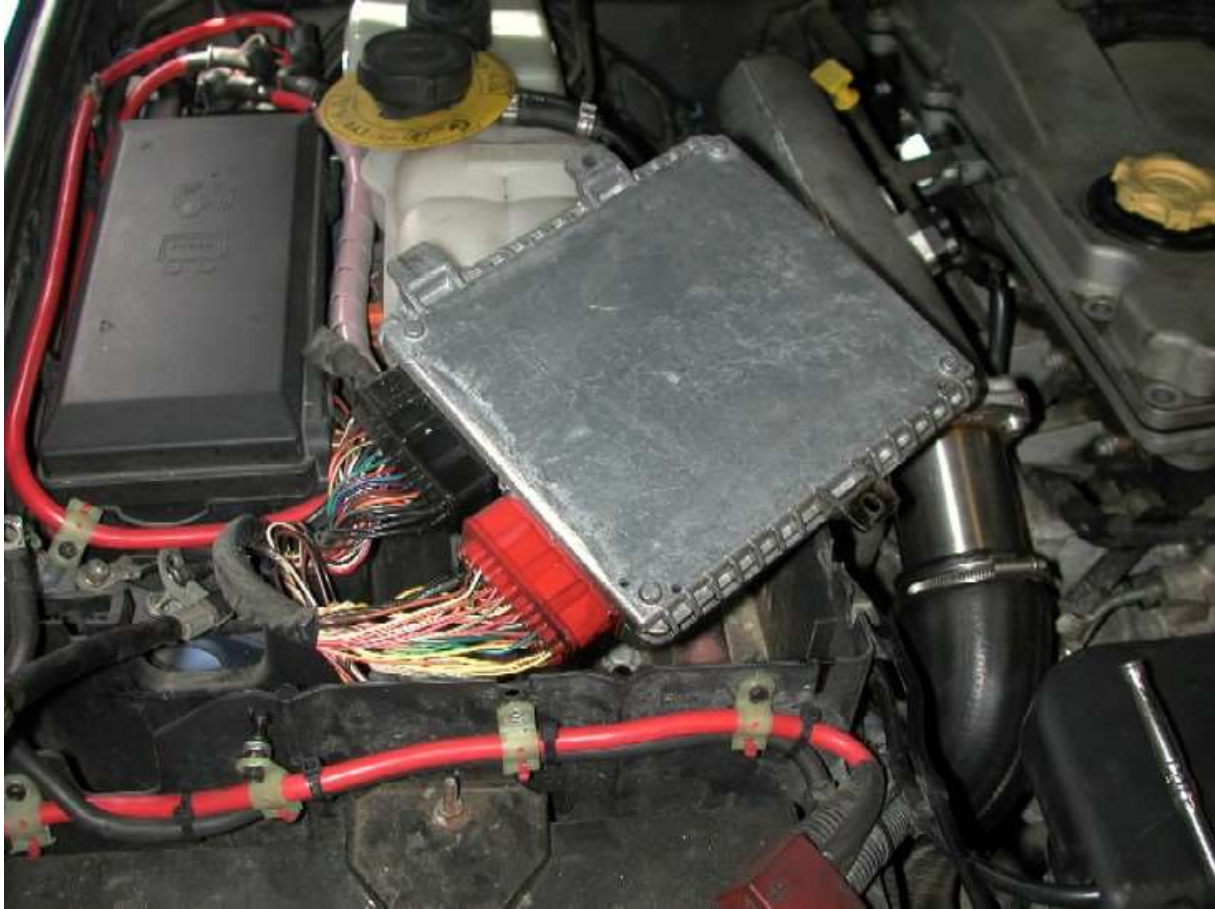
*Here because of my winch install, I had to remove the "p" clips holding the power cables going to the winch as they also hold the ECU. Your ECU "should" be held by just 1 self tapping screw, which you can remove, also lift out the bottle jack and put aside to give you more room as well.*

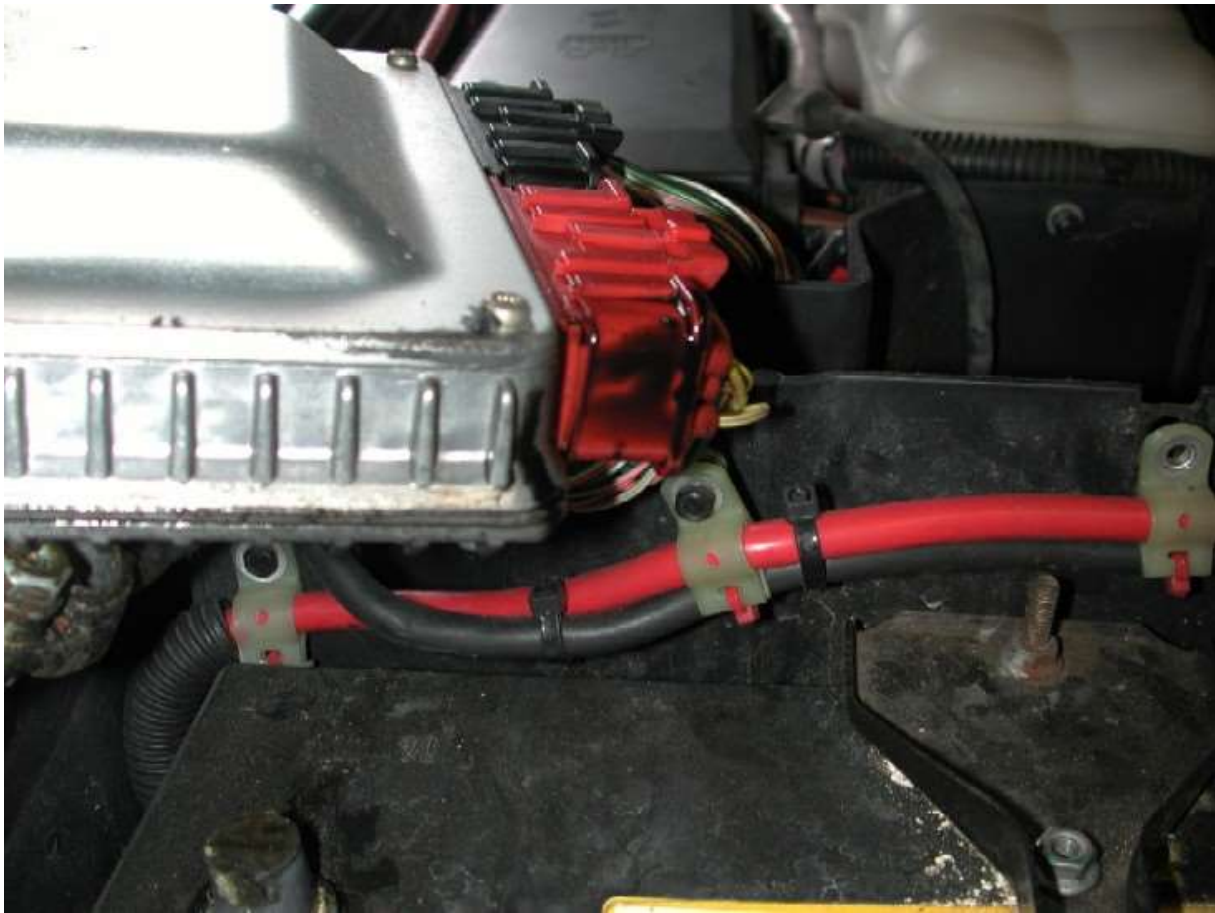
*Now you can lift out the ECU, Here in the pictures you can see the "small" amount of oil I had noticed on the bottom of the RED plug, from looking at it when the ECU is installed.*

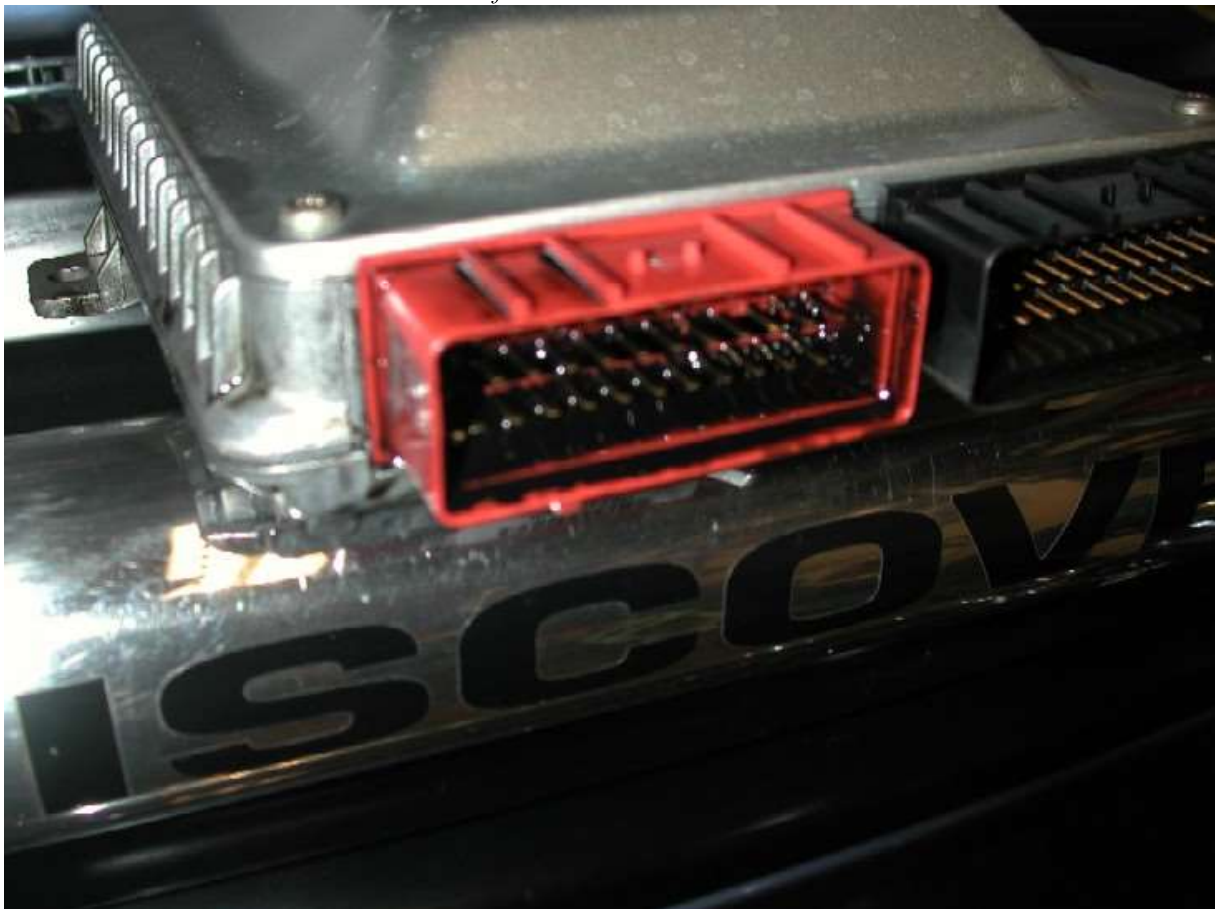
*Does not look a lot does it ?. well you can then disconnect the 2 plugs from the ECU, and then I found this below :-*

*As you can see, the RED plug socket is full of oil, It was probably only a matter of time before it may have began to give me rough running issues. Below you can clearly see the oil has got to all parts of the plug as well....*

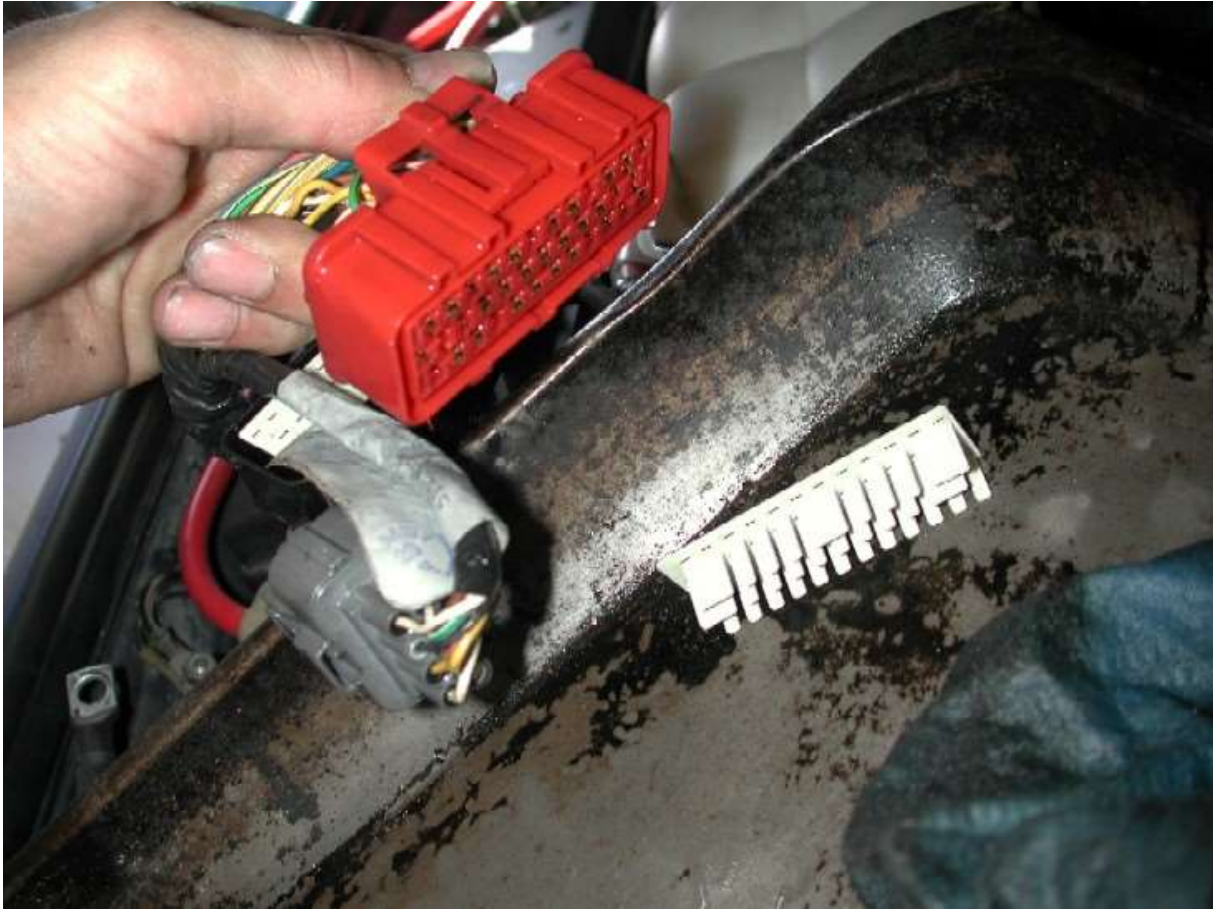
*You can remove the white locking plate to help get at the connections to clean them.*

*I used a fast drying solvent spray to clean all the oil out of the plug, and left it to dry / drain whilst I went onto the next bit. You will also see an orange rubber seal inside the plug, you can carefully "hook" that out to clean that as well. With the amount of oil that was actually in the plug, I was unsure whether or not it had actually made its way into the ECU itself.*

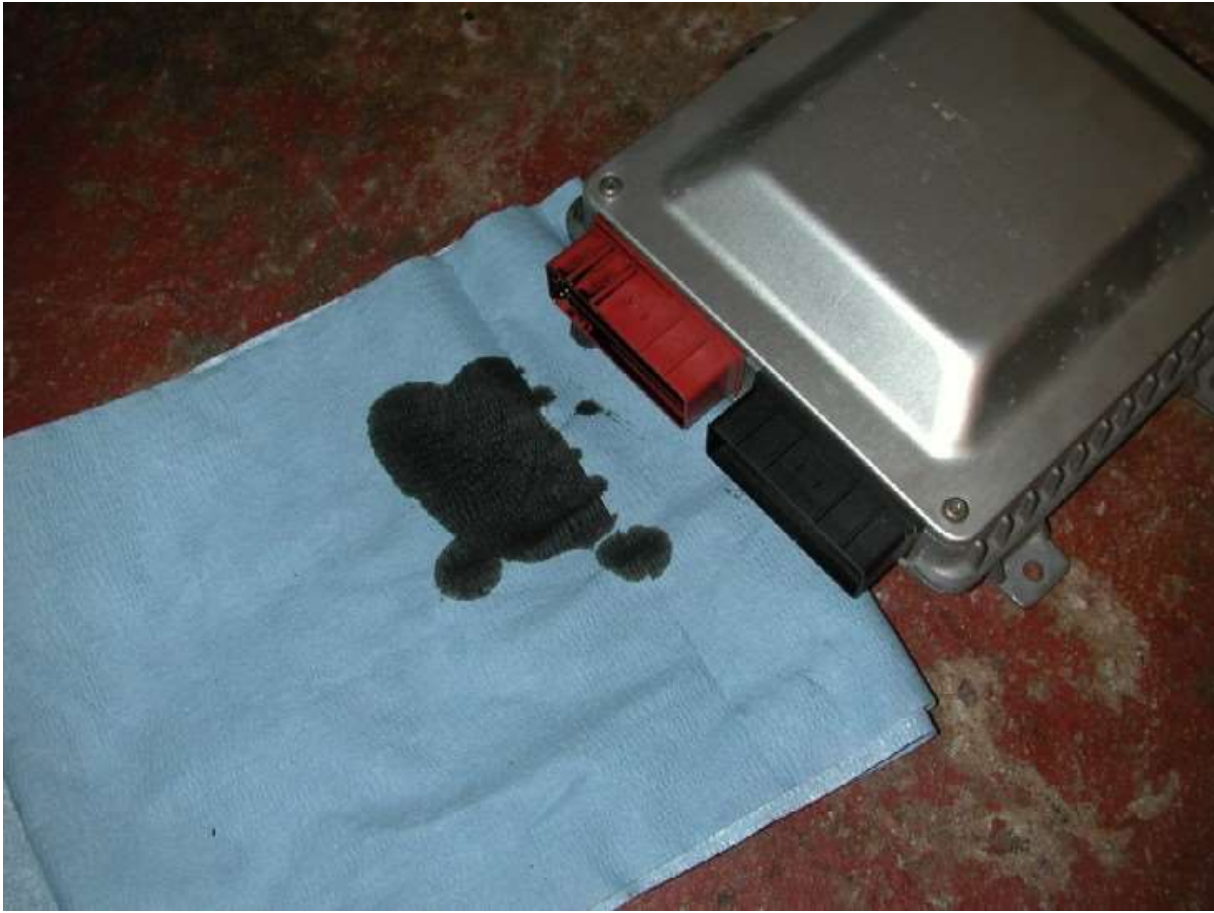
*While I was cleaning the plug out, the ECU was stood up on some paper, below you can see the amount that had drained out of it in only a few minutes*

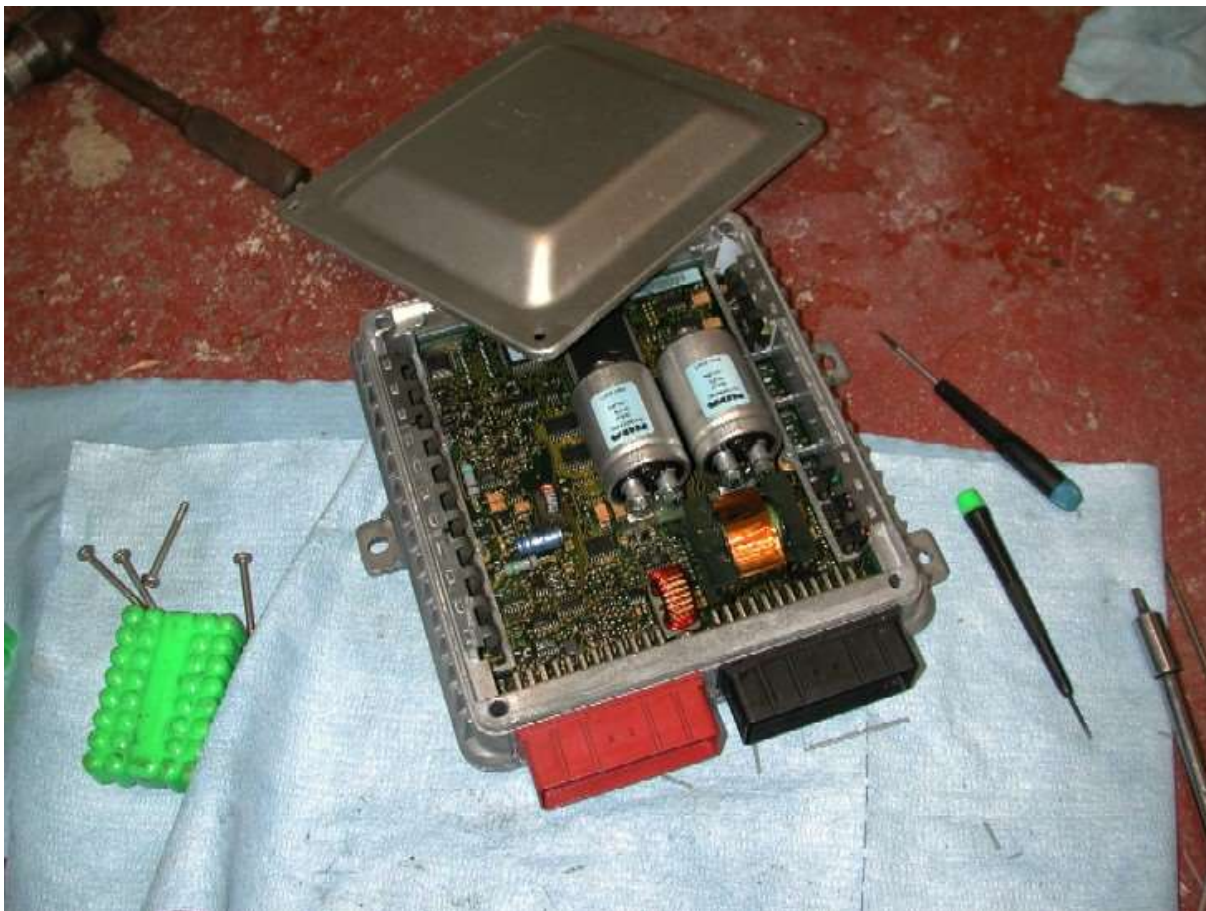
*With this in mind, I decided to remove the top cover of the ECU to have a look inside to see if that was ok, The cover is held on with 4 tamper proof torx bolts, the top is also sealed / stuck down and needed to be levered free VERY carefully. The top is only thin aluminum, so if you go at it too hard you WILL damage / bend it out of shape. "If" you decide to take the ECU top off, do it entirely at YOUR OWN RISK.....*

*After actually getting the top off, there was only a very very small amount that had actually got inside the ECU, a small spray on the internal connector and it was clean. I cannot say whether or not yours would be any better or worse, the decision to open up the ECU is entirely up to you !!*

*The ECU top is also sealed with a silicone like adhesive sealant to keep moisture etc out when its put together, I cleaned of all the old stuff being carefully not to get it inside, and then re-sealed the lid back on with some RTV sealant to keep it water / moisture proof. I then went onto the injector loom itself.*

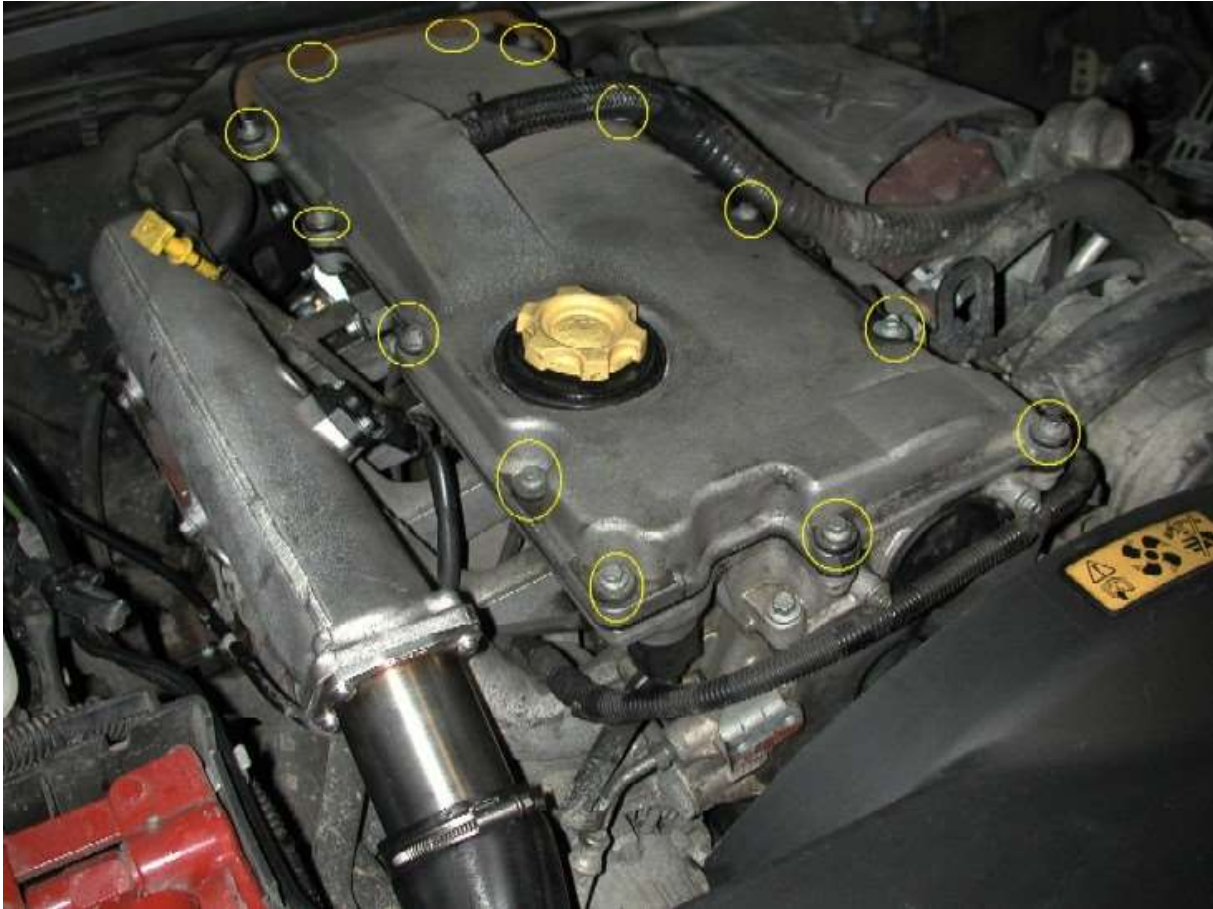
*The loom is actually under the rocker cover, so to get it out you have to remove the bolts holding the rocker cover on. The picture below shows the bolts circled, you will also have to disconnect the quick*

*clamp and take off the breather hose on the top*

*The bolts have bushes and rubber washers on each one, so make sure you collect all of them before lifting the cover off.*

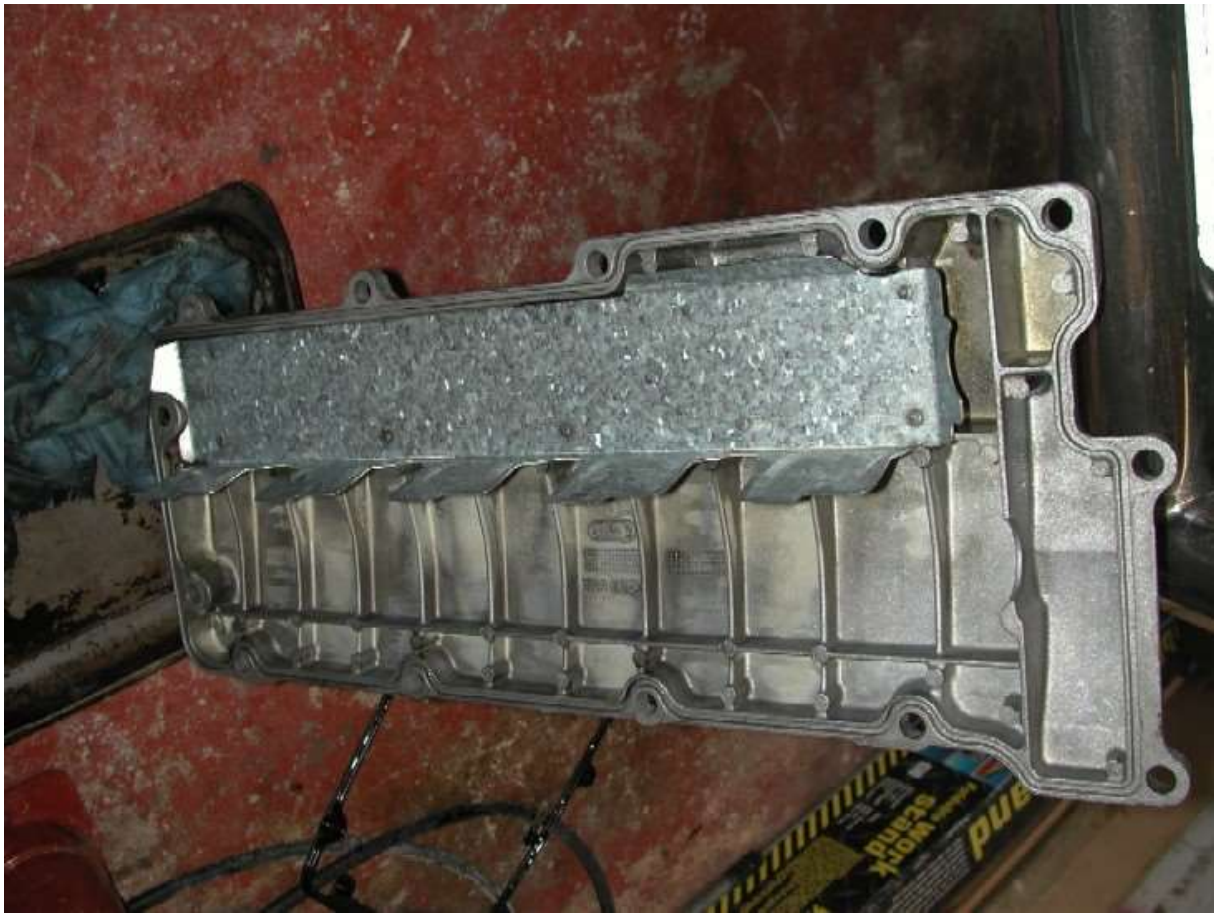
*I was pleasantly surprised to see how good the condition of the engine was underneath, although it was not dirty at all, I removed the rocker seal and cleaned up the cover ready to refit later*

*Above in the picture you can see the "splash guards" that protect the injector plugs*

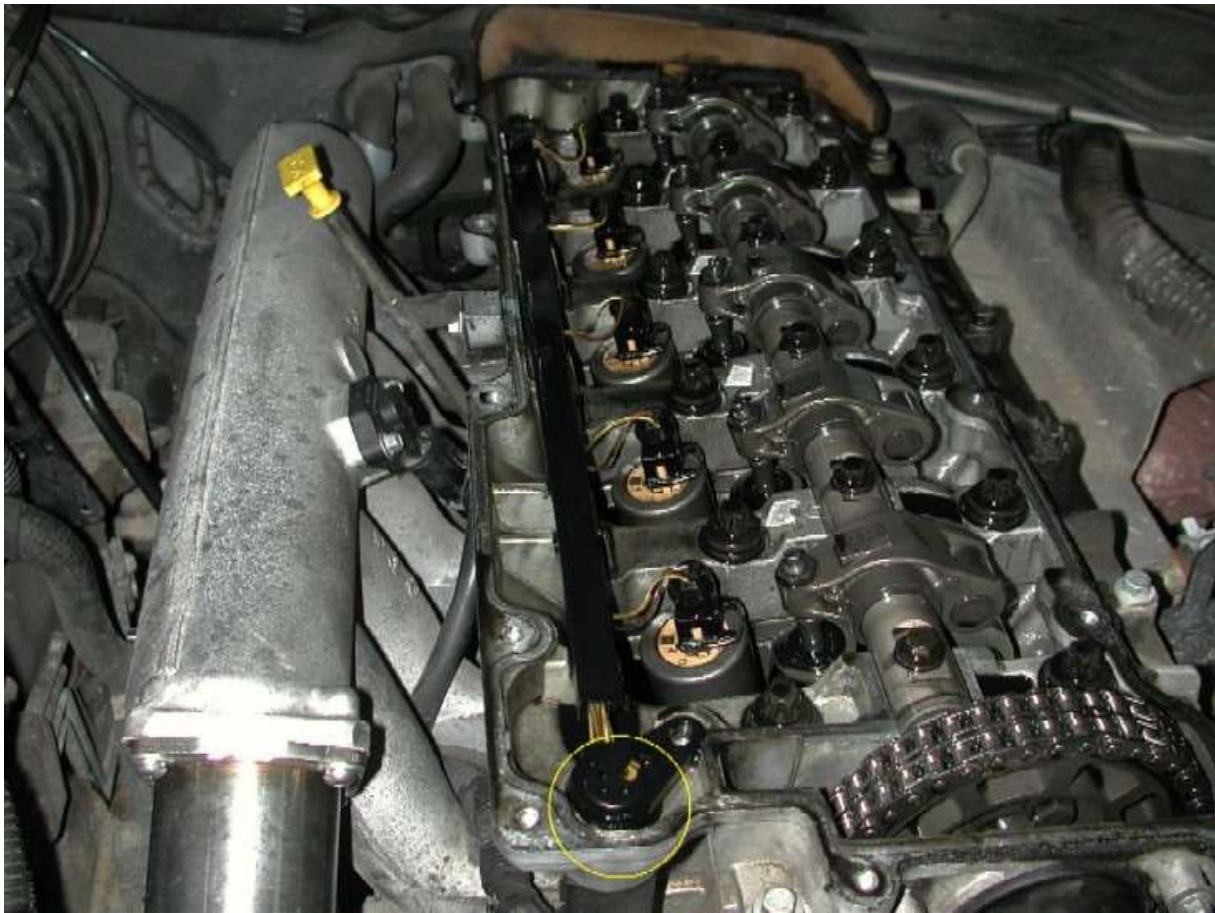
*Below is the injector harness in place, and circled in yellow is where the seals fail and allow oil to drain down into the ECU and loom.*

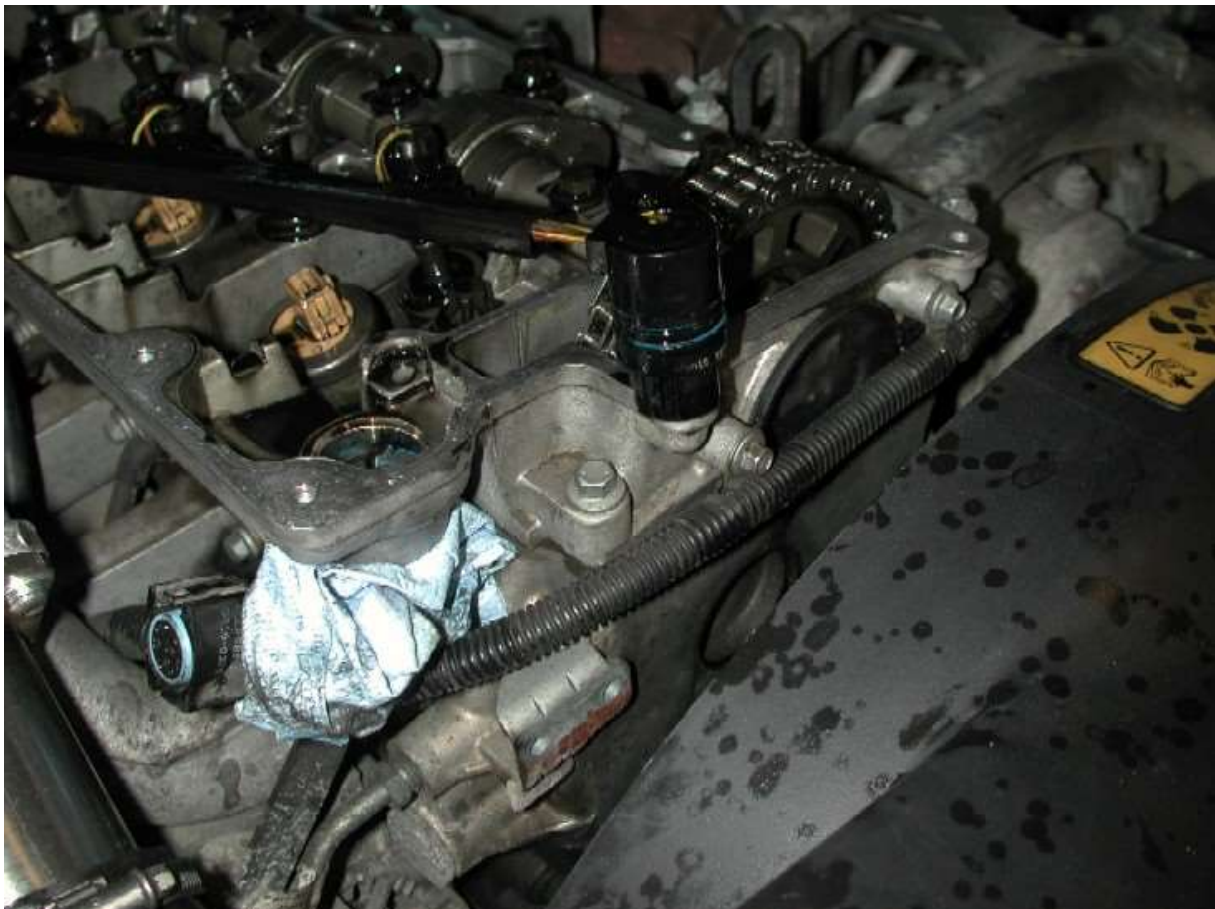
*You simply now have to disconnect each plug off the 5 injectors,*

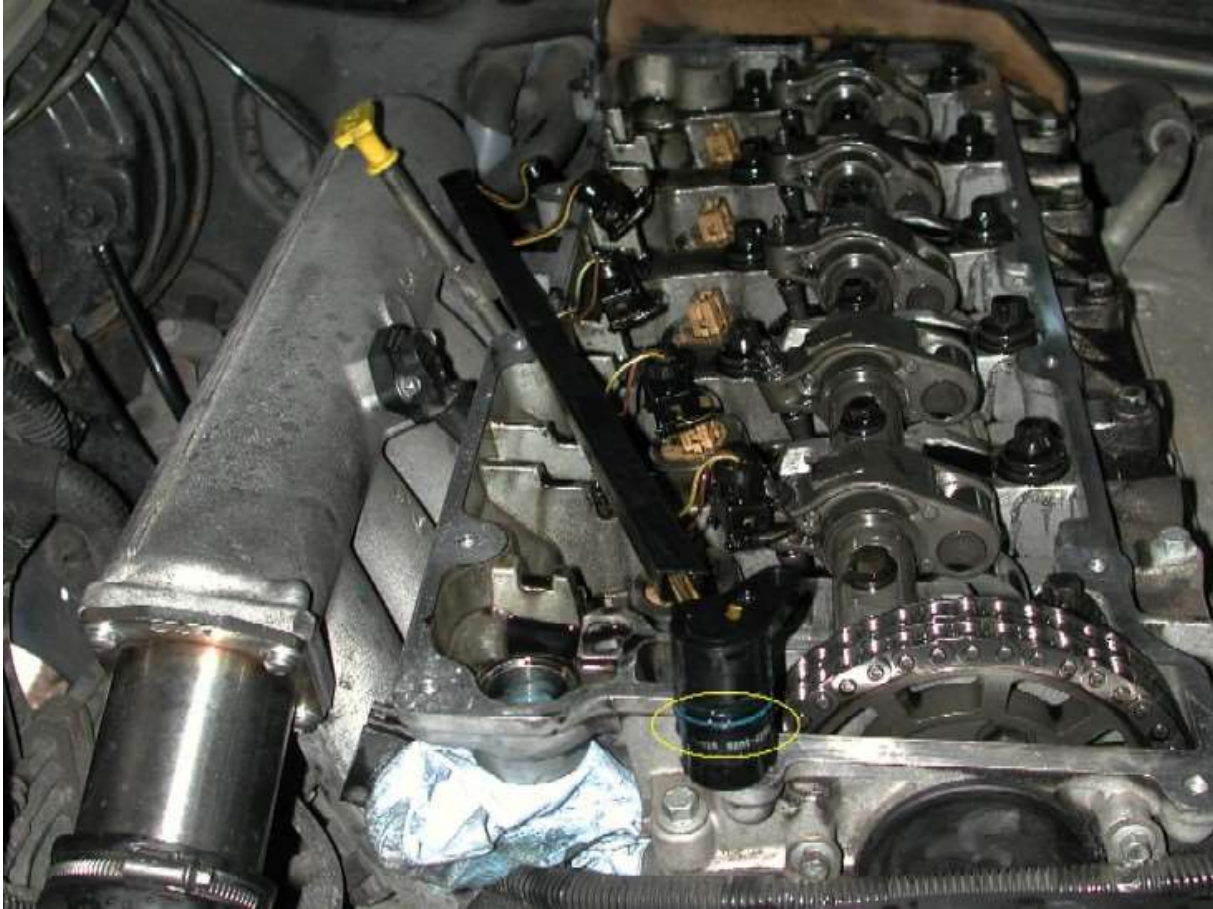
*And the plug that is underneath where the main loom joins the injector harness. Once they are all disconnected, the harness simply lifts out. Below you can see the 2 guilty "o" rings that fail and allow the oil to pass into the loom.*

*You can also see above where the "o" rings have stuck themselves in the hole to the head, this ideally needs to be cleaned up before fitting the new one, use some scotch bright pads or "very" fine emery paper to carefully clean up the hole where the plug sits.*

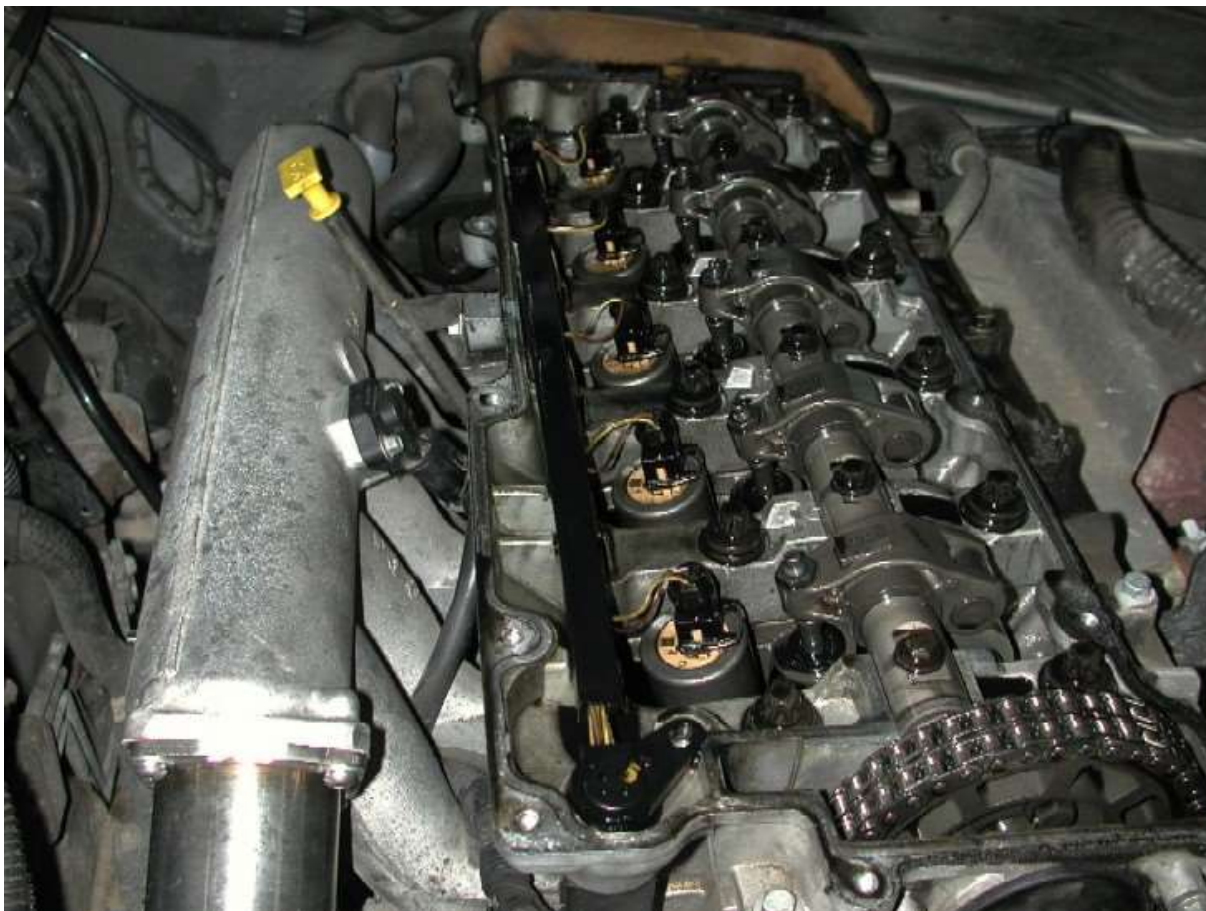
*Now its just a case of simply re-fitting the new harness into position, make sure all the injector plugs are properly clipped home, and also the plug that goes underneath at the front.*

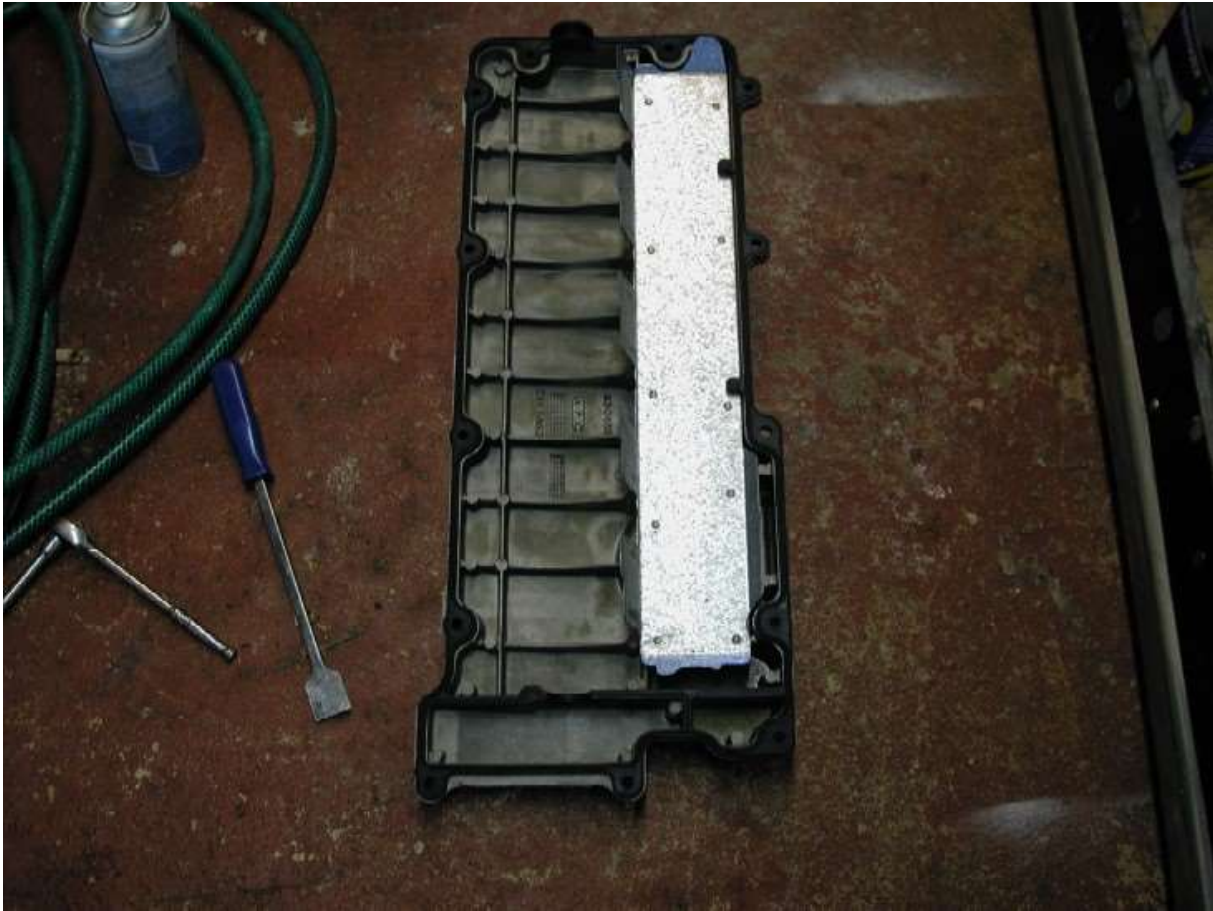
*The new seal should be fitted to the rocker cover first, as it will be almost impossible to lay it on the head and get it lined up correctly. The seal does fit nice and snug onto the rocker cover, and make sure its fitted correctly all the way around its edge, and in particular where it goes over the camshaft at the front, you can if you wish use a few "small" dabs of hylomar to help keep the seal in place on the rocker cover.*

*Now using some paper towel, or clean rags, clean around the edge of the head where the rocker cover seal sits making sure you don't push any dirt into the head. I already had a new rocker seal to re-fit once I had done this job, It is entirely your decision whether or not to replace the seal. It is good practice to do it and upon "feeling" the old seal, it had started to go hard with age etc, so I would recommend that you DO fit a new seal.*

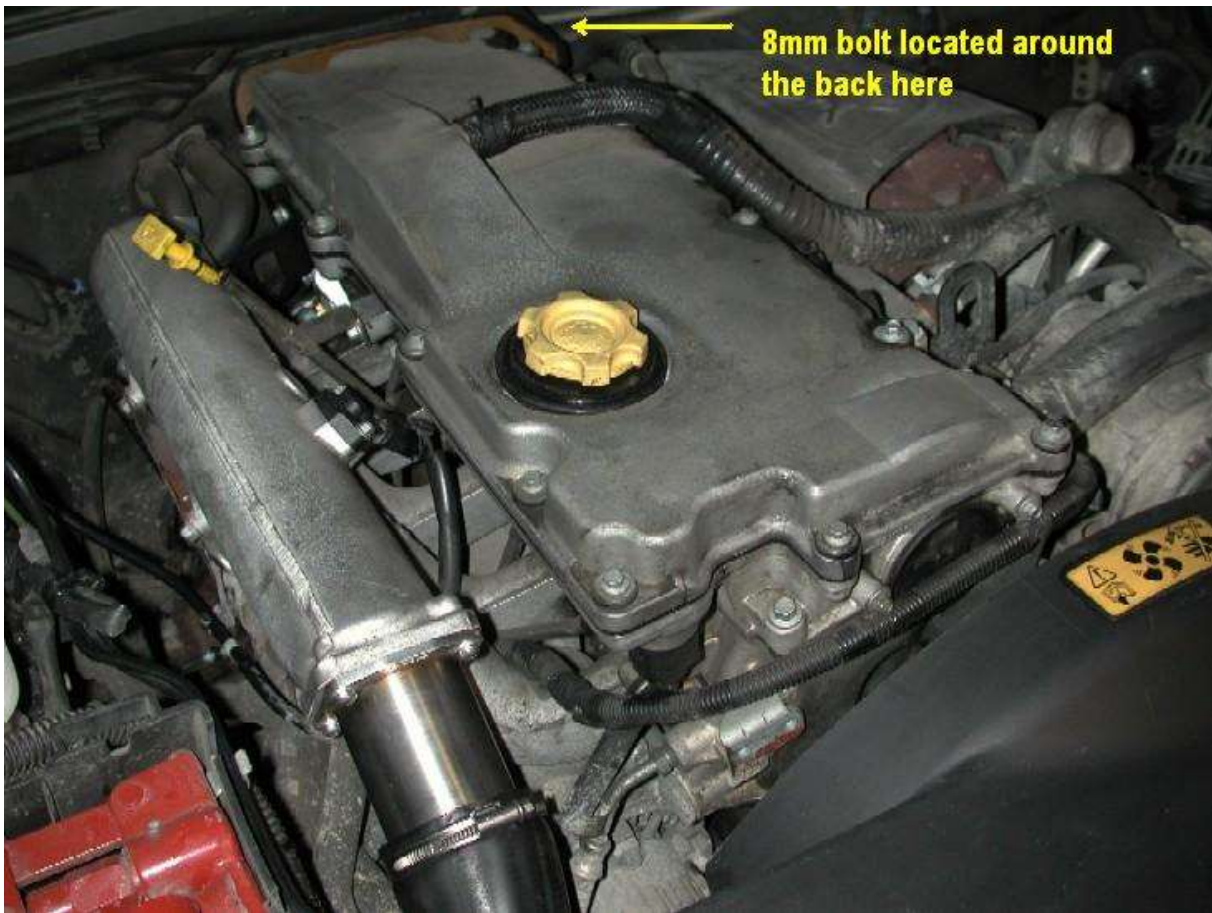
*Now because of the rear acoustic engine cover, and the injector splash shields, its almost impossible to "feed" the rocker cover into place without knocking the seal of where it goes over the rear of the camshaft, so to help me get around this, at the back of the engine on the passenger side (uk car) there's an 8mm bolt that holds the rear plastic engine cover to the block, remove that bolt and this will allow you to push the engine cover back towards the bulkhead and makes it far easier to get the rocker cover back into position without knocking the seal off each time. I wedged a hammer handle in between the cover and block to keep the cover pushed back against the bulkhead. below is a picture of the rough location of where the bolt is*

*Now remove your hammer handle or what ever you used to "wedge" the rear cover out of the way, and re-fit the 8mm bolt at the rear of the engine.*
