[www.discovery2.co.uk](http://www.discovery2.co.uk)

"TD5 Engine Oil Pump Bolt" (Including Power Steering pipe Issue)

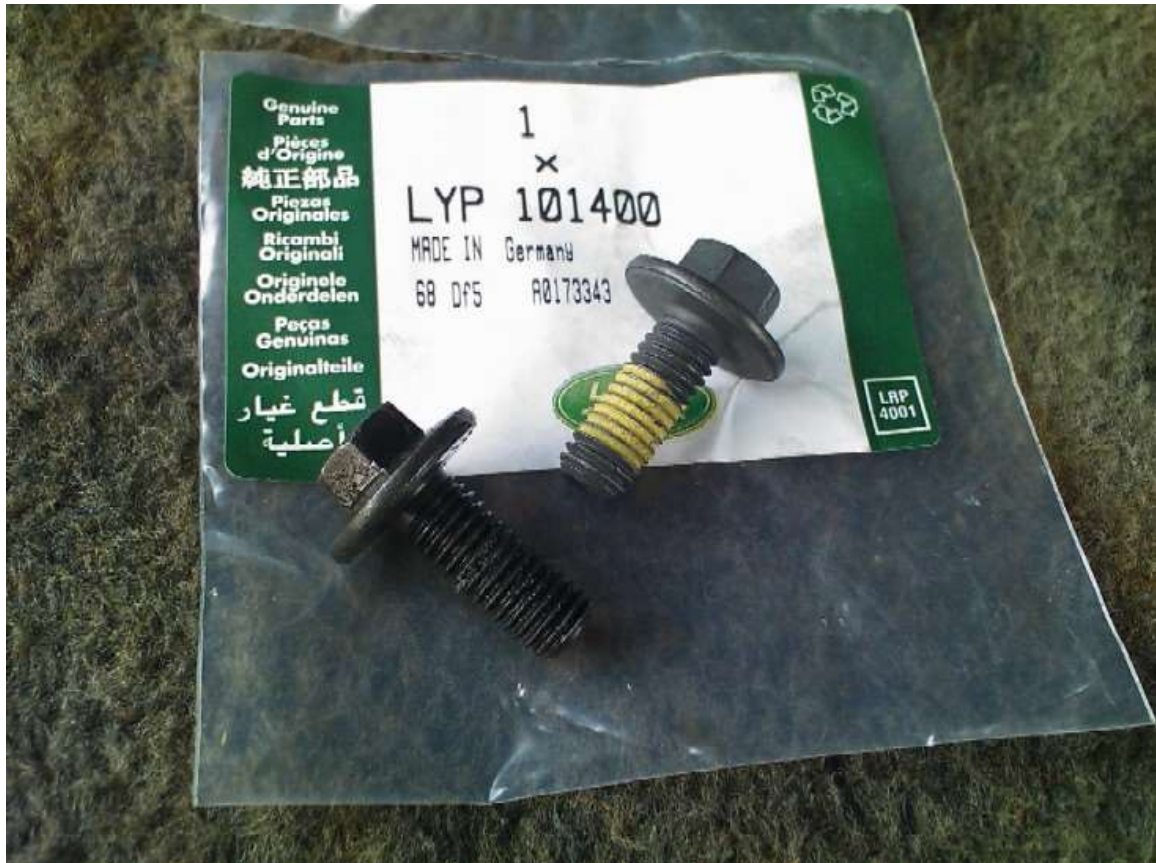
*This is a simple 10mm headed bolt that holds the sprocket on for the oil pump down in the sump, its a well known fact that these bolts can and "do" come loose and eventually fall out, this obviously is not good as the oil pump sprocket falls off and the engine basically is destroyed as a result.*

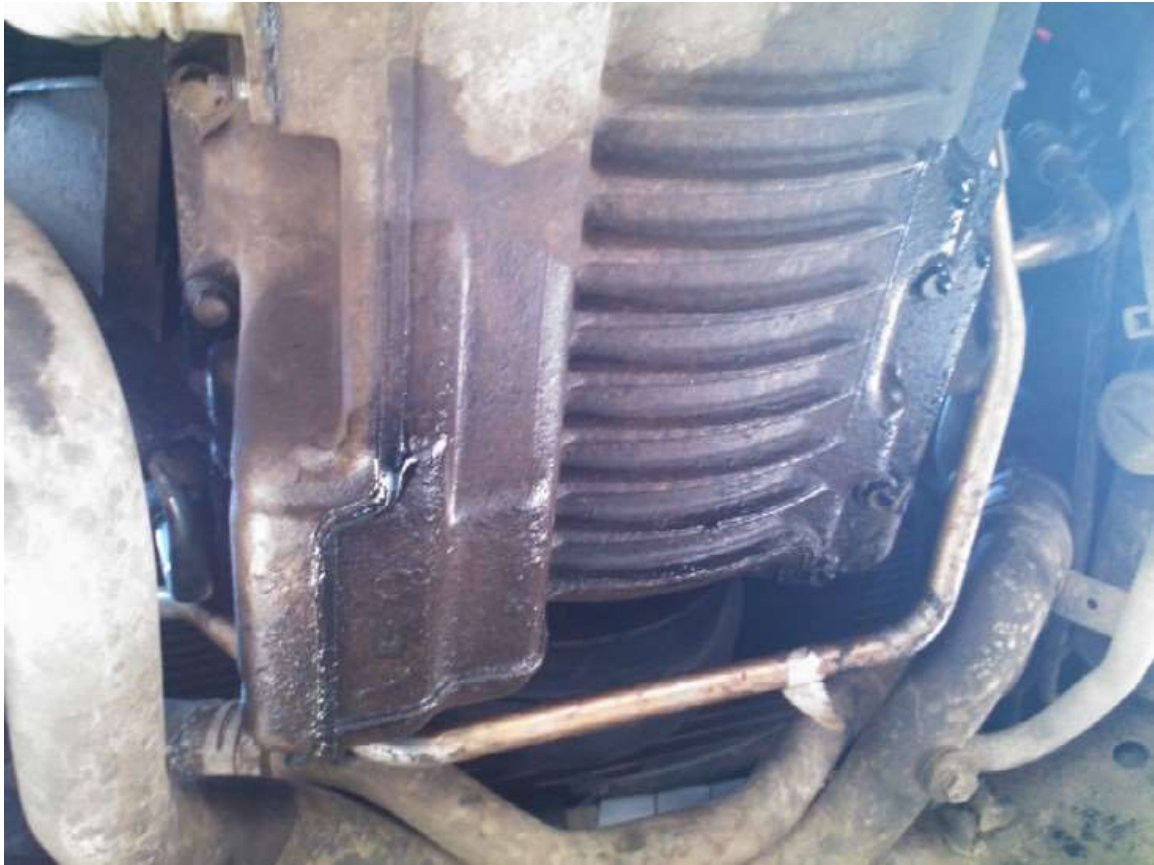
*Now because of this "potential" issue, and the fact that 1)..I was due for an oil change and 2)...the sump gasket on my car was beginning to weep,*

*I thought it definitely would not hurt to check / replace the bolt on my oil pump whilst combining it with these 2 other jobs.*

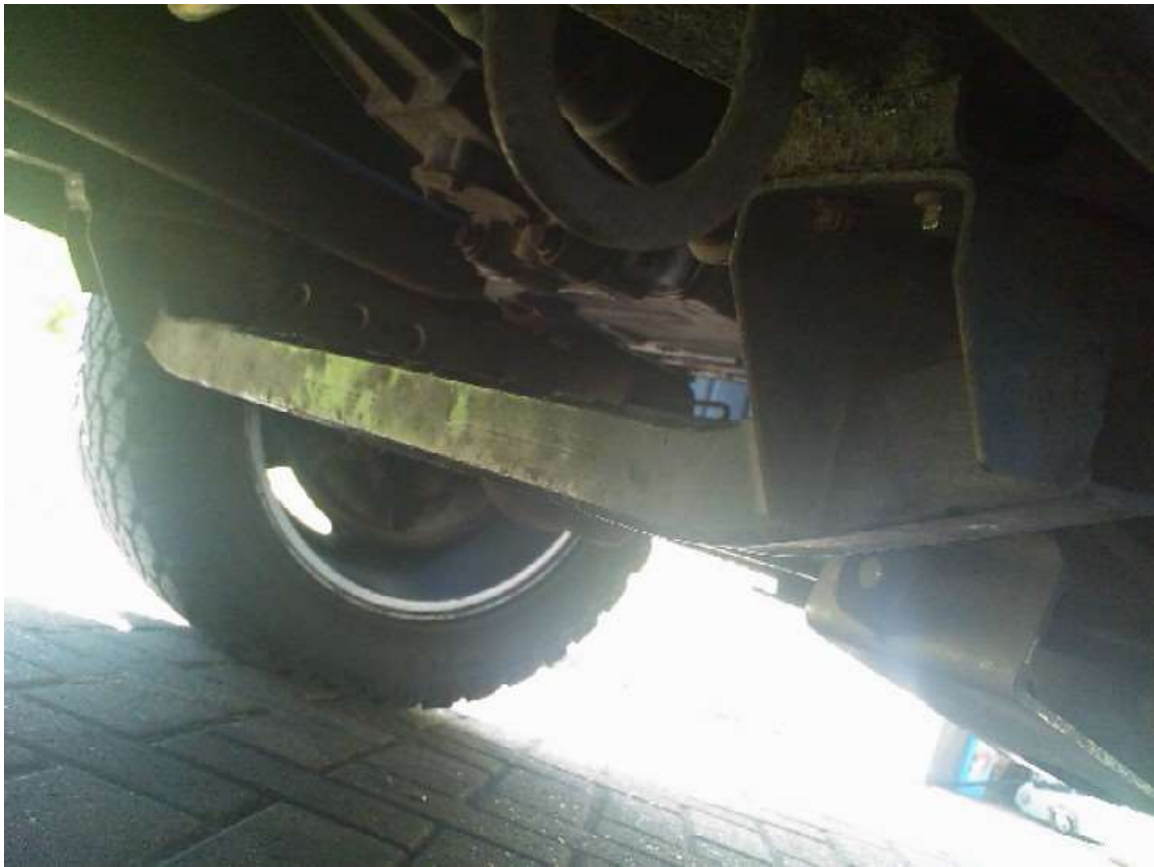
*So remove the **front** cross member by simply undoing the 8 bolts (4 each side). They may well be a little corroded, so a good soak in WD40 will help before hand.*

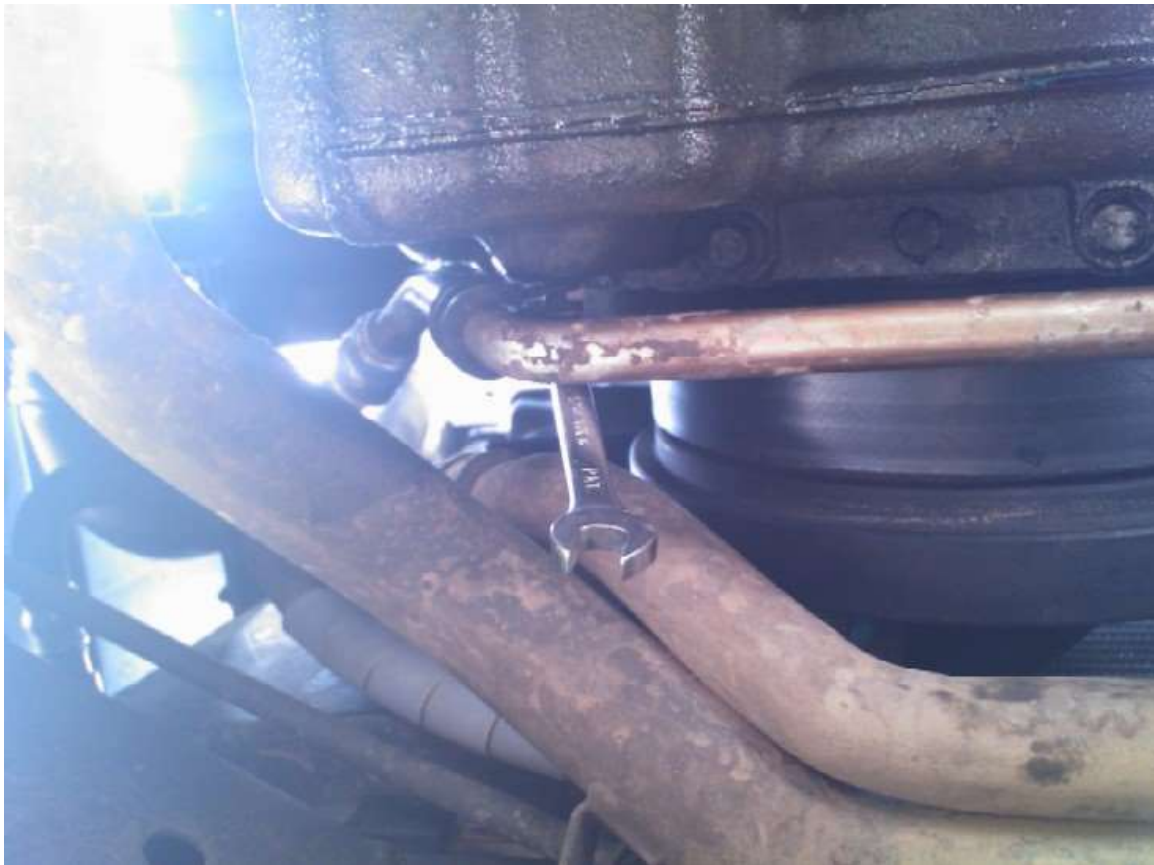
*Next you will have to remove the plastic under shields (if you still have them). Once they are removed, then undo and remove the "P" clip that holds the left hand Gearbox Oil cooler pipe to the front of the engine sump.*

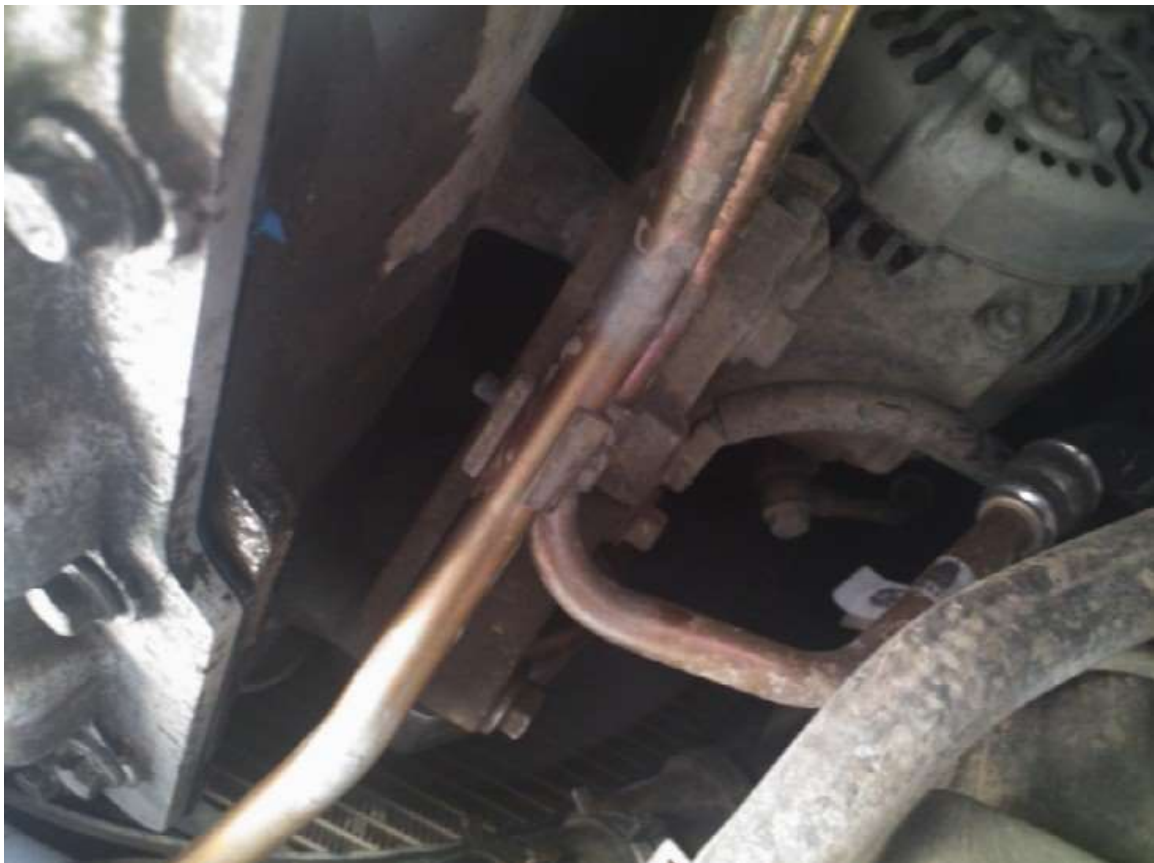
*Next, undo the clamp that also holds this pipe on the drivers side of the car, this will allow you to flex the pipe out the way when removing the sump.*

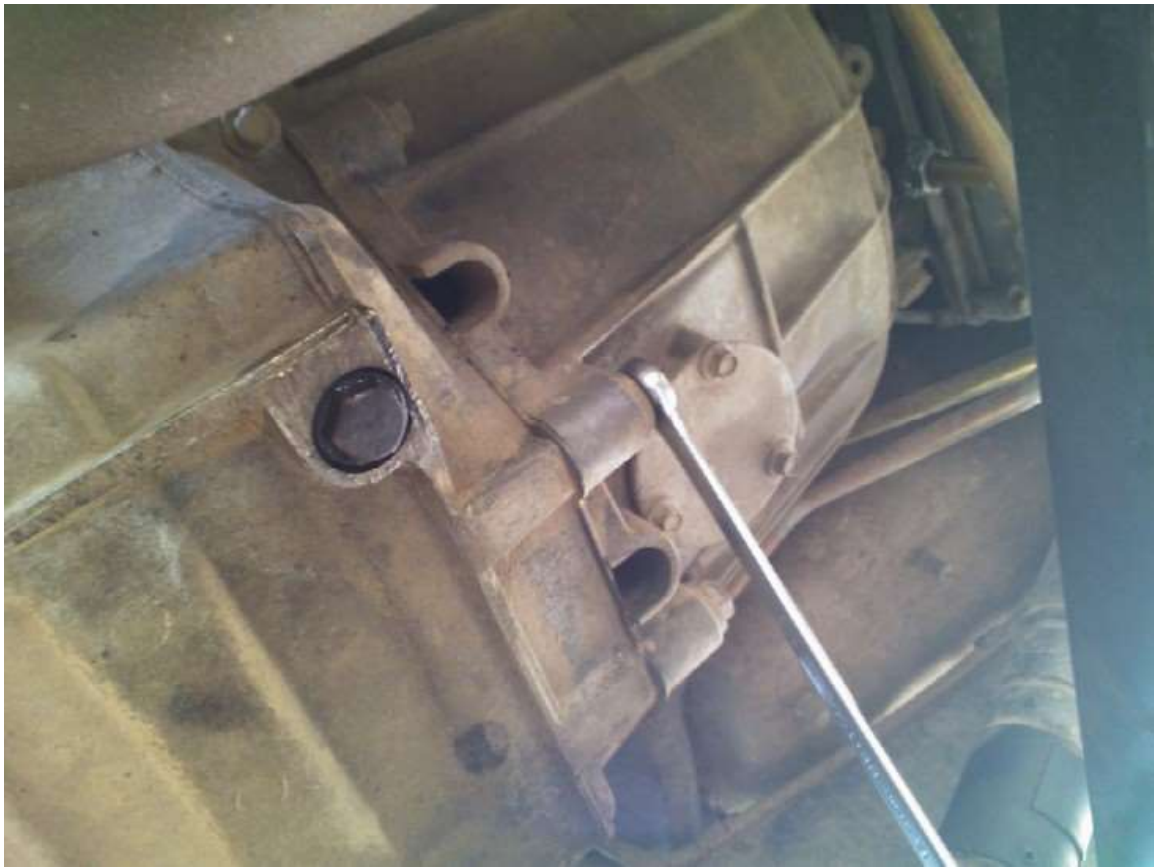
*Now at the back of the sump, there is 4 bolts running forwards that go through the bell housing and into the sump. Remove all 4 of these.*

*3 can be seen in this picture, the one you cannot see is directly on the opposite side. All 4 of these bolts are the same length / type, but it is good practice to note which one went where for re-assembly later on.*

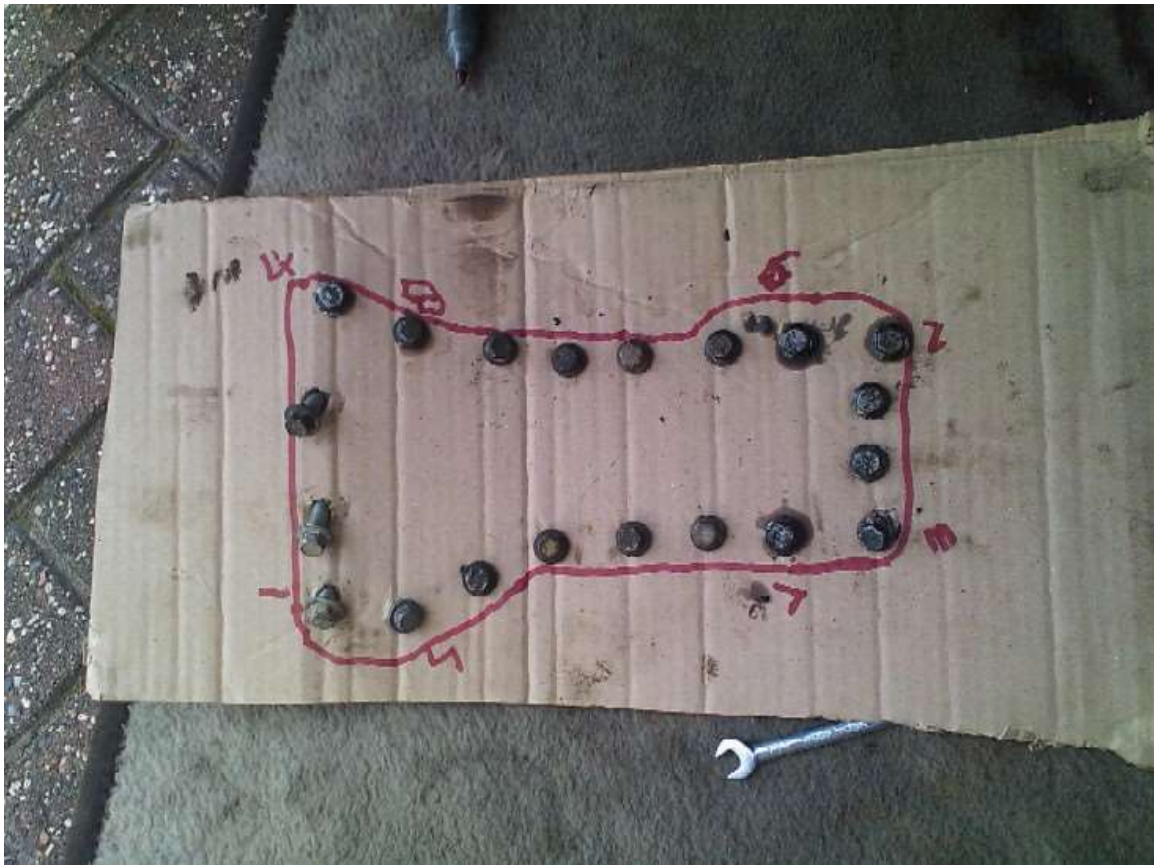
*Now, most of the bolts are the same length, except the ones nearest the bell housing. There is 3 different lengths here, so you **MUST** note their original fitted positions. To save any possible error or confusion when it comes to the refit, you could do what I did and simply get a piece of cardboard and draw the shape of the sump on it, and each time you remove a bolt, poke it through the cardboard in the relative position it came from and number either a few for reference or all of them.*

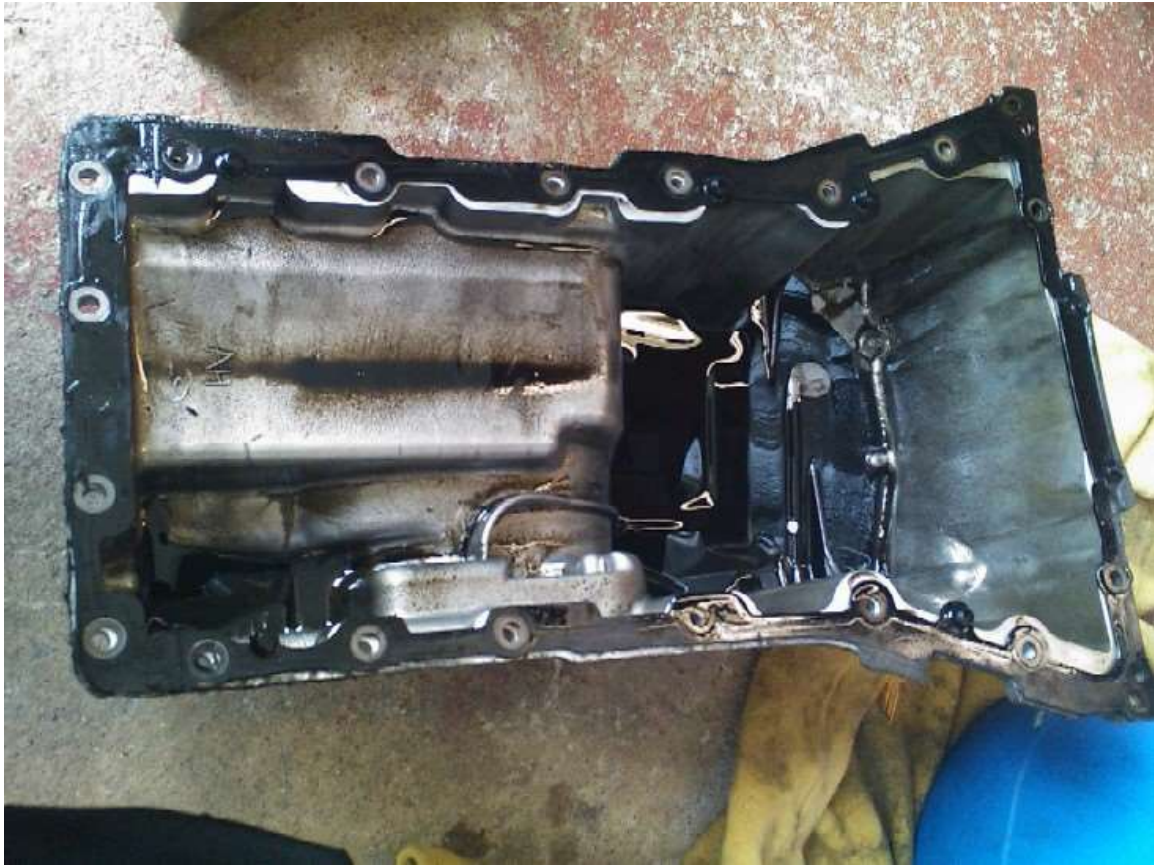
*Here's the sump below, as you can see there's ALWAYS some old oil you just cannot get out with a normal drain and refill !!*

*My Sump gasket was actually weeping from the top left corner (looking at picture above), later you will see why...*

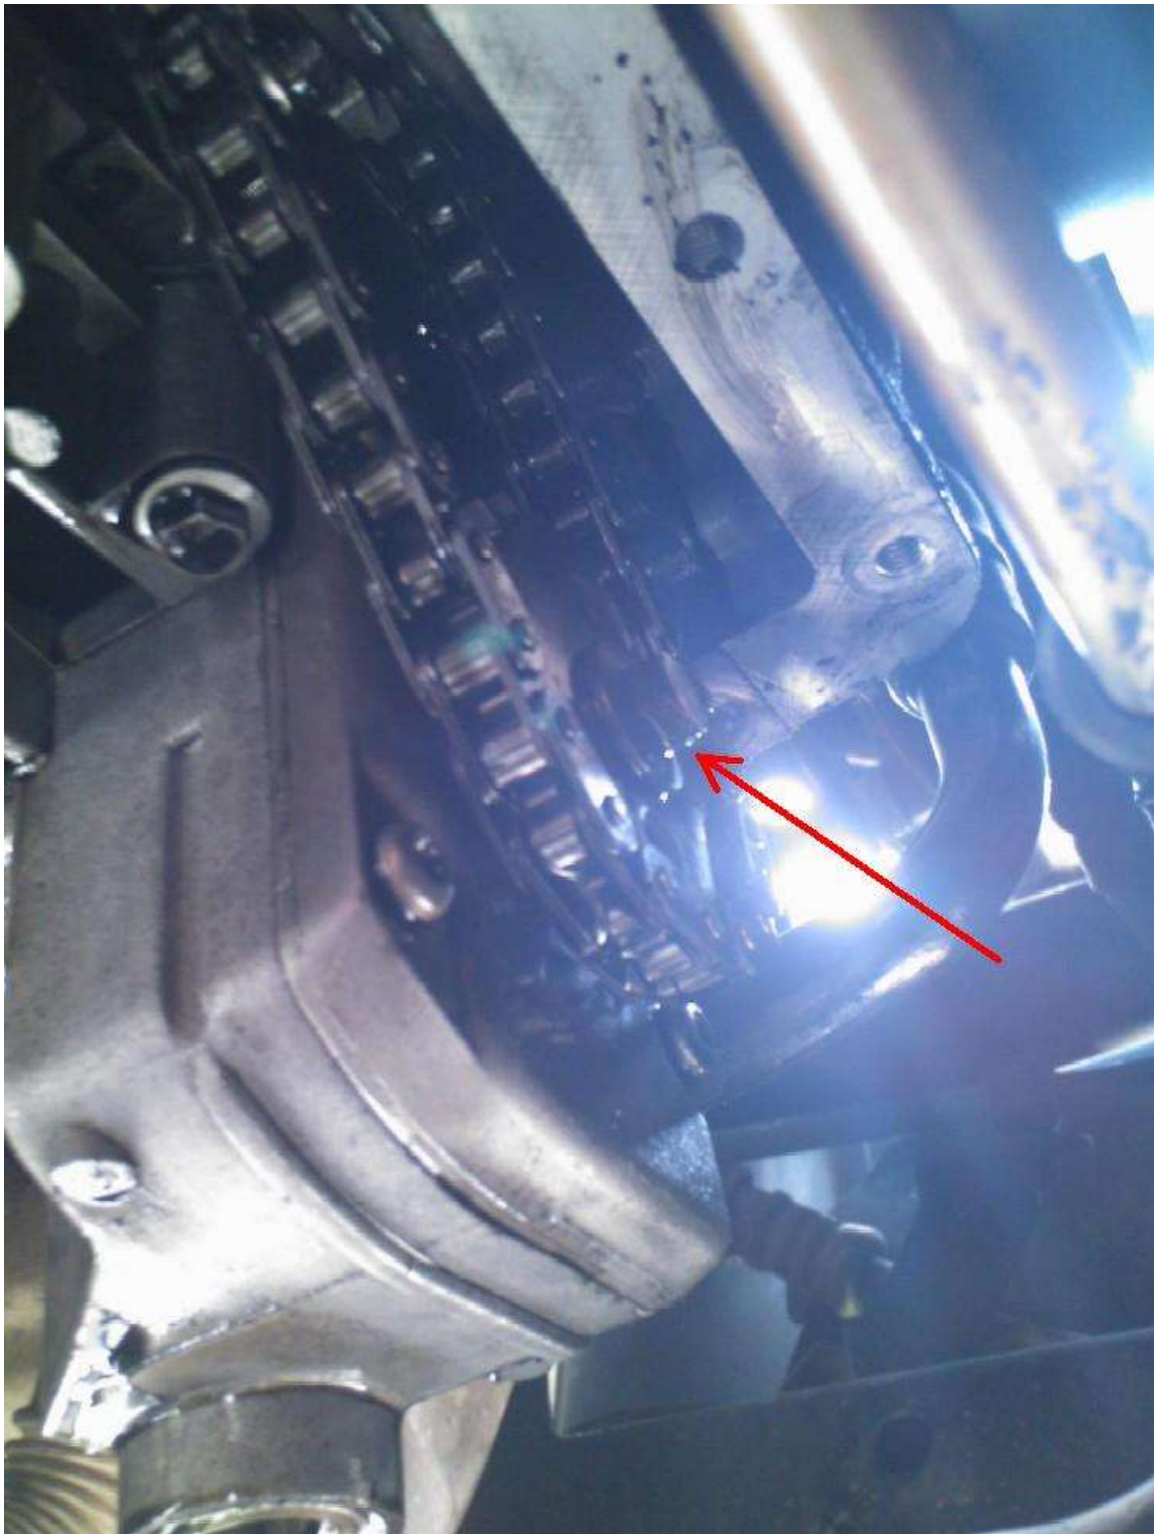
*Right, now the sump is off, you will be able to see the famous bolt!!! I'm not to sure what I wanted to find really, if it had been half out ( as has happened) then it would have been a great sigh of relief, however, mine was definitely still in there, although it was a "little" loose for my liking, so I'm glad I checked it anyway.*

*The Pump bolt was superseded by a new part that has thread lock already on it, so its just a case of carefully removing the bolt and installing the new one. Keep hold of the sprocket to make sure it stays in position when you take the bolt out.*

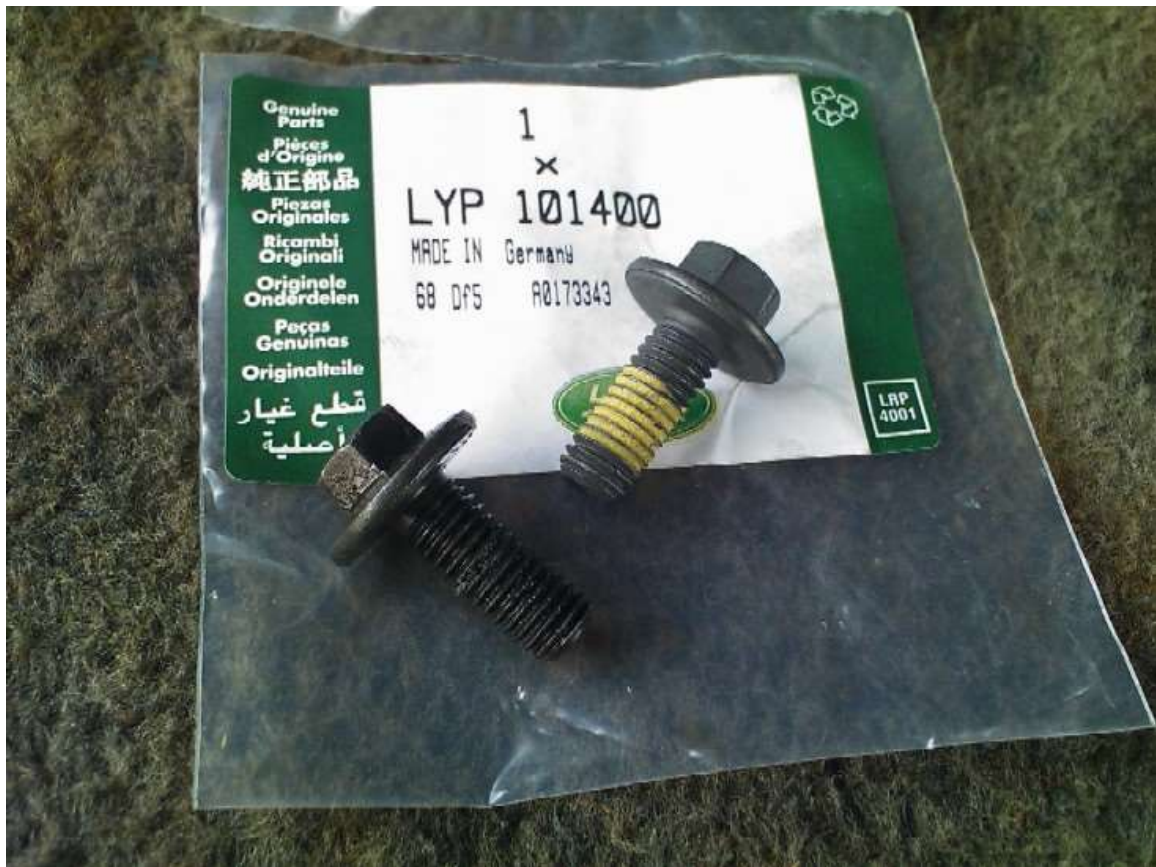
*Here's the new bolt below, you can clearly see the thread lock all ready on it. The "old" bolt did not really show any signs of thread lock at all.*

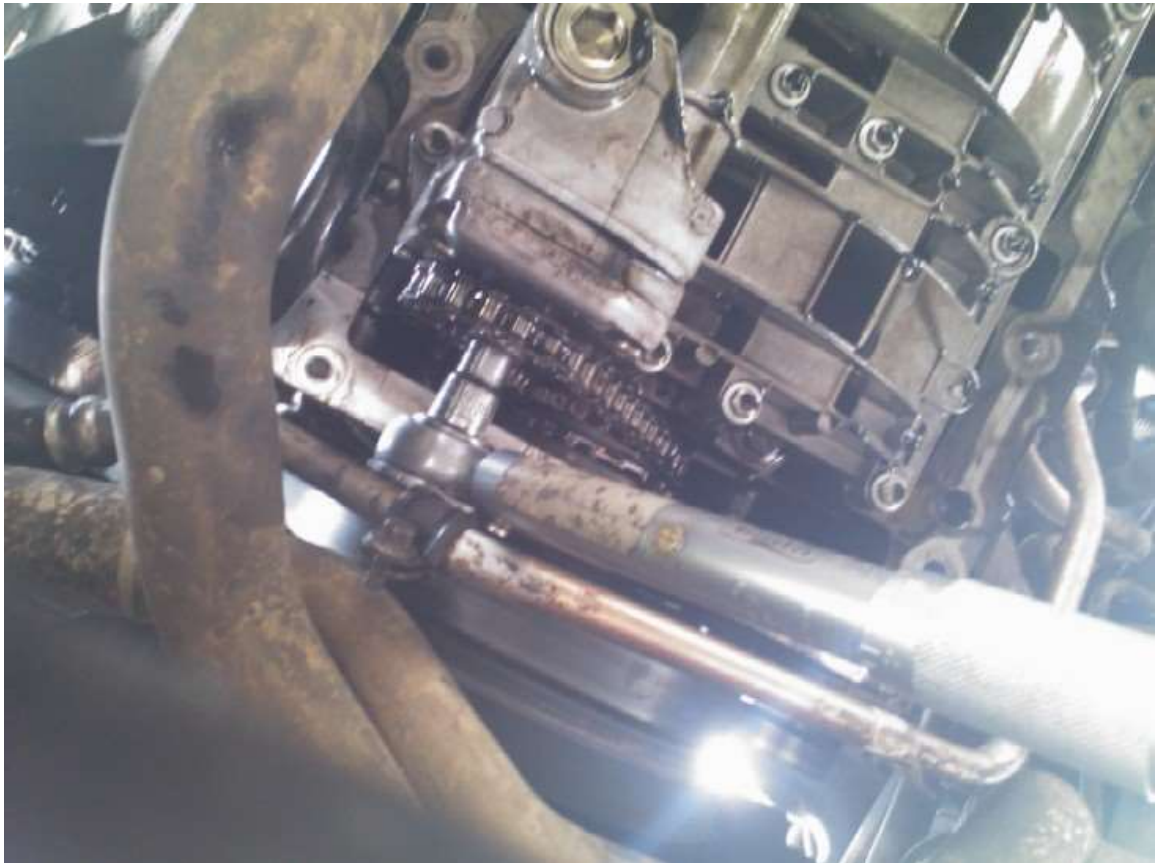
*Simply fit the new bolt into the pump sprocket and tighten / torque it up to 25NM, 18Lbs FT or 216 Lbs IN depending on your torque wrench. A 3/8 drive torque wrench is about the right size and probably the biggest you can fit into the space to torque it up with.*

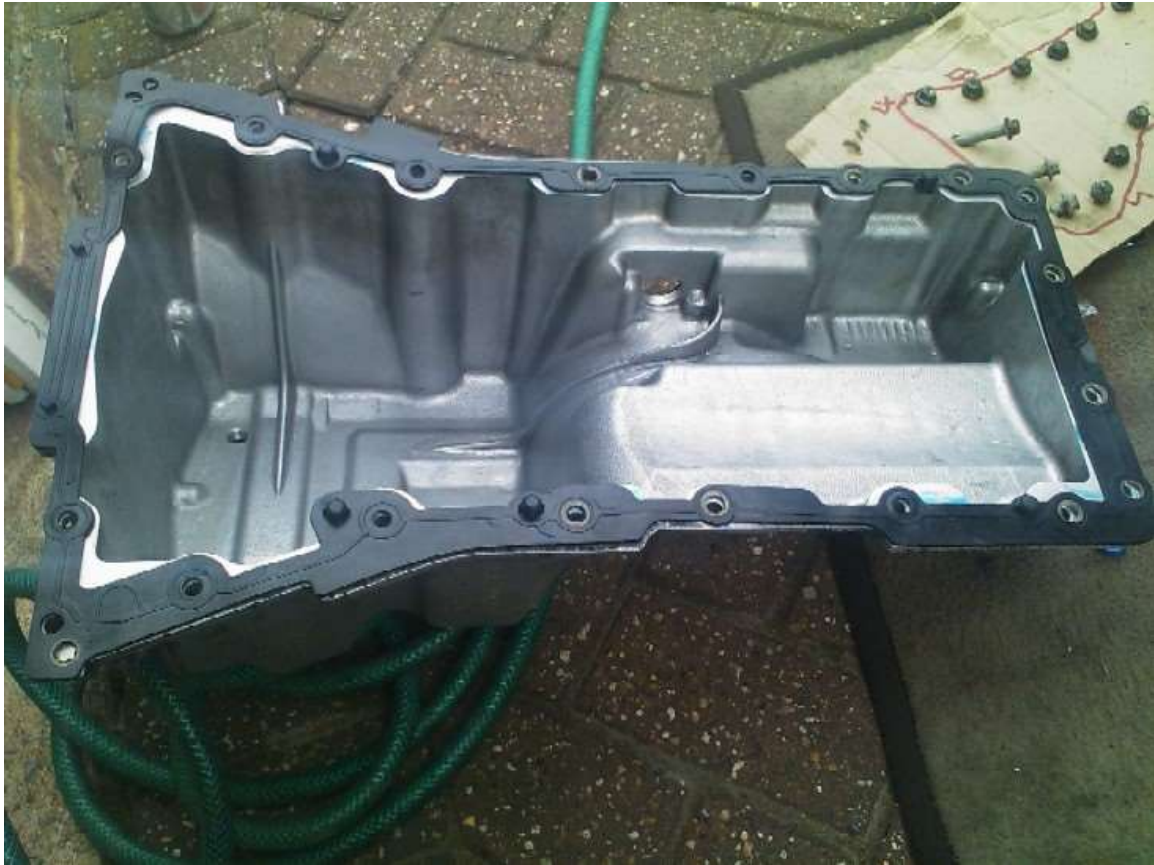
*Whilst the sump was off, I took the opportunity to give it a full clean / degrease both inside and out. Below is the clean sump with a new gasket installed.*

*The gasket has molded "dowels" on it to make sure it locates correctly both on the sump and on the bottom of the cylinder block. The gasket is installed DRY.*

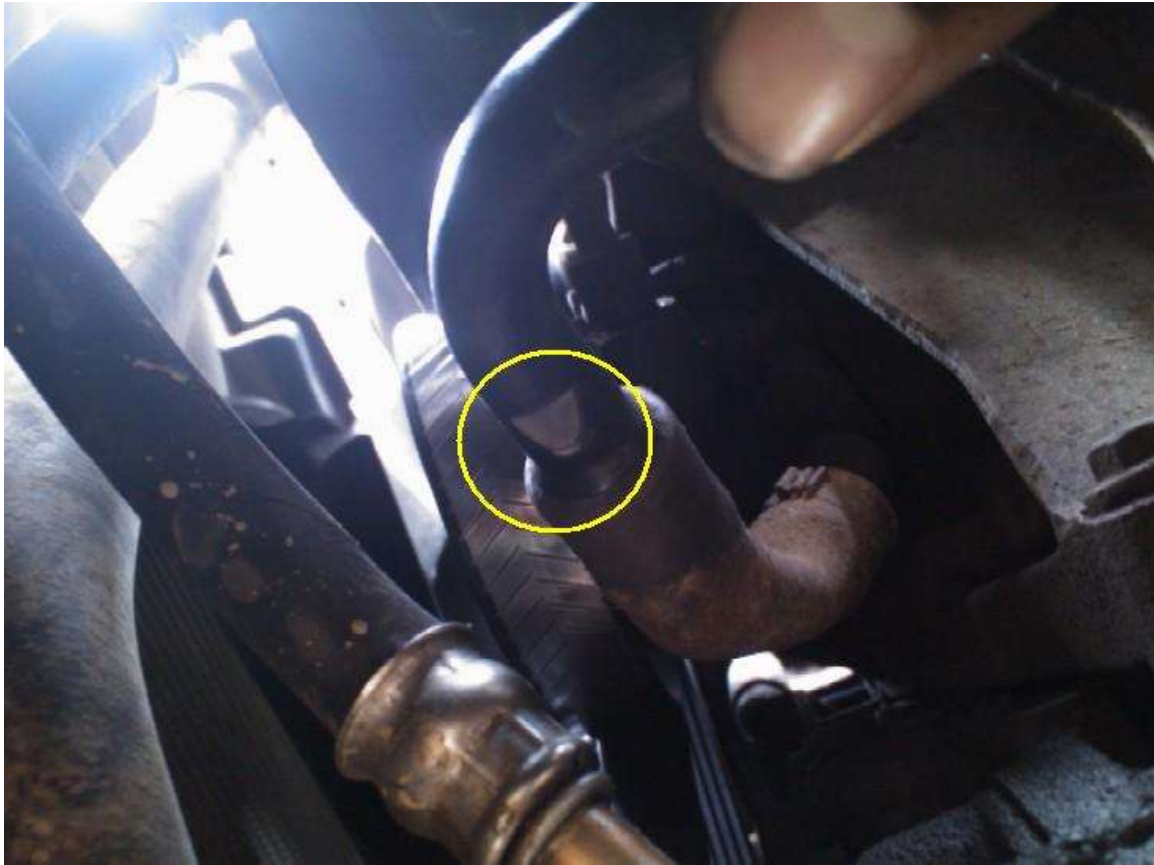
*At the front left corner of the sump, the power steering pipe coming down from the reservoir passes the sump VERY closely on its way up to the pump, in fact its too bloody close as it has been chaffing away and was only a matter of time before it made a hole in the pipe.*

*If you look at the picture below you will see the damage that has been done to the pipe!!*

*This pipe is a solid metal and rubber pipe. The damage here is at least 50% through the thickness of the metal part of the pipe. Now that have found it and moved it away it would most likely be ok, but I will replace this at the earliest opportunity. Land Rover in their wisdom fitted a pathetic piece of foam to stop this pipe chaffing, but as you can see it didn't really work. A simple bracket and "P" clip would have been the correct way to do it.*

*The Pipe is now currently tie-wrapped securely out the way of the sump, once I get a replacement pipe, I will make a bracket and fit a "p" clip to hold it and stop it ever happening again. After writing this article, I did a little research and this is a VERY common issue, although its generally found once it has actually holed the pipe.*

*The new pipe is Part No **ANR6974** and is around £20 inc VAT.*

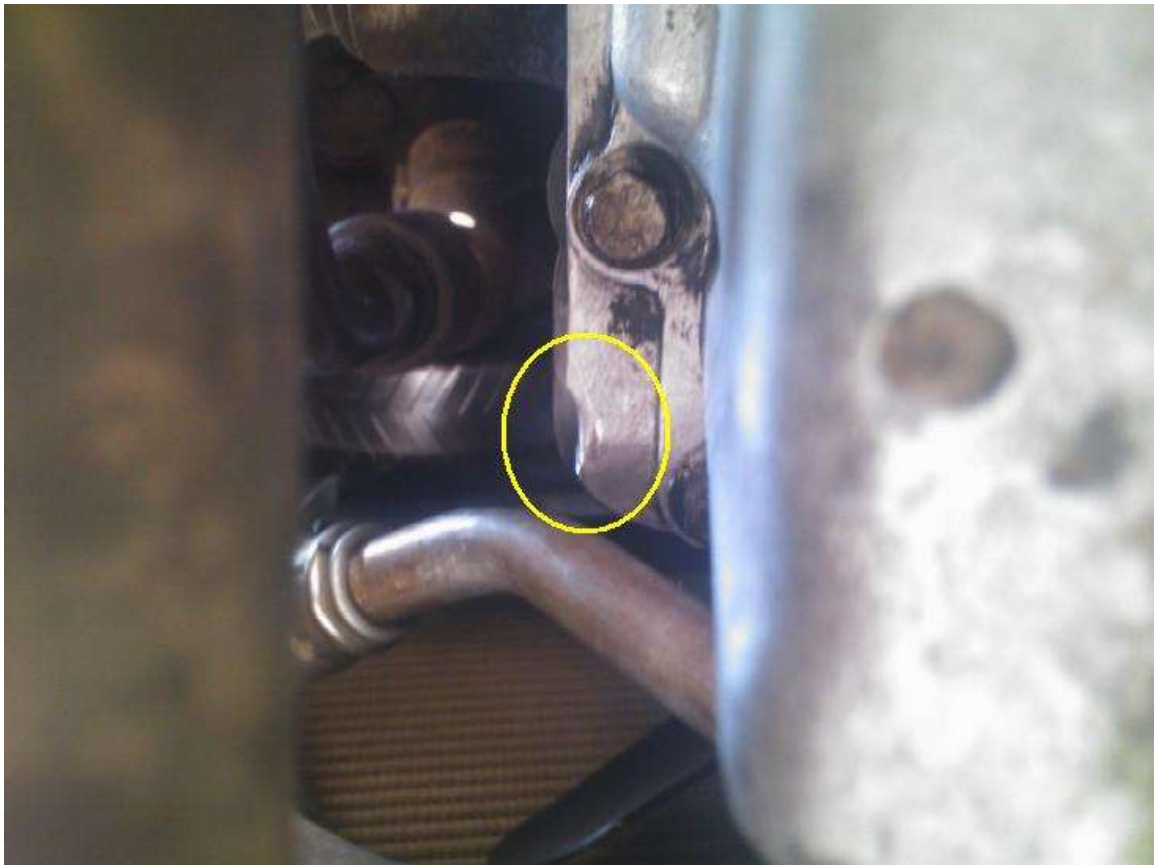
*Below you can also see how much of the edge of the sump the pipe has worn away!!*
