Viscous Fan Pulley - Bearing Replacement

The vehicle in this article is fitted with a 15P engine and had covered over 150,000 miles, so in fairness the bearing had not done to bad. The procedure for replacement would be the same on any variant of the TD5 engine. NOTE some images are library images from other articles.

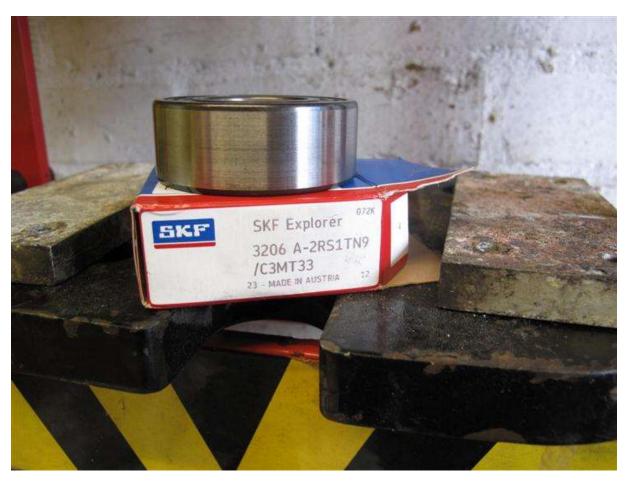
Below is the bearing, this was supplied as an OEM part (NOT pattern) and as you can see if it arrives in a SKF box, then we can be sure it's a quality product. The Land Rover Part No for this bearing is ERR5285

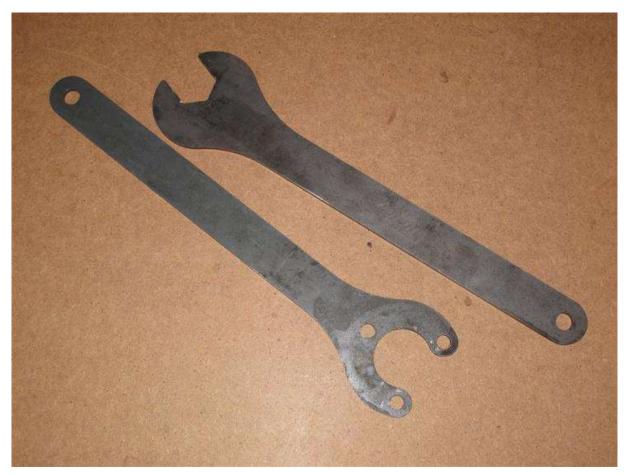
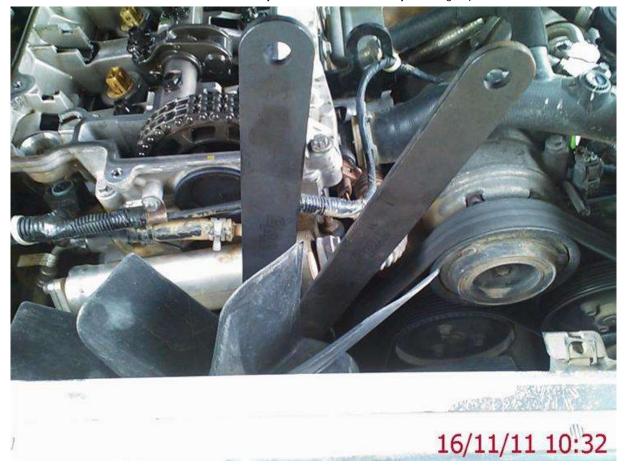
Next we need to remove the viscous fan itself. The fan has a NORMAL right hand thread. The best way to remove the fan is to use spanners like these below....

One spanner sits over the pulley bolts, the other fits the nut on the fan itself.

These spanners are available on Ebay and a well worth buying, not only for just fan removal itself, but you will **NEED** one of these spanners also as a tool to do the actual bearing replacement.

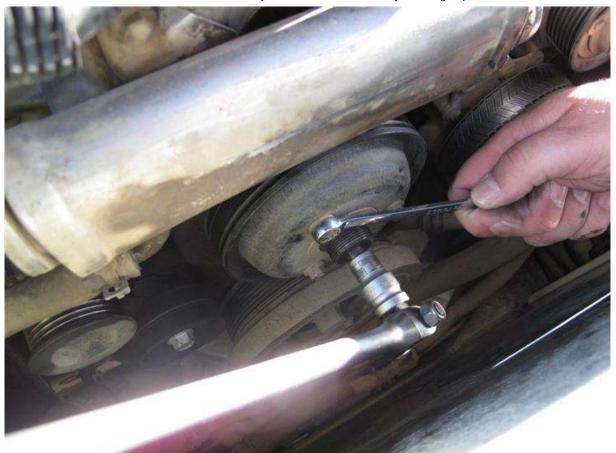
Next you will need to remove the fan pulley. The shaft of the Fan pulley has a 12mm Hex in the end which enables you to hold the shaft and stop the pulley rotating whilst you undo the 3 pulley retaining bolts.

The 12mm Hex tool is **CRITICAL** to the bearing replacement job, so you will need to obtain one of those BEFORE attempting this job.

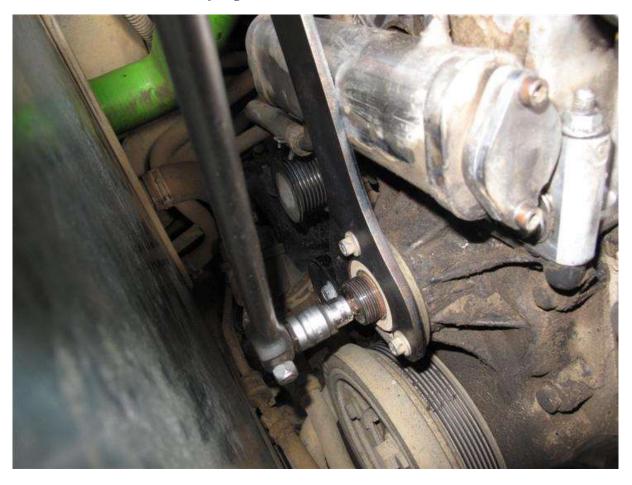
The flange on the pulley is threaded onto the shaft just like the viscous fan, so using the spanner to hold the flange and the 12mm hex in the centre,

This will enable you to wind the flange off the shaft. Now the flange is thread locked onto the shaft for obvious reasons, you have to "break" that threadlock. Heating the flange in that area with a blow torch will "soften" the threadlock a little, even then it was VERY tight and required one person to hold the fan spanner and the other to turn the breaker bar.

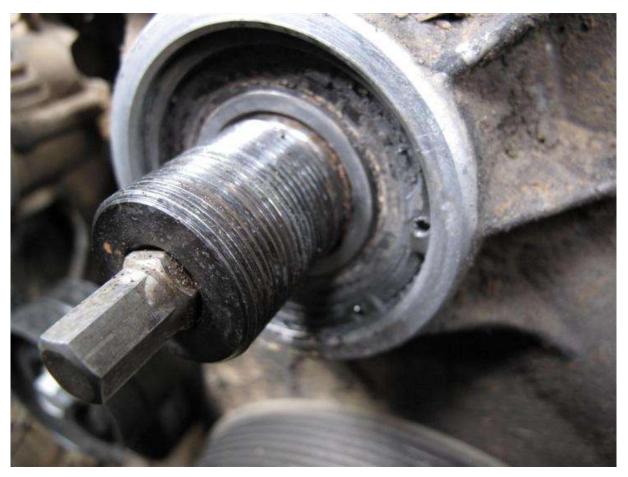
To wind it off, hold the fan spanner and turn the shaft using the bar and hex tool **CLOCKWISE** as to undo the flange...Once it breaks the threadlock, wind it all the way of the shaft. This will reveal the bearing and more importantly the circlip which retains the bearing in the housing.

Now clean all the dirt etc away from the circlip and housing, then using circlip pliers, remove the circlip...it is advisable to wear safety goggles when removing and re-fitting circlips.
