CHASSIS ELECTRICAL

CONTENTS

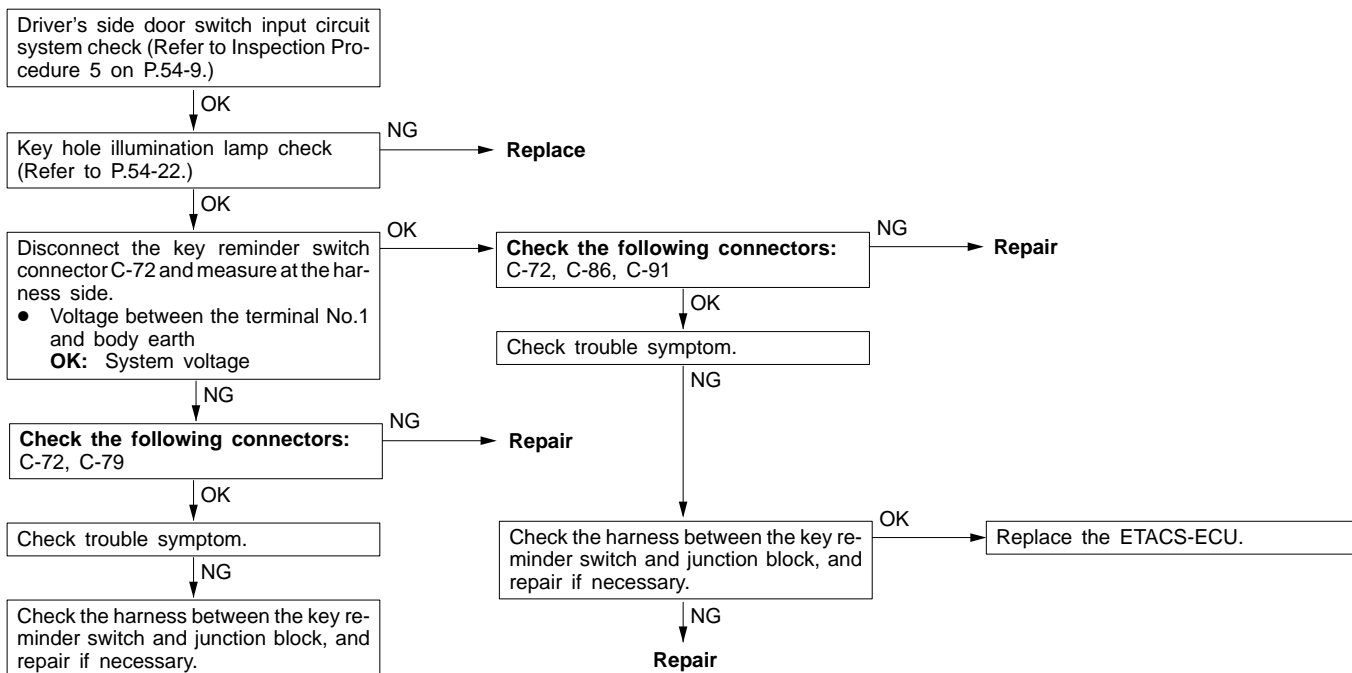
Inspection Procedure 3

Even if the driver's side door is opened, the key hole illumination lamp does not illuminate.	Probable cause
The cause is probably a defective key hole illumination lamp circuit system or a defective driver's side door switch input circuit system.	<ul style="list-style-type: none"> • Malfunction of driver's side door switch • Malfunction of key hole illumination lamp • Malfunction of harness or connector • Malfunction of ETACS-ECU

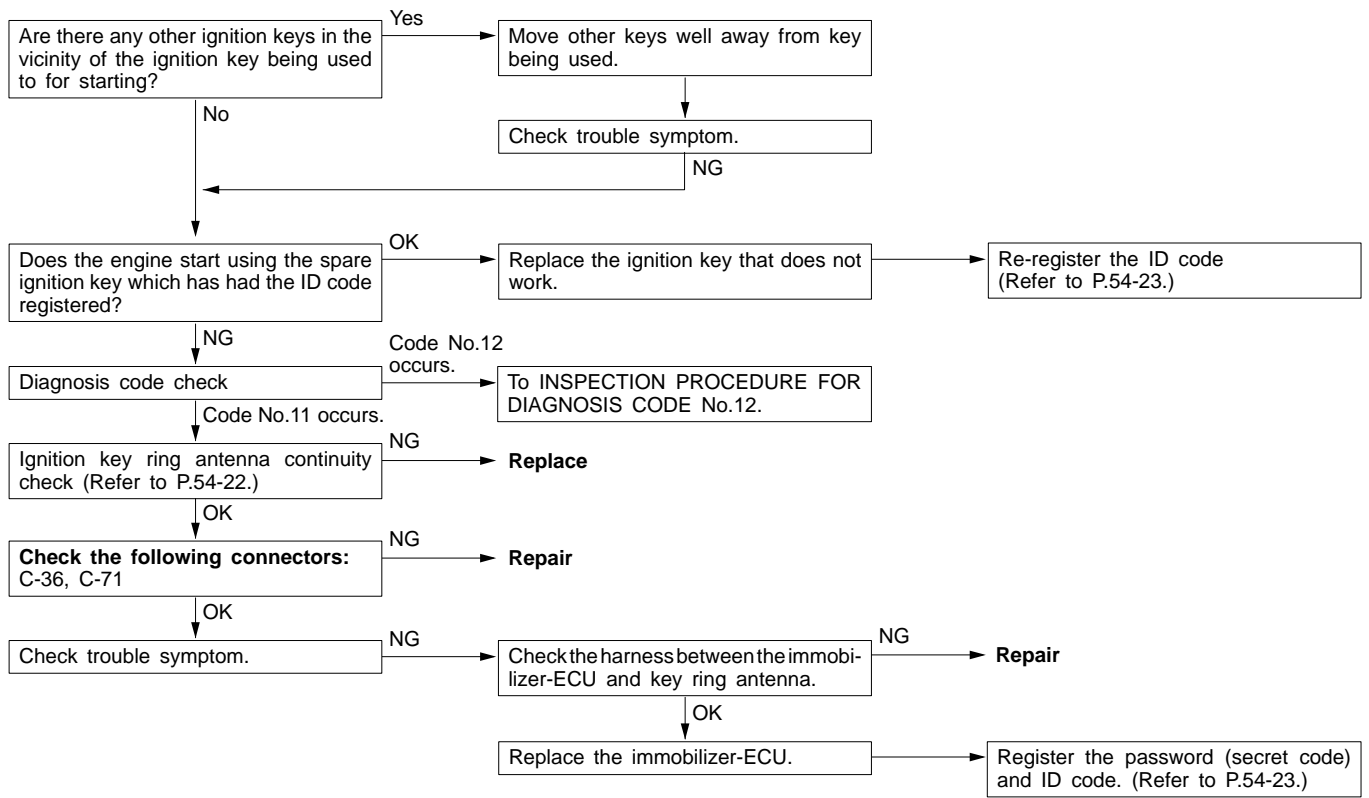
Code No.11 Transponder communication system or radio interference of ID code	Probable cause
<ul style="list-style-type: none"> • The ID code of the transponder is not sent to the immobilizer-ECU immediately after the ignition switch is turned to ON position. • If the engine is started while several ignition keys are in the vicinity, then interference between the different keys may occur, which will cause this code to be generated. 	<ul style="list-style-type: none"> • Radio interference of ID code • Malfunction of transponder • Malfunction of ignition key ring antenna • Malfunction of harness or connector • Malfunction of immobilizer-ECU

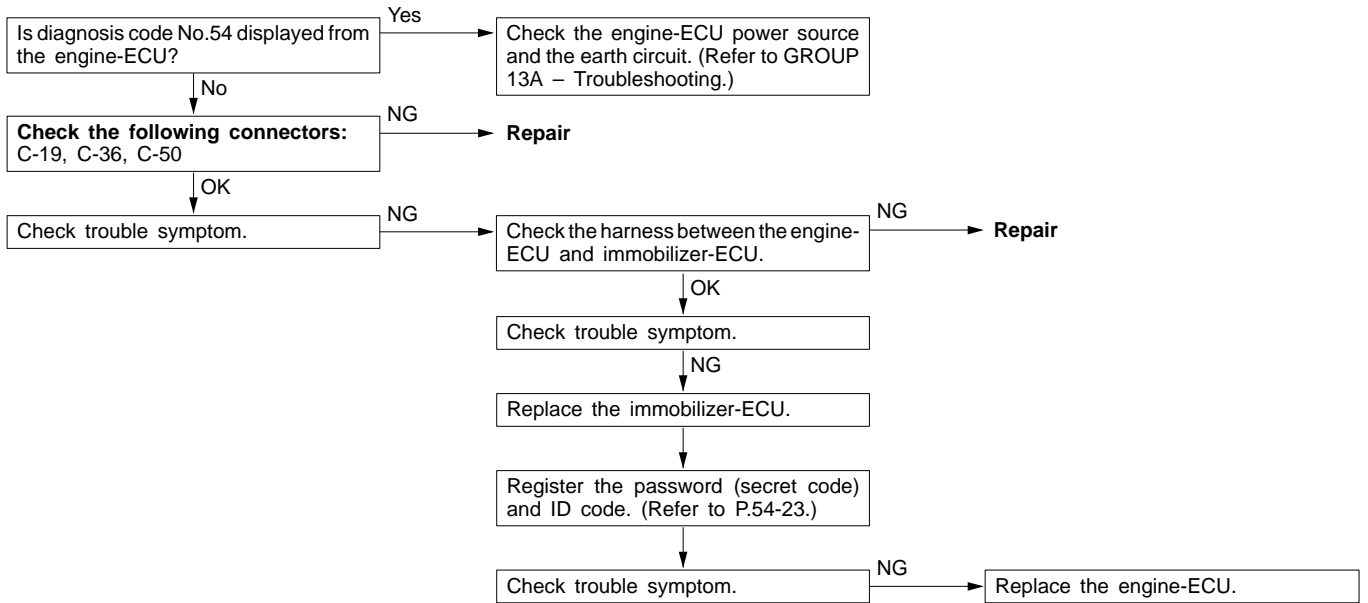
Code No.21 Communication system between MUT-II and engine-ECU	Probable cause
After the ignition switch turned to ON, the confirmation code is not received from the engine-ECU within allowable time, or an abnormal code is received.	<ul style="list-style-type: none"> • Malfunction of harness or connector • Malfunction of engine-ECU • Malfunction of immobilizer-ECU

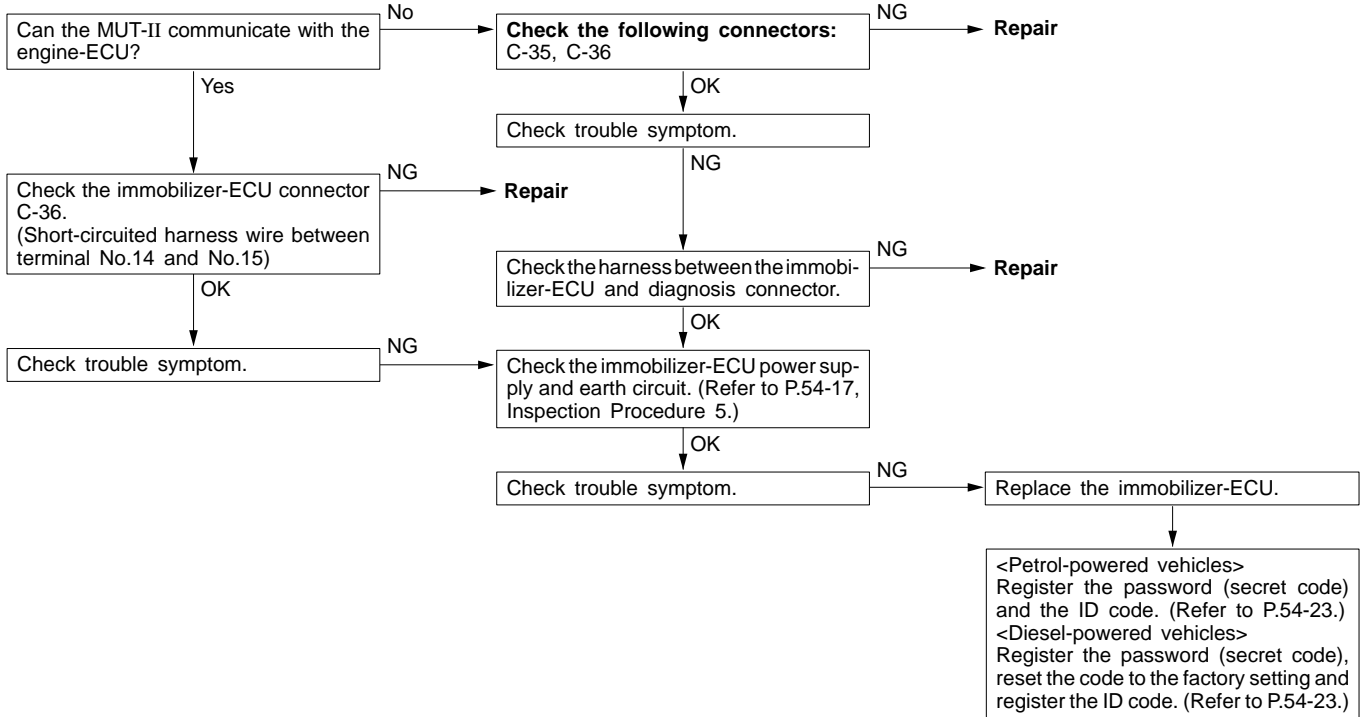
Inspection Procedure 1

Communication with MUT-II is impossible	Probable cause
The cause is probably that a malfunction of the diagnosis line or the immobilizer-ECU is not functioning.	<ul style="list-style-type: none"> • Malfunction of diagnosis line • Malfunction of harness or connector • Malfunction of immobilizer

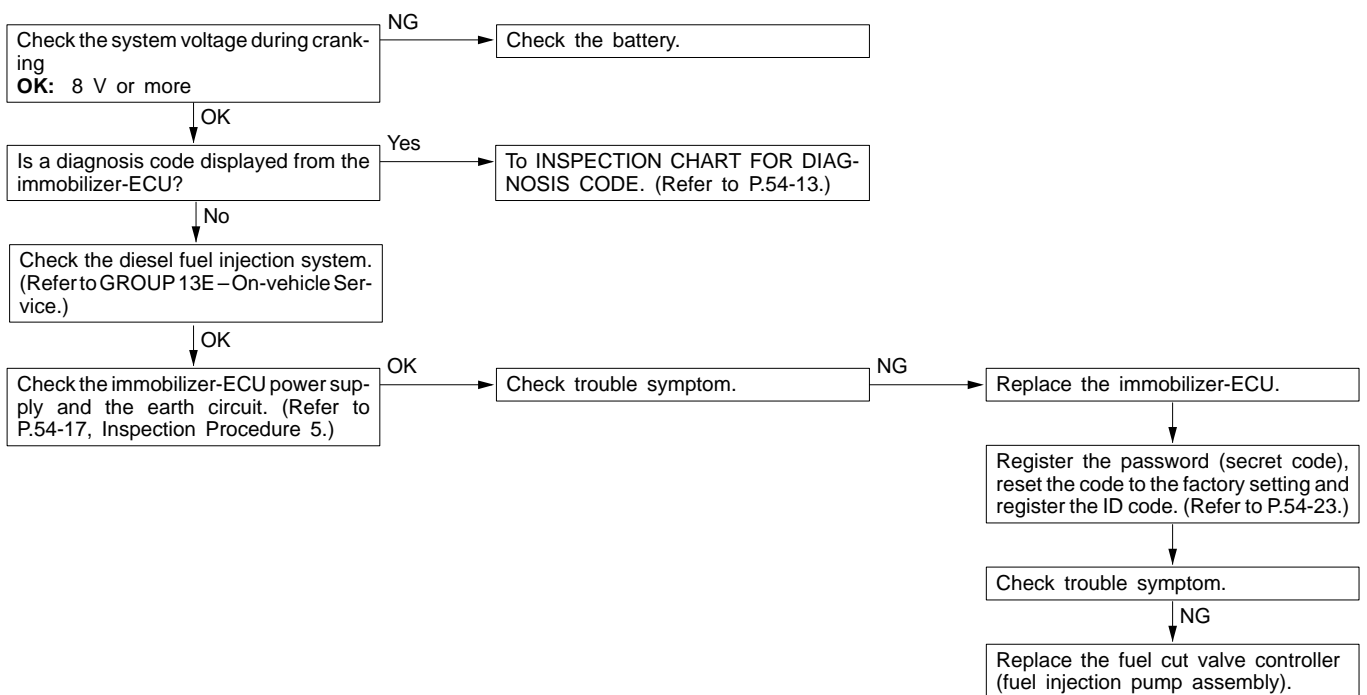
Inspection Procedure 4

Engine does not start (Cranking but no initial combustion). <Diesel-powered vehicles>	Probable cause
If no fuel injection, there might be a problem with the fuel injection system in addition to a malfunction of the immobilizer system. It is normal for this to occur if an attempt is made to start the engine using a key that has not been properly registered.	<ul style="list-style-type: none"> ● Malfunction of diesel fuel injection system ● Malfunction of immobilizer-ECU

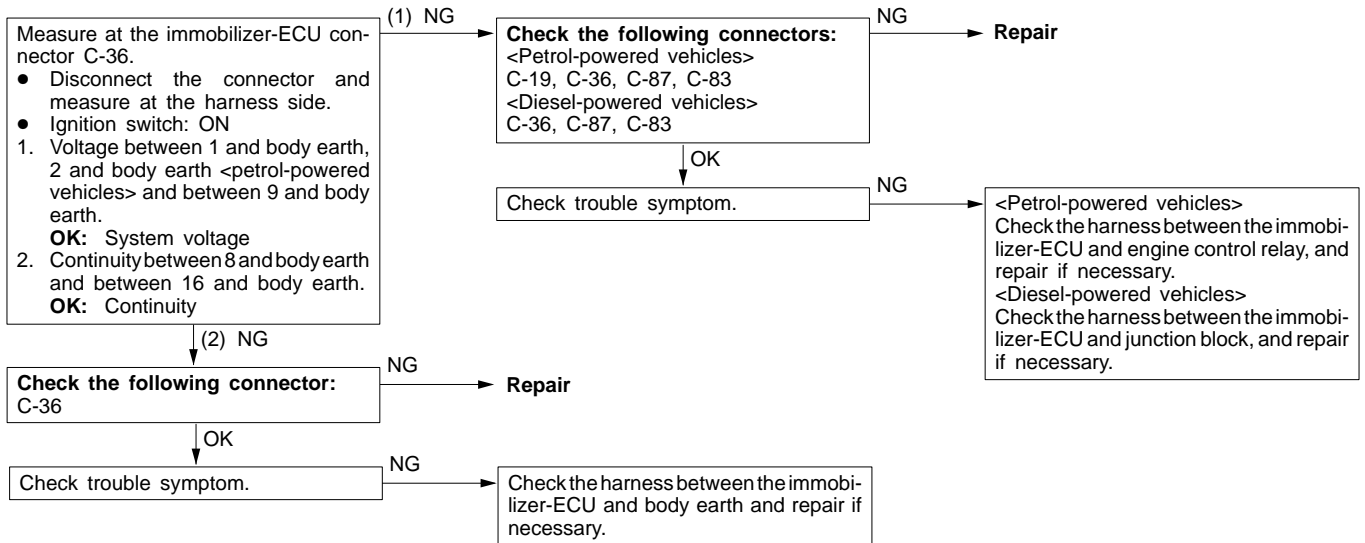
Inspection Procedure 5

Malfunction of the immobilizer-ECU power source and earth circuit

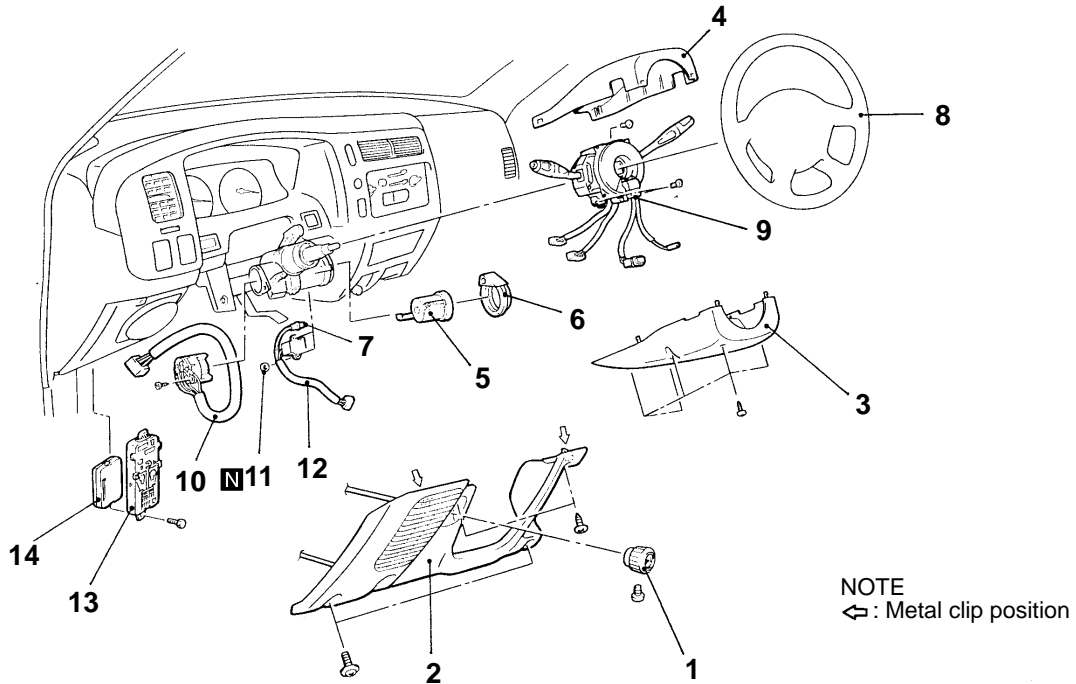
<Vehicles without immobilizer system>

Steering lock cylinder and key hole illumination lamp removal steps

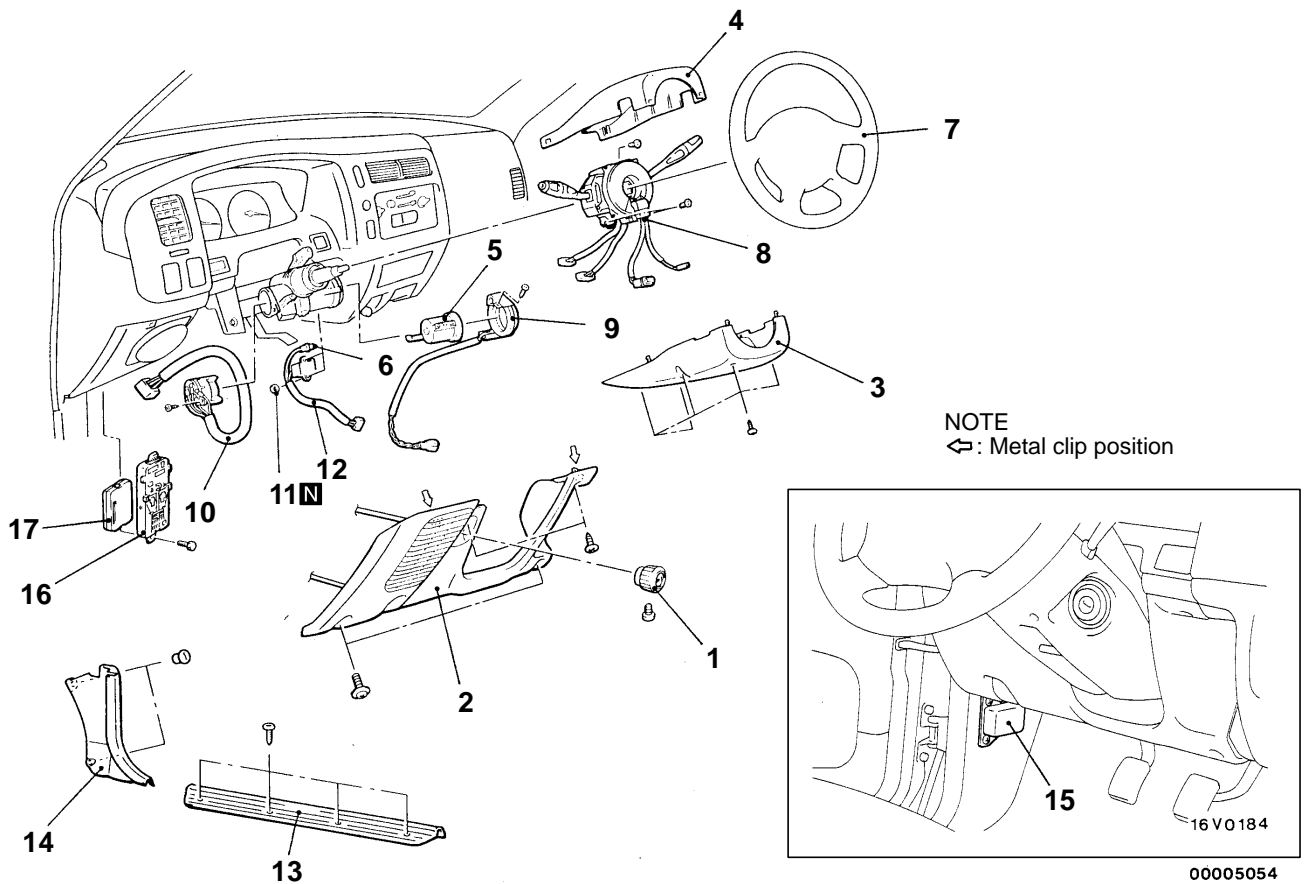
<Vehicles with immobilizer system>

Steering lock cylinder and key hole illumination lamp removal steps

1. Throttle cable knob
<Diesel-powered vehicles>
2. Driver's side under cover
3. Column cover, lower
4. Column cover, upper
5. Steering lock cylinder
6. Key hole illumination lamp

Immobilizer-ECU removal steps

13. Front scuff plate (driver's side)
14. Cowl side trim (driver's side)
15. Immobilizer-ECU

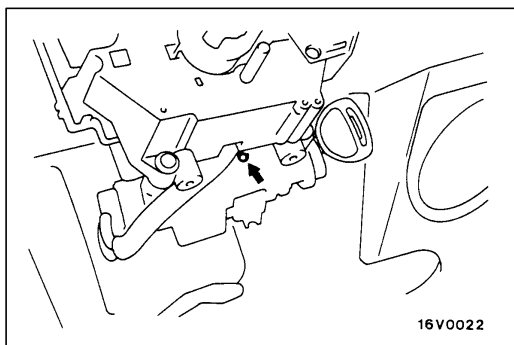
◀A▶ STEERING LOCK CYLINDER REMOVAL

1. Insert the key in the steering lock cylinder and turn it to the "ACC" position.
2. Using a cross-tip (+) screwdriver (small) or a similar tool, push the lock pin of the steering lock cylinder inward and then pull the steering lock cylinder toward you.

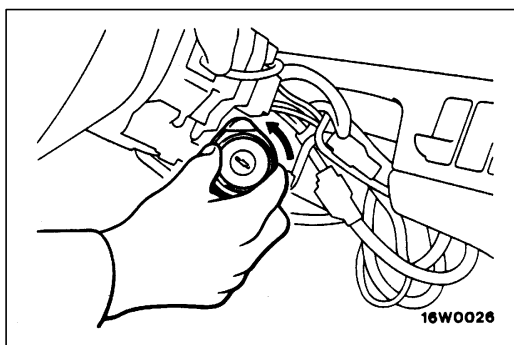
◀B▶ IGNITION KEY CYLINDER ILLUMINATION RING REMOVAL

Turn the ignition key cylinder illumination ring to the left and remove it.

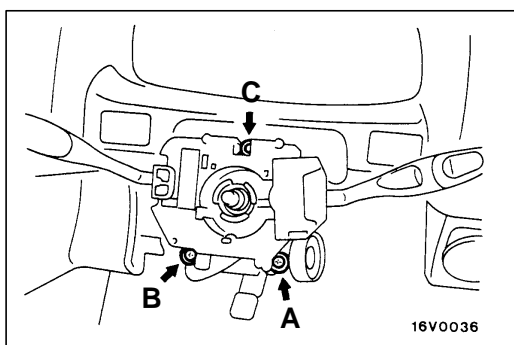
▶A◀ COLUMN SWITCH ASSEMBLY INSTALLATION

Tighten the column switch assembly mounting screws to the specified torque in the order of A, B and C.

Tightening torque: 25 Nm

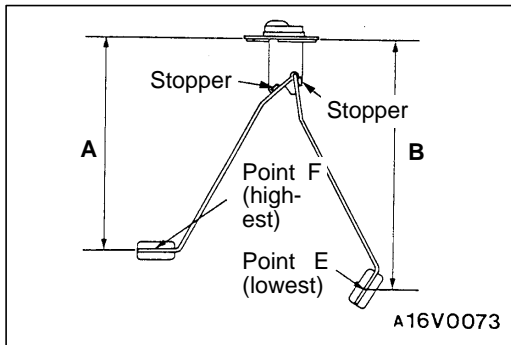
FUEL GAUGE UNIT FLOAT HEIGHT

Move float and measure the height A at point F (highest) and B at point E (lowest) with float arm touching stopper.

A: 214.1 mm

B: 251.2 mm

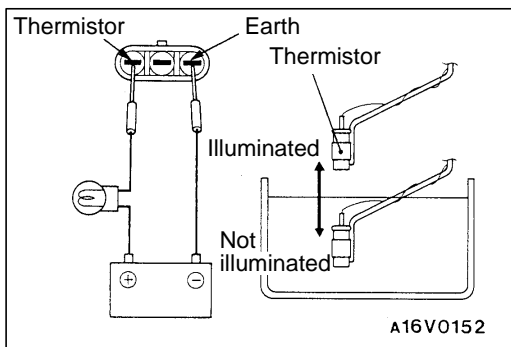
THERMISTOR

1. Connect fuel gauge unit (thermistor) to battery via test lamp (12 V – 3.4 W). Immerse in water.
2. Condition is good if lamp goes off when the thermistor is immersed in water and goes on when it is taken out of water.

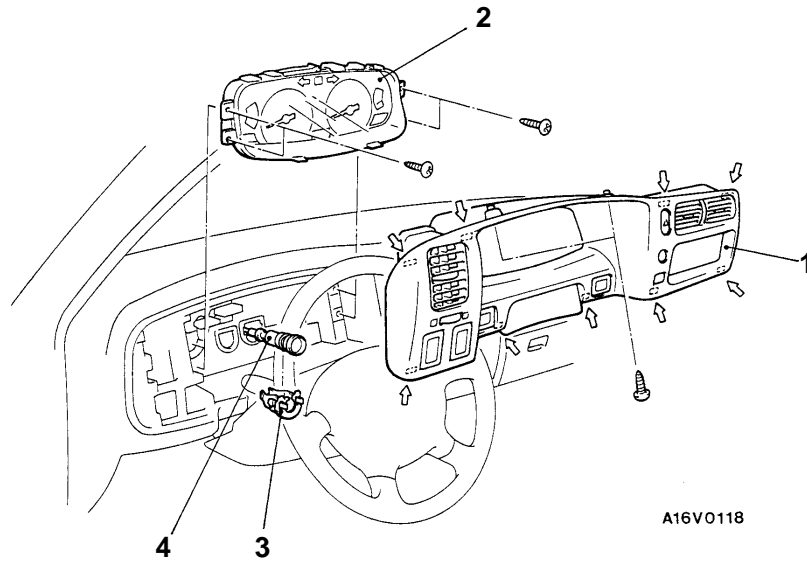
NOTE
 ↵: metal clip position

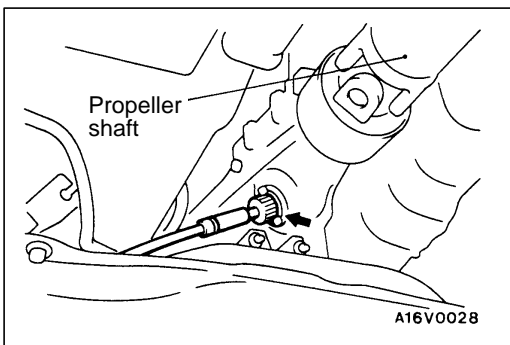
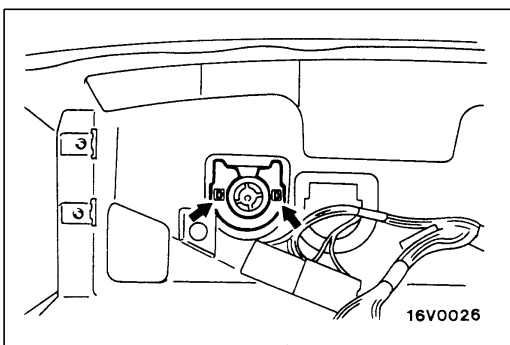
◀▶ ADAPTER REMOVAL

1. Disconnect the speedometer cable from the transmission.
2. Unlock the adapter and then remove the adapter by pulling it into the passenger compartment along with the speedometer cable.

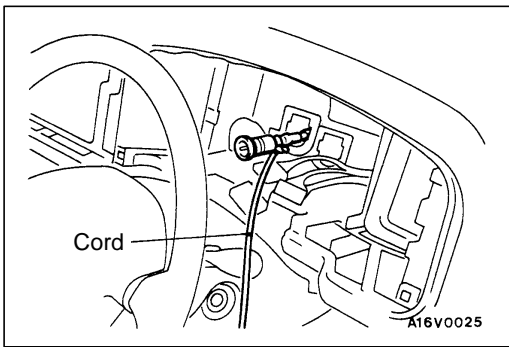
◀B▶ SPEEDOMETER CABLE REMOVAL

After tying a cord to the speedometer cable, remove the grommet and pull the speedometer cable out into the engine compartment.

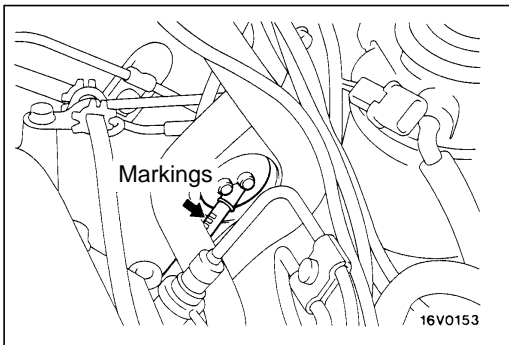
▶A◀ SPEEDOMETER CABLE INSTALLATION

1. Install the grommet to the toeboard so that the speedometer cable is facing downwards.
2. Pull the speedometer cable until you can see the markings.

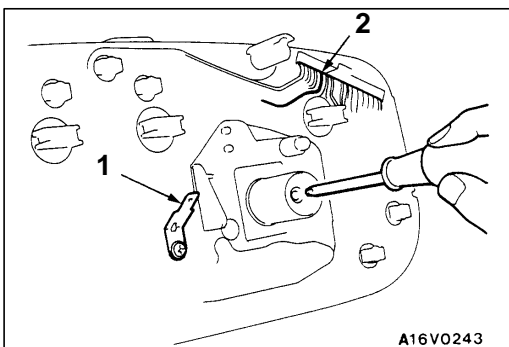
REED SWITCH CONTINUITY CHECK

Using a circuit tester, check that continuity and discontinuity alternates between terminals 1 and 2 four times at every rotation of the shaft of the speedometer cable connection.

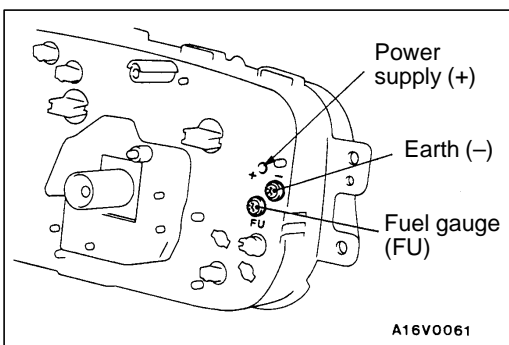
FUEL GAUGE RESISTANCE CHECK

1. Remove the power supply tightening screw.
2. Use a circuit tester to measure the resistance between the terminals.

When inserting the test probe into the power supply terminal, be careful not to touch the printed board.

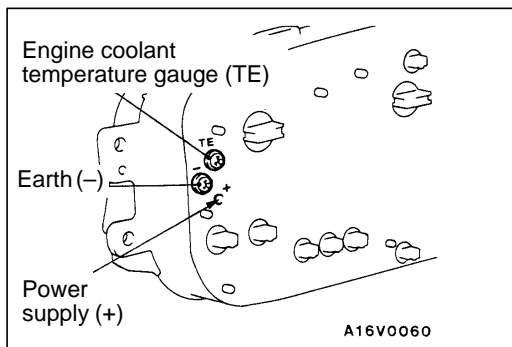
ENGINE COOLANT TEMPERATURE GAUGE RESISTANCE CHECK

1. Remove the power supply tightening screw.
2. Use a circuit tester to measure the resistance between the terminals.

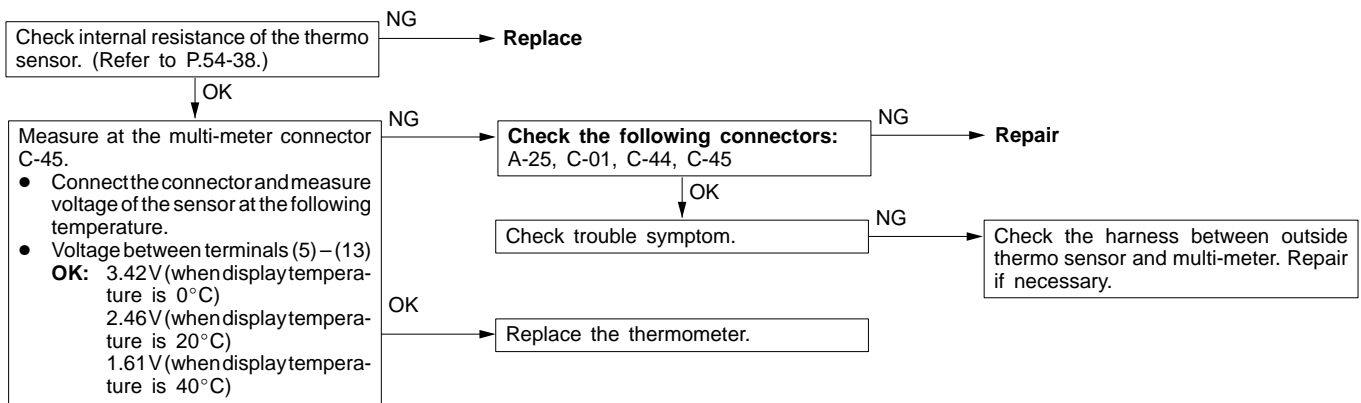
Inspection Procedure 1

Actual outside temperature is different from thermometer.	Probable cause
The defective internal resistance of the thermo sensor or thermometer may be present.	<ul style="list-style-type: none"> ● Malfunction of outside thermo sensor ● Malfunction of harness or connector ● Malfunction of thermometer

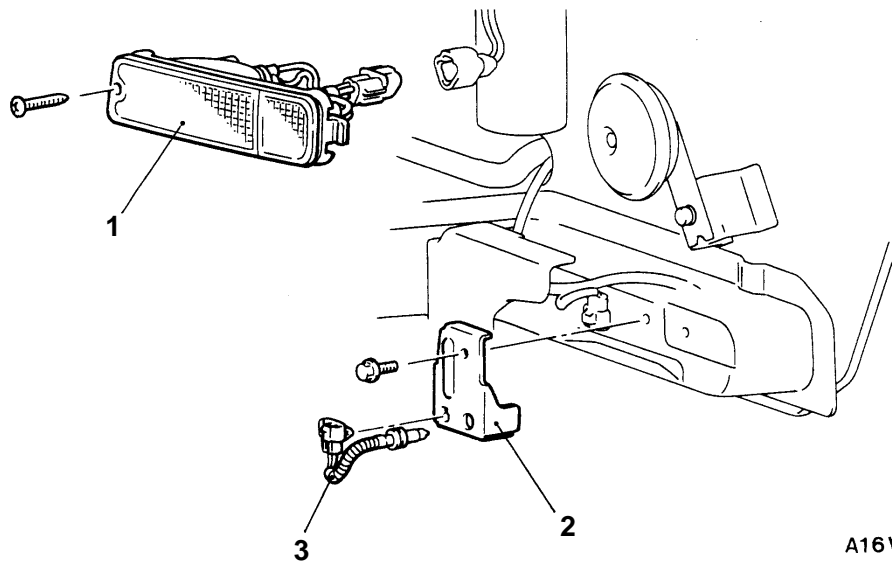
A16V0130

1. Front combination lamp (L.H.)
2. Bracket
3. Outside thermo sensor

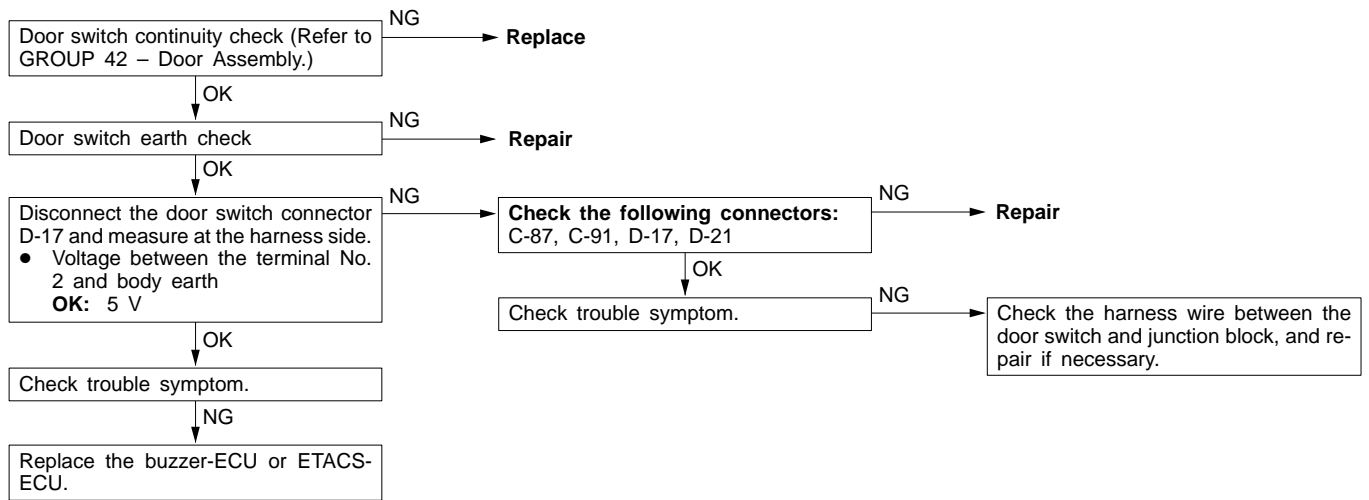
Inspection Procedure 4

Driver's side door switch input circuit system check

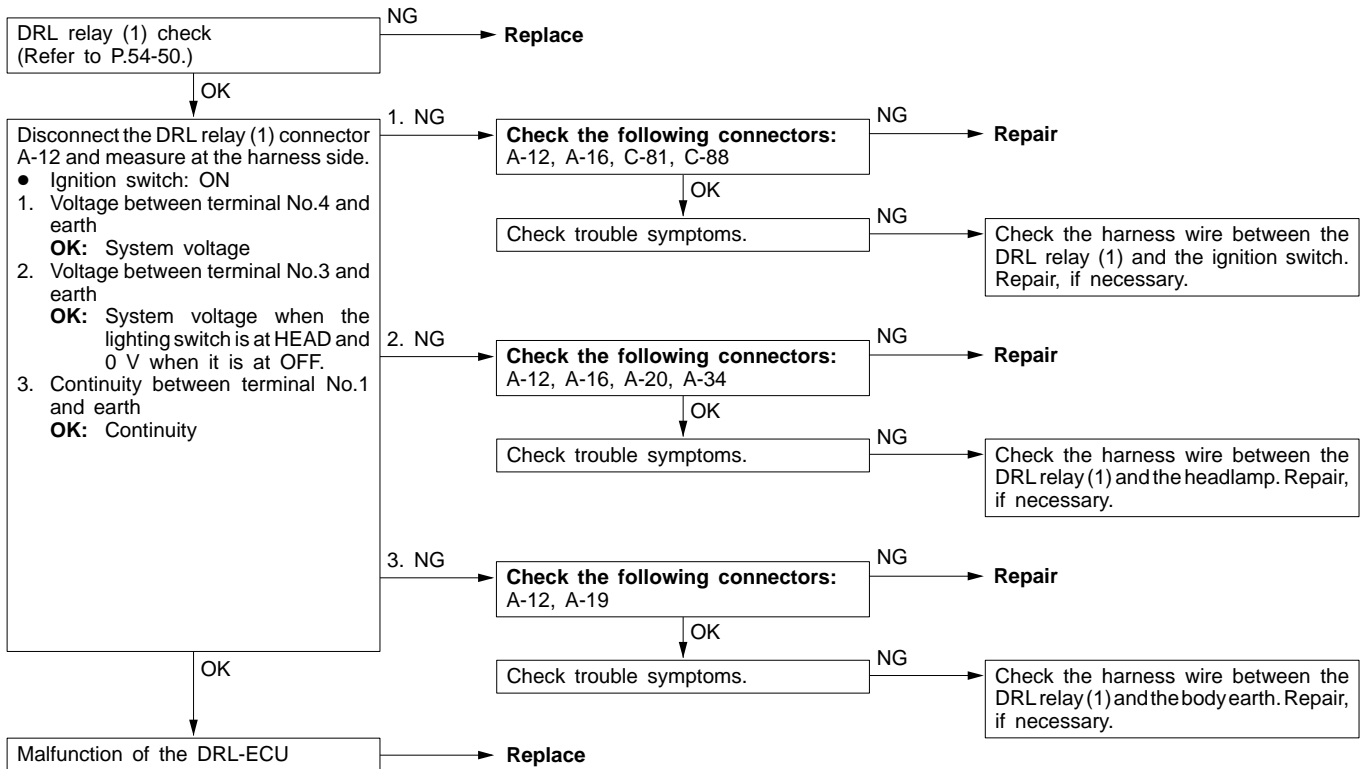
Inspection procedure 6

<p>The headlamps do not illuminate when the vehicle is in the following condition and the ignition switch is moved to the ON position. However, they illuminate when the lighting switch is moved to the HEAD position. <Vehicles with daytime running lamp></p> <ul style="list-style-type: none"> ● Lighting switch: OFF ● Passing switch: OFF 	<p>Probable cause</p>
<p>The cause is probably a malfunction of the daytime running lamp control unit (DRL-ECU) circuit system. If there is a blown fuse, there may also be a short-circuit in a harness.</p>	<ul style="list-style-type: none"> ● Malfunction of fuse ● Malfunction of connector ● Malfunction of harness wire ● Malfunction of the DRL relay (1) ● Malfunction of the DRL-ECU

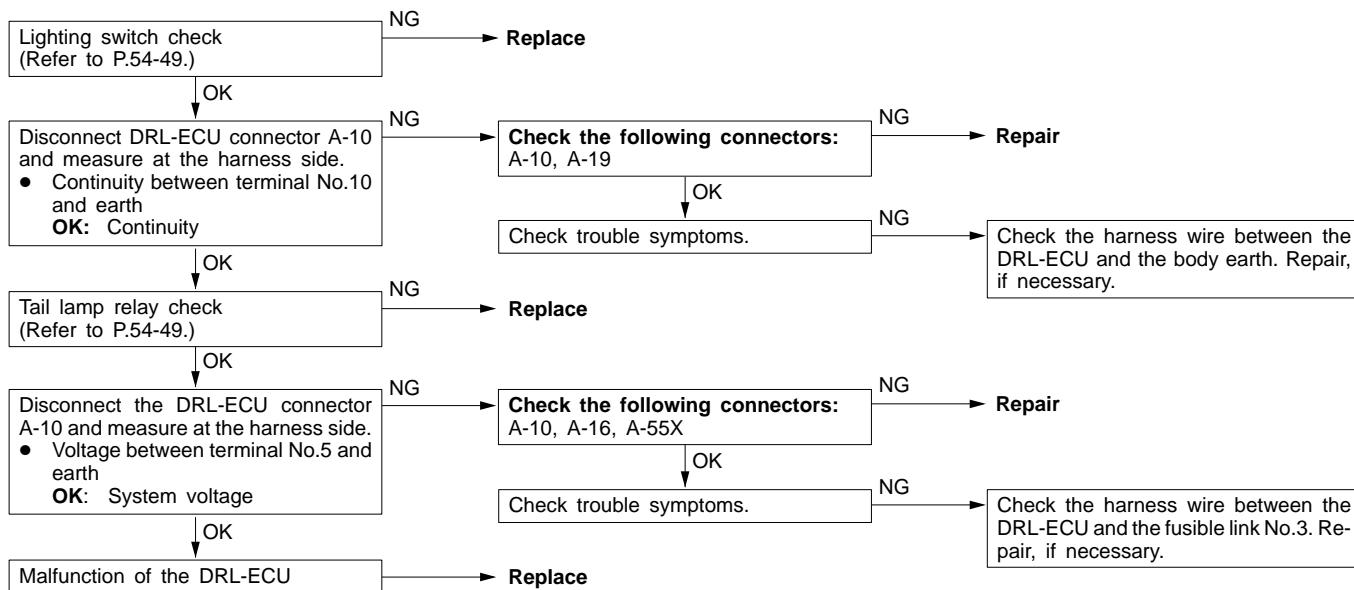
Inspection procedure 7

<p>The headlamps do not switch off when the vehicle is in the following condition and the lighting switch is moved to the TAIL position. <Vehicles with daytime running lamp></p> <ul style="list-style-type: none"> ● Ignition switch: OFF ● Passing switch: OFF 	<p>Probable cause</p>
<p>The cause is probably a malfunction of the daytime running lamp control unit (DRL-ECU) circuit system. If there is a blown fuse, there may also be a short-circuit in a harness.</p>	<ul style="list-style-type: none"> ● Malfunction of fuse ● Malfunction of connector ● Malfunction of harness wire ● Malfunction of the tail lamp relay ● Malfunction of the DRL-ECU

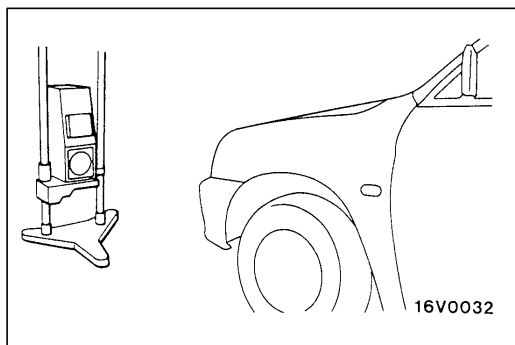
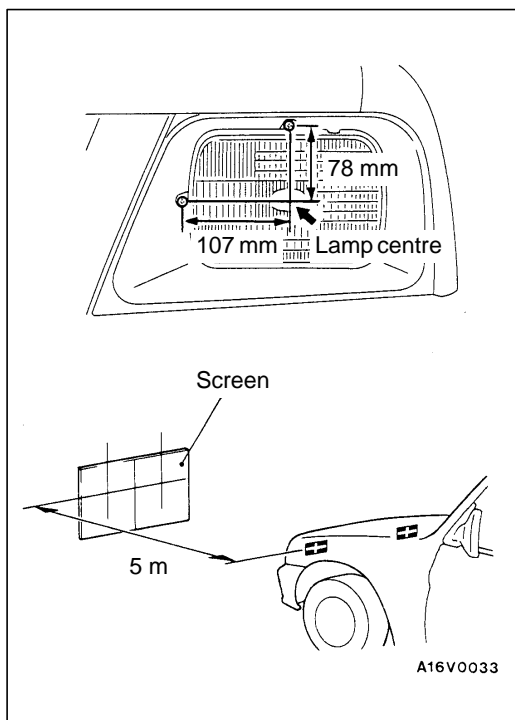
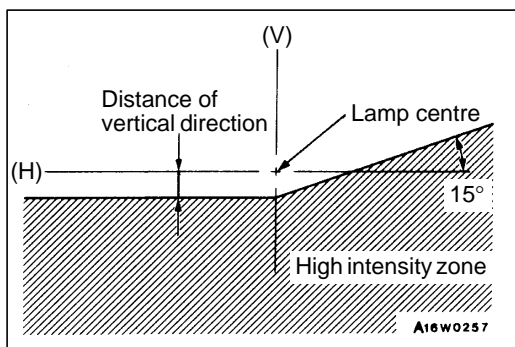
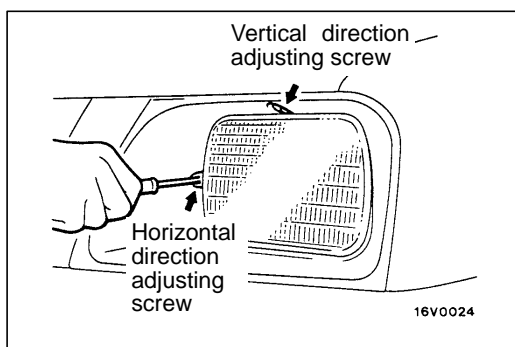
1. Inflate the tyres to the specified pressures and there should be no other load in the vehicles other than driver or substituted weight of approximately 75 kg placed in driver's position.
2. Set the distance between the screen and the centre of the headlamps as shown in the illustration.

3. Check if the beam shining onto the screen is at the standard value.

Standard value:**(Vertical direction)****60 mm below horizontal (H)****(Horizontal direction)****Position where the 15° sloping section intersects the vertical line (V)**

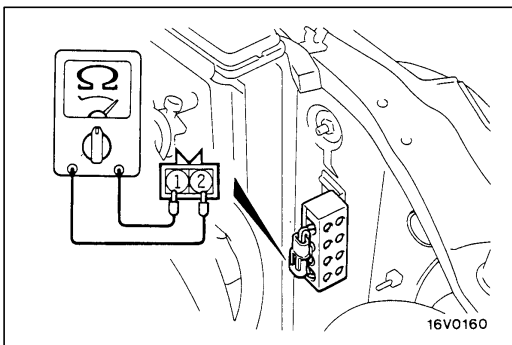
DIM-DIP LAMP RELAY (1), (2) AND (3) CONTINUITY CHECK <R.H. drive vehicles>

Battery voltage	Terminal No.			
	1	2	3	4
Supplied	○	⊕	○	⊖
Not supplied		○		○

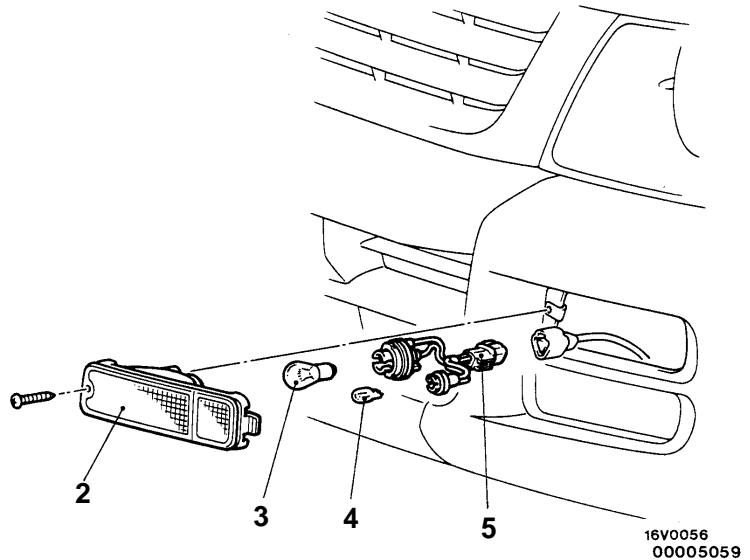
Front combination lamp removal steps

2. Front combination lamp
3. Bulb (For turn-signal lamp)
4. Bulb (For position lamp)
5. Bulb socket assembly

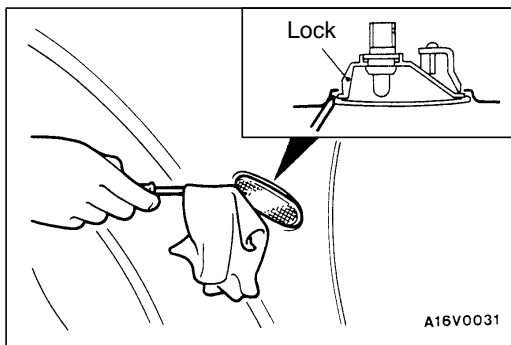
◀▶ SIDE TURN-SIGNAL LAMP REMOVAL

Use a flat-tipped screw driver or similar tool to remove the lock from the fender panel, and then remove the side turn-signal lamp.

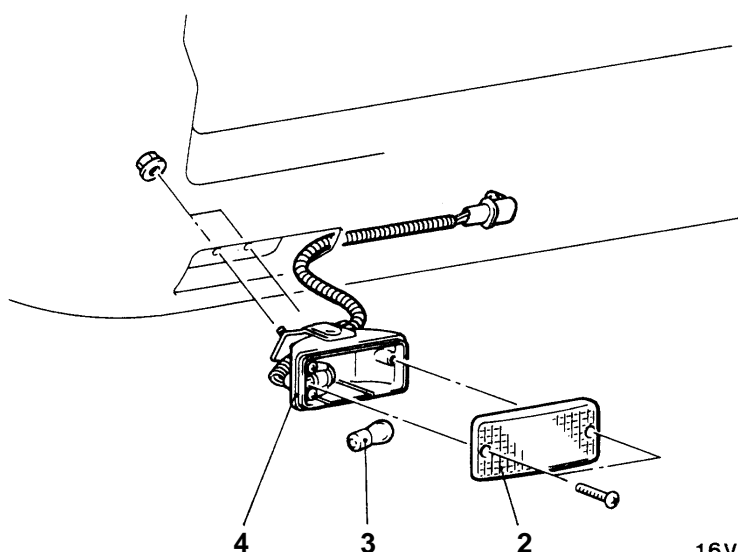
REMOVAL AND INSTALLATION

Removal steps

1. Rear fog lamp switch
2. Lens

3. Bulb
4. Rear fog lamp body assembly

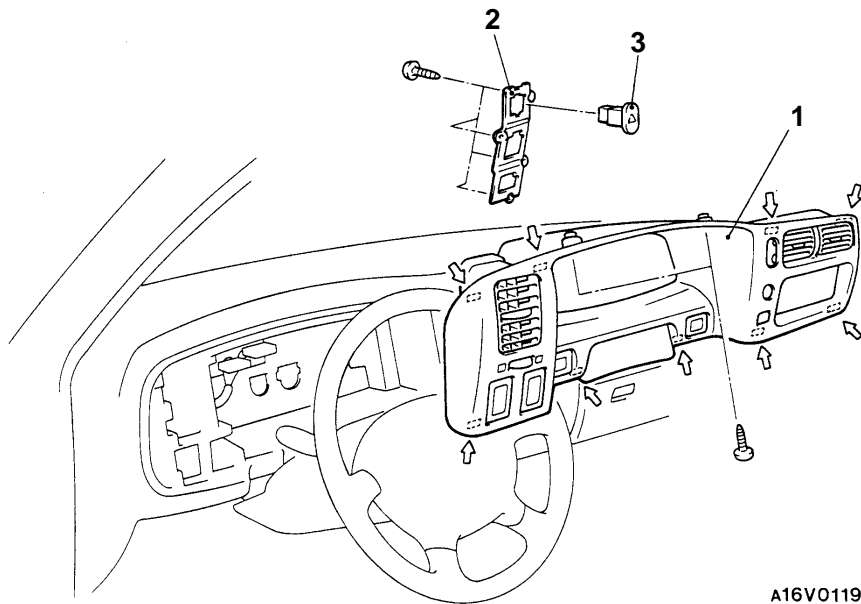
REMOVAL AND INSTALLATION

NOTE
↔ : metal clip position

Removal steps

1. Meter bezel assembly
2. Switch holder
3. Hazard warning lamp switch

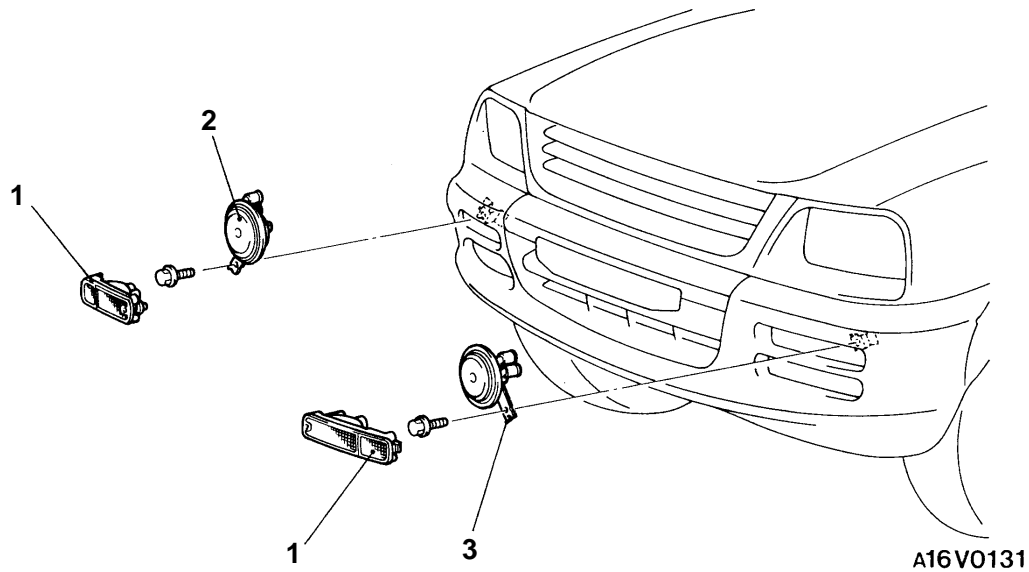
REMOVAL AND INSTALLATION

Removal steps

1. Front combination lamp
2. Horn (High sound)
3. Horn (Low sound)

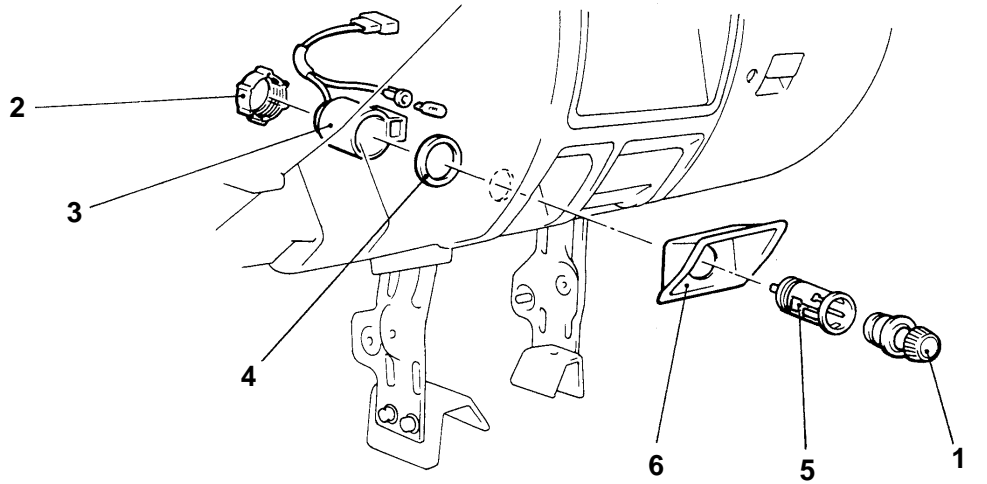
REMOVAL AND INSTALLATION

Removal steps

- Front floor console assembly
(Refer to GROUP 52A.)
- 1. Plug
- 2. Fixing ring

- 3. Socket case
- 4. Socket washer
- 5. Socket
- 6. Protector

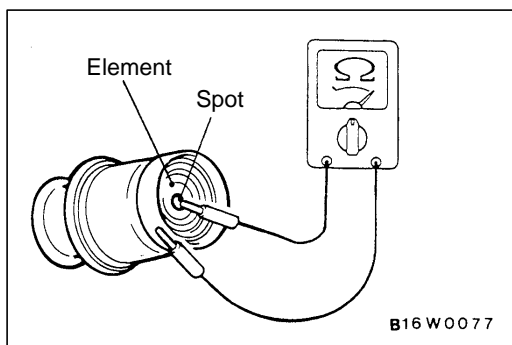
**INSPECTION**

- Take out the plug, and check for a worn edge on the element spot connection, and for shreds of tobacco or other material on the element.
- Using a circuit tester, check the continuity of the element.

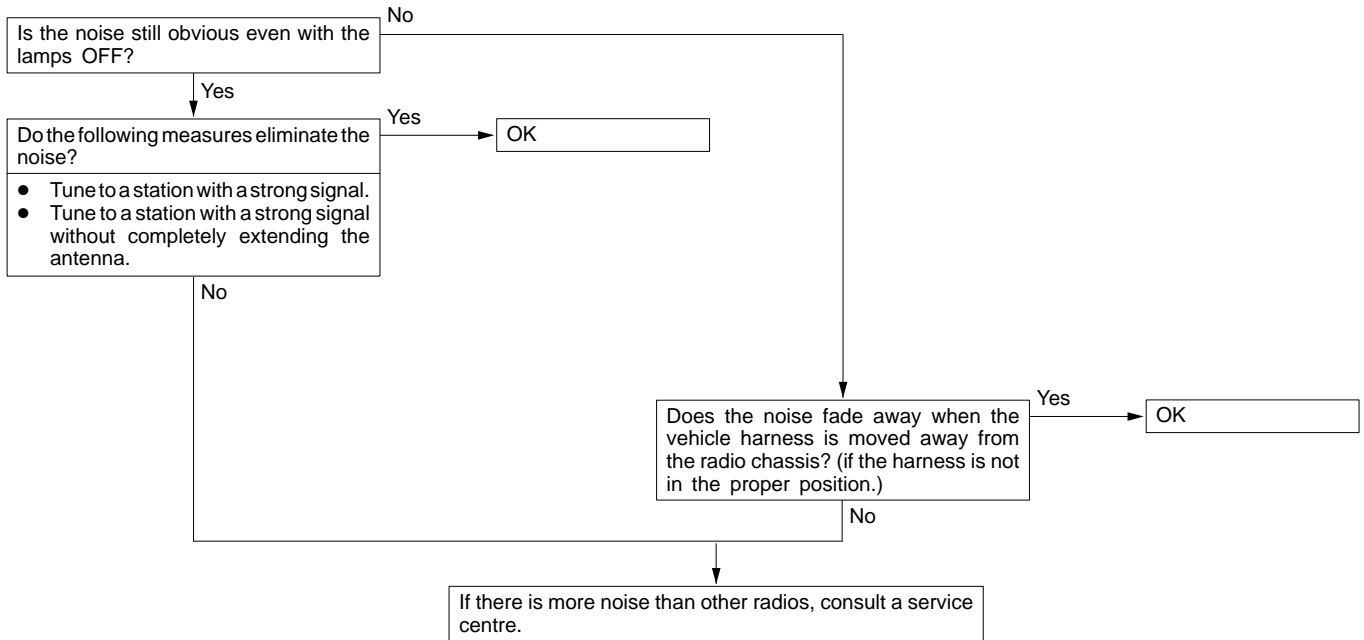
The following factors can be considered as possible causes of noise appearing at night.

1. Factors due to signal conditions: Due to the fact that long-distance signals are more easily received at night, even stations that are received without problem during the day may experience interference in a general worsening of reception conditions. The weaker a station is the more susceptible it is to interference,

and a change to a different station or the appearance of a beating sound* may occur. Beat sound*: Two signals close in frequency interfere with each other, creating a repetitious high-pitched sound. This sound is generated not only by sound signals but by electrical waves as well.

2. Factors due to vehicle noise: Alternator noise may be a cause.

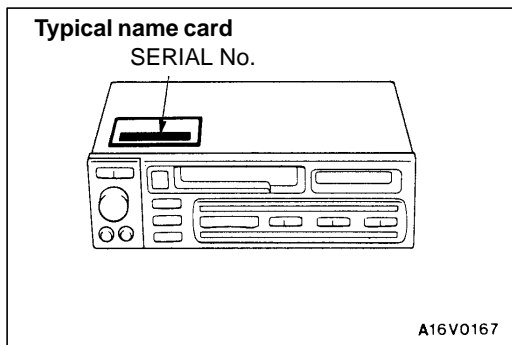
- (2) If the security code is unknown owing to the user's loss of the card:
 - a. Remove the radio and tape player, referring to P.54-80.
 - b. Read the serial No. stamped on the radio and tape player.
 - c. Look up the security code (anti-theft code table) corresponding to the serial number, or ask the authorized Mitsubishi dealer.

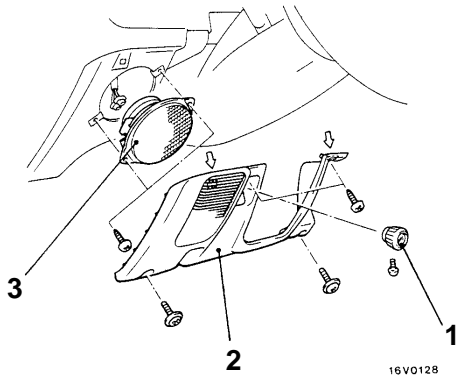
Driver's side

NOTE

↔ : metal clip position

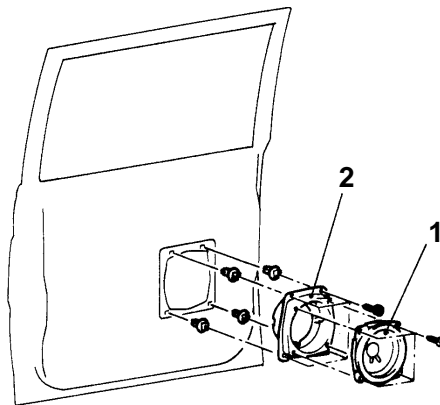
A19V0055

<REAR SPEAKER>

Removal steps

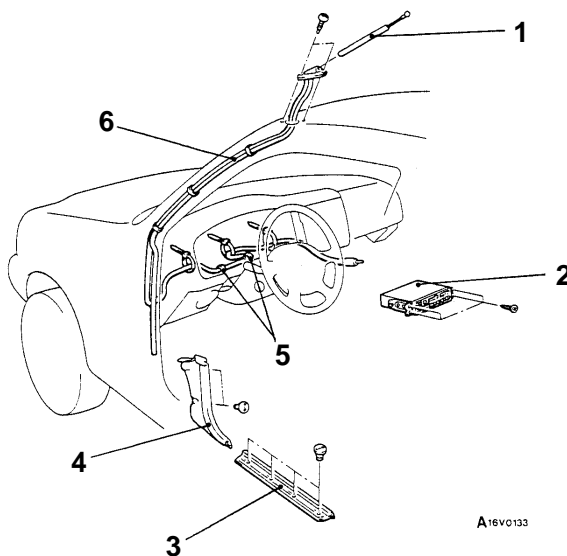
Removal steps

1. Pole
2. Radio and tape player
3. Front scuff plate (driver's side)

4. Cowl side trim (driver's side)
5. Cable clipped portion
6. Antenna base

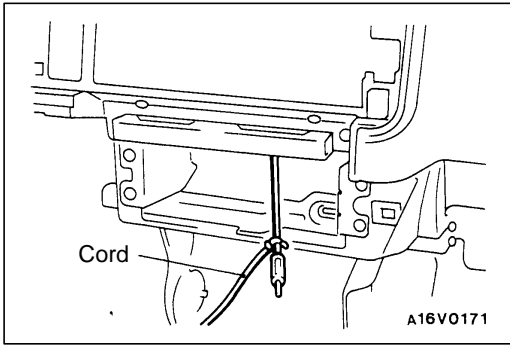
◀A▶ ANTENNA BASE REMOVAL

1. Tie a cord to the end of the feeder cable.

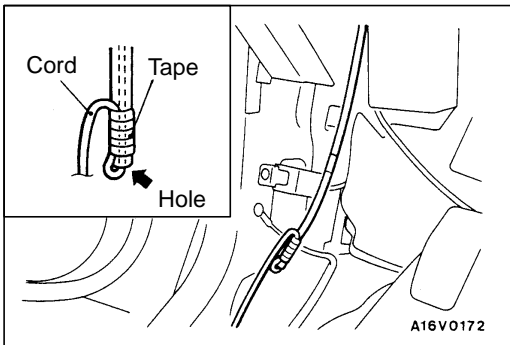
2. Pull out the antenna base until the end of the drain pipe can be seen.
3. Pass the cord through the hole in the end of the drain pipe and wrap it with vinyl tape.

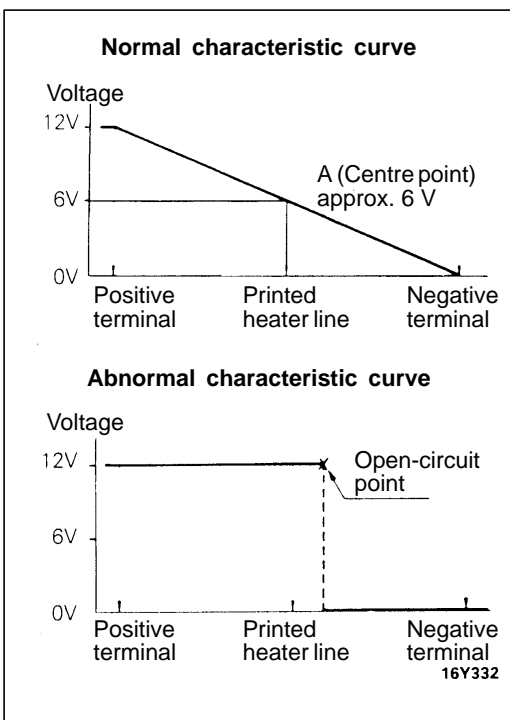
1. Run engine at 2,000 r/min. Check heater element with battery at full.
2. Turn ON rear window defogger switch. Measure heater element voltage with circuit tester at rear window glass centre A. Condition is good if it indicates about 6V.
3. If 12 V is indicated at A, there is a break in the negative terminals from A. Move test bar slowly to negative terminal to detect where voltage changes suddenly (0V).
4. If 0 V is indicated at A, there is a break in the positive terminals from A. Defect where the voltage changes suddenly (12 V) in the same method described above.

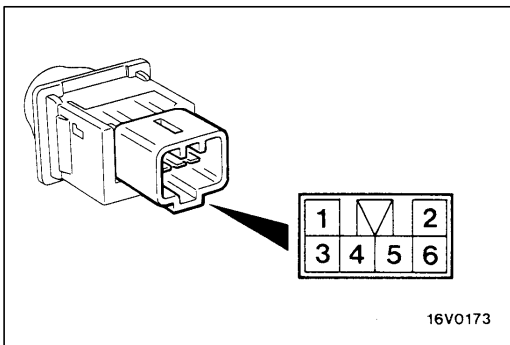
16V0173

DEFOGGER SWITCH CONTINUITY CHECK

Switch position	Terminal No.							
	1	ILL	5	2	IND	6	3	4
OFF	○	⊕	○	○	⊕	○		
ON	○	⊕	○	○	⊕	○	○	○
