CHASSIS ELECTRICAL

CONTENTS

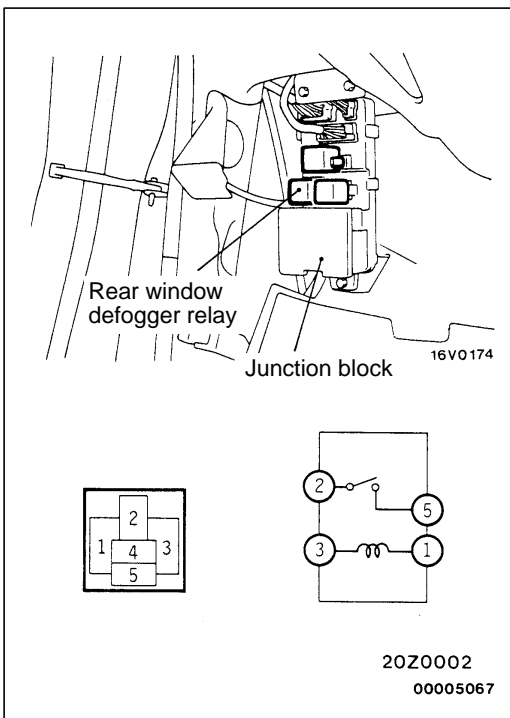
16V0174

REAR WINDOW DEFOGGER RELAY CONTINUITY CHECK

Battery voltage	Terminal No.			
	1	2	3	5
Power is not supplied	○		○	
Power is supplied	⊕	○	⊖	○

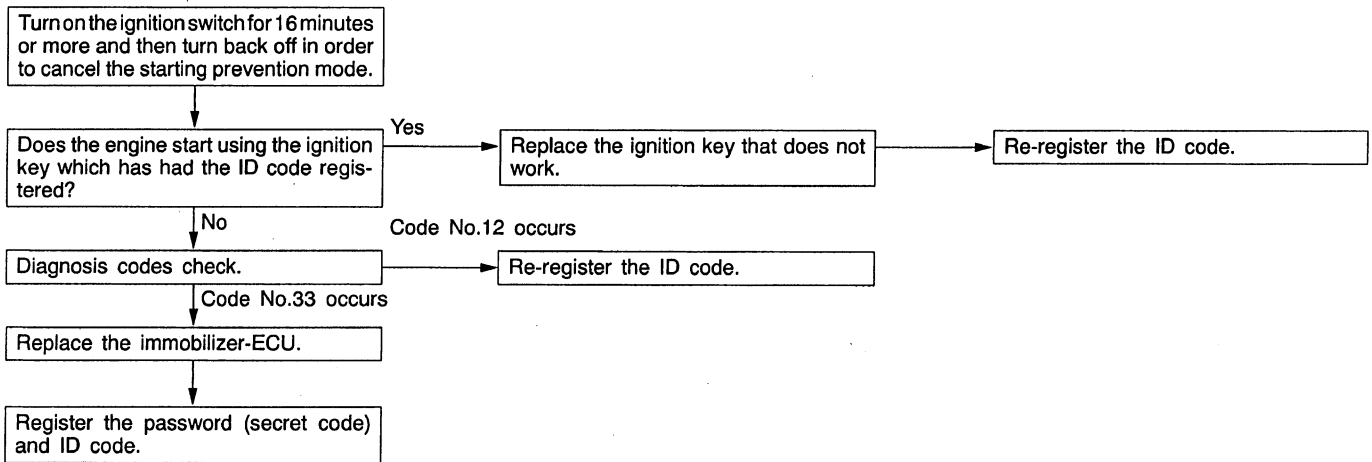
Code No.33 Starting prevention mode activated due to incorrect operation	Probable cause
The ID codes do not match for a total of 5 continuous operations.	<ul style="list-style-type: none"> • The ID code in the ignition key being used has not been properly registered. • Malfunction of the immobilizer-ECU • Malfunction of the transponder

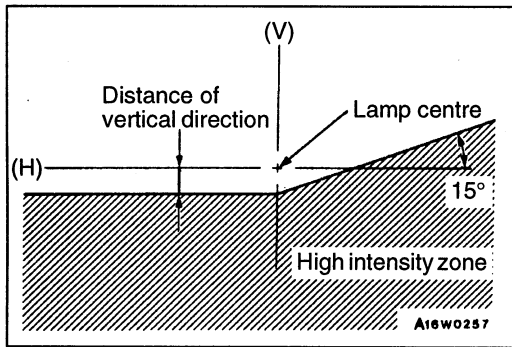
1. Inflate the tyres to the specified pressures and there must be no other load in the vehicles other than a driver or substituted weight of approximately 75 kg placed in driver's position.
2. Set the distance between the screen and the centre of the headlamps, as shown.

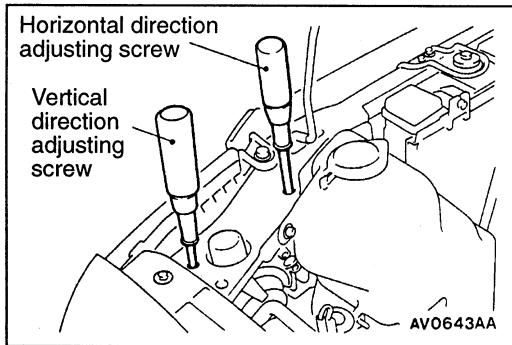
3. Check that the beam shining onto the screen is at the standard value.

Position where the 15° sloping section intersects the vertical line (V)

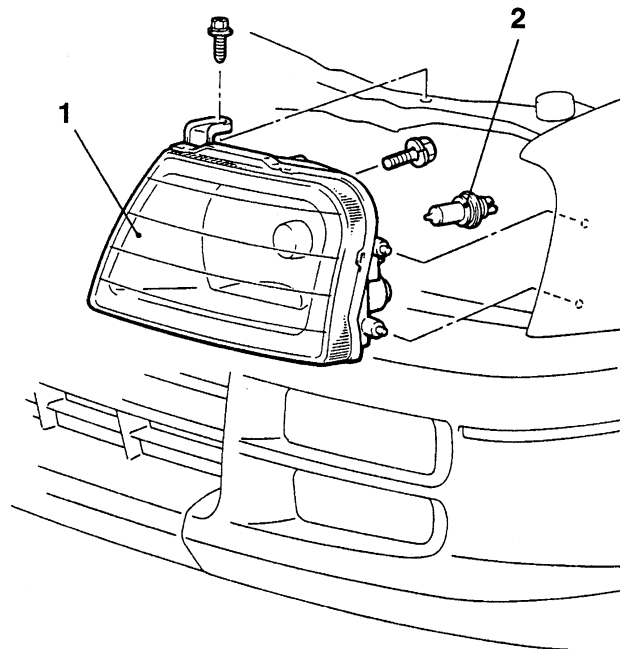
AV0625AA

Removal steps

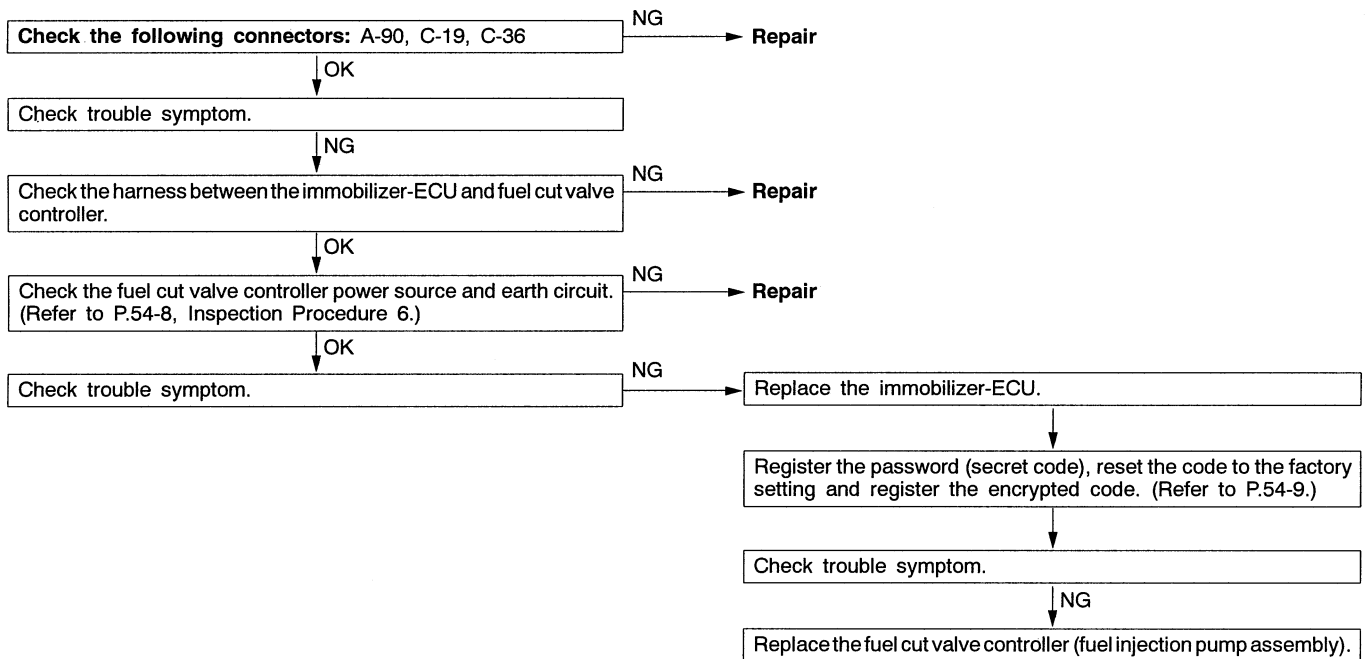
Code No.21 Communication system between fuel cut valve controller and immobilizer-ECU	Probable cause
The confirmation code is not sent from the fuel cut valve controller within the specified time after the ignition key is turned to ON or, an incorrect code is sent.	<ul style="list-style-type: none"> ● Malfunction of harness or connector ● Malfunction of fuel cut valve controller ● Malfunction of immobilizer-ECU

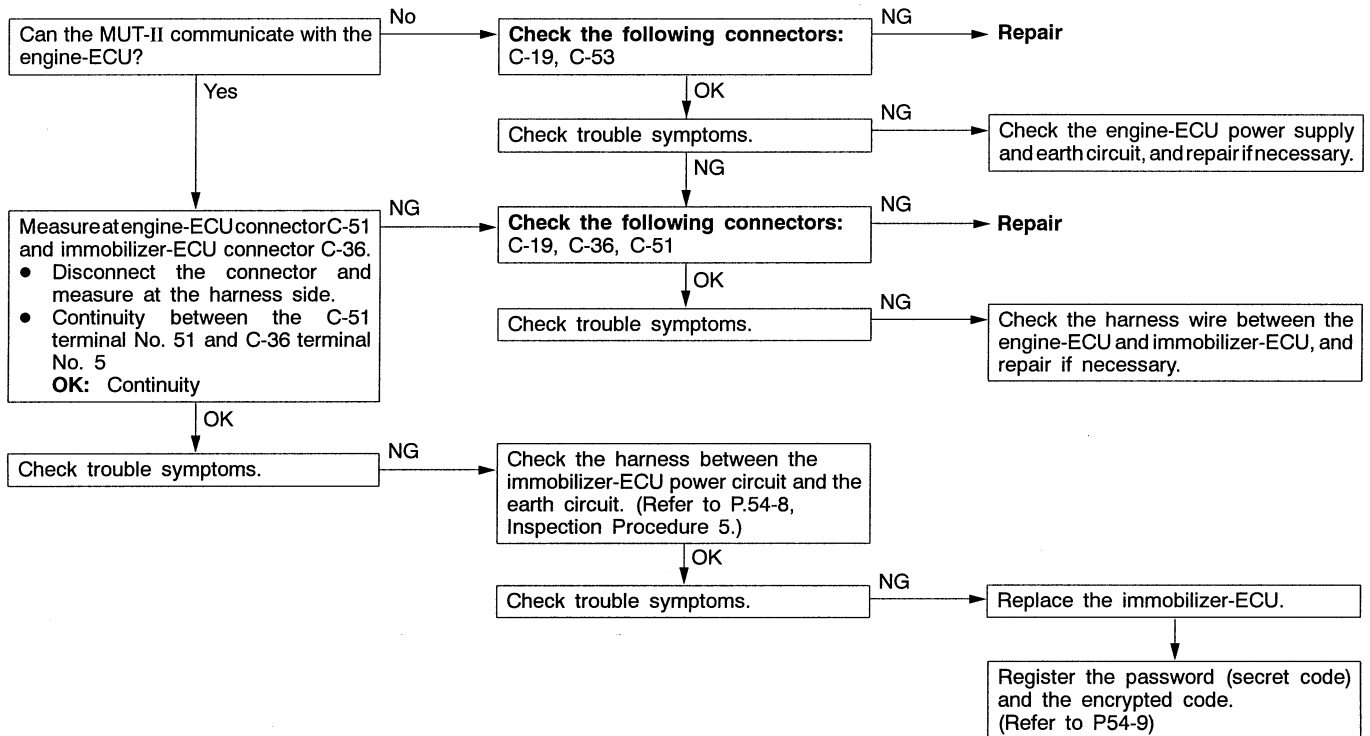
<4G6>

Communication with MUT-II is impossible	Probable cause
The cause is probably that a malfunction of the diagnosis line or the immobilizer-ECU is not functioning.	<ul style="list-style-type: none"> ● Malfunction of diagnosis line ● Malfunction of harness or connector ● Malfunction of immobilizer-ECU

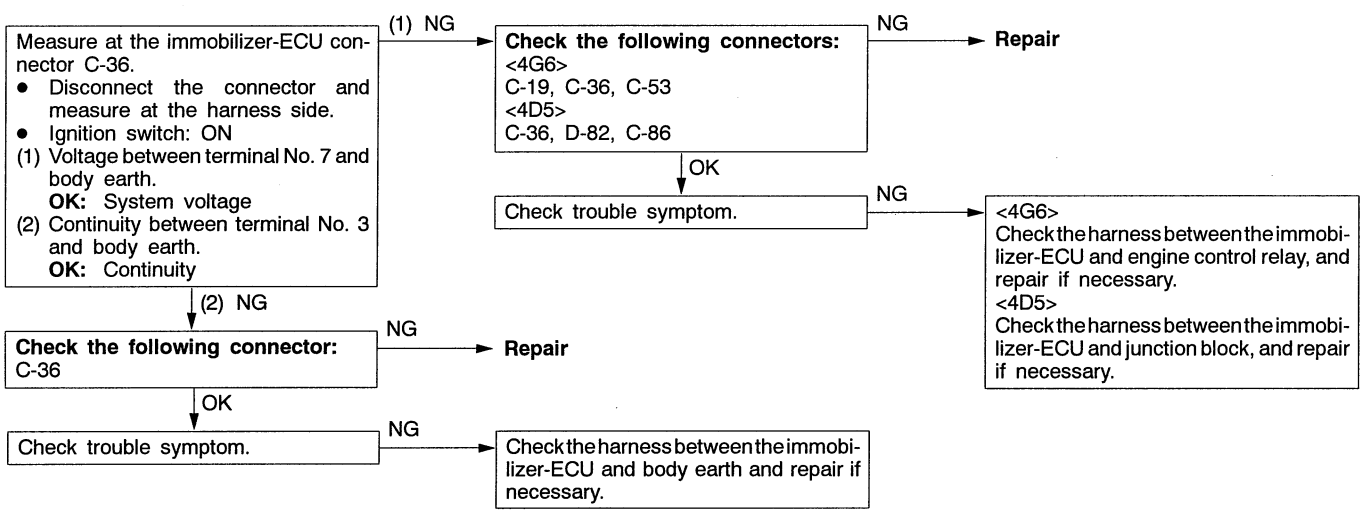
Inspection Procedure 5

Malfunction of the immobilizer-ECU power source and earth circuit

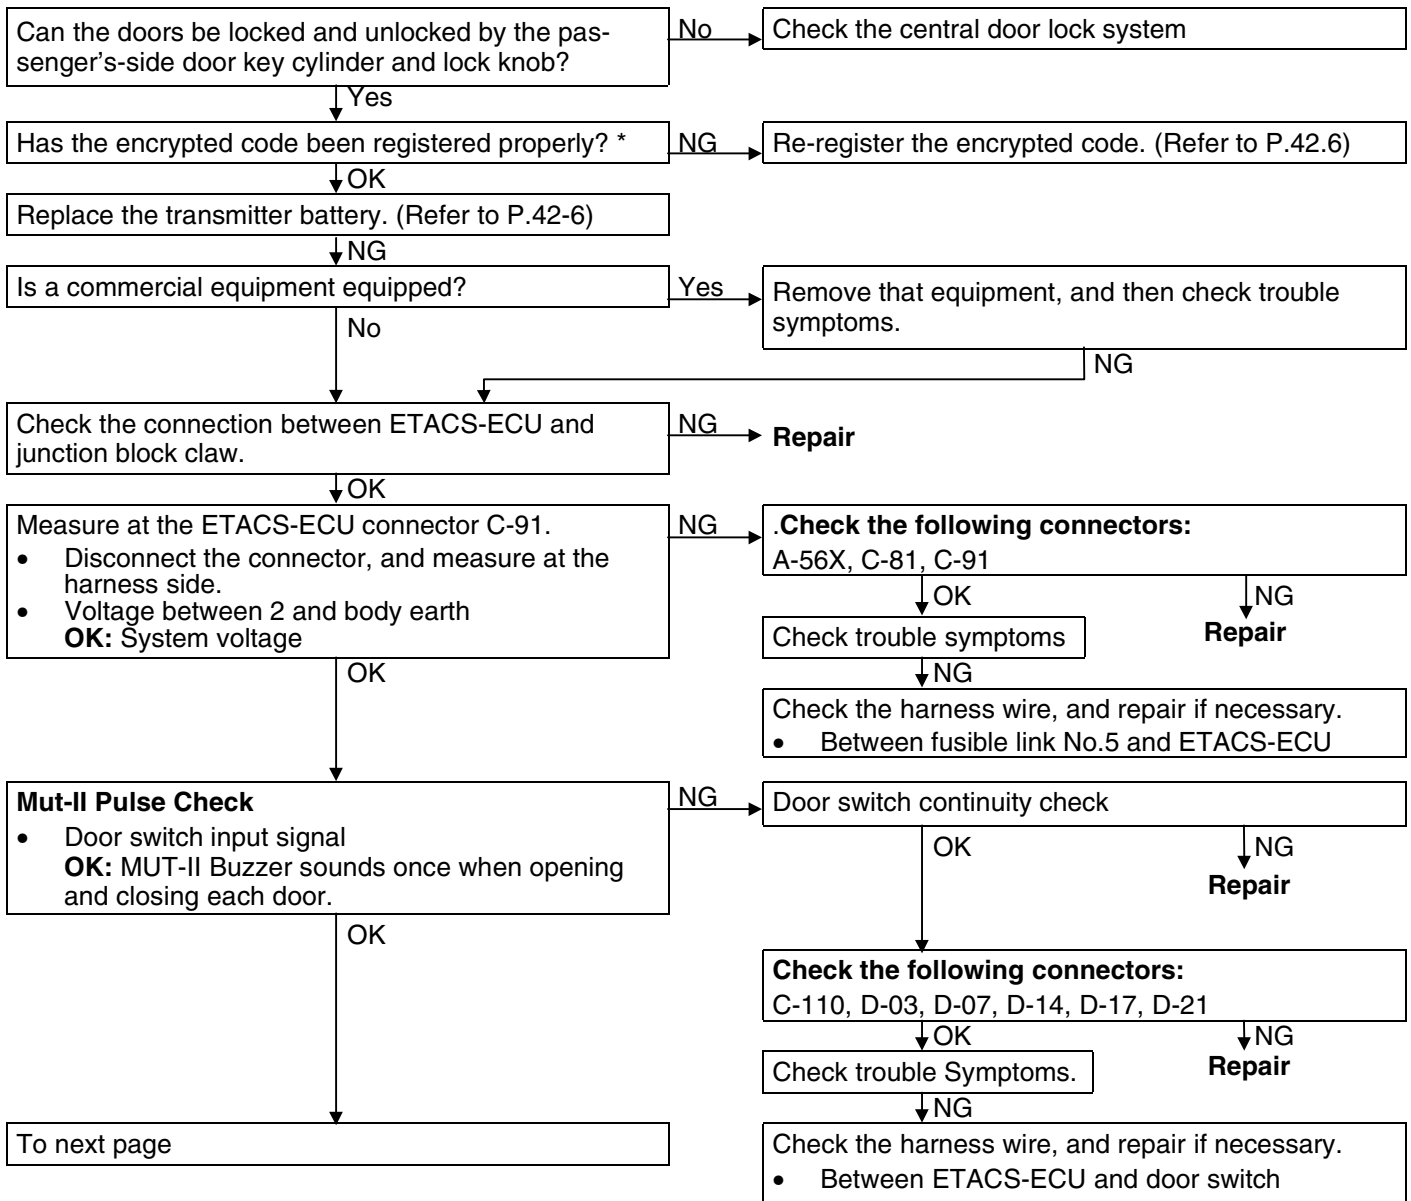
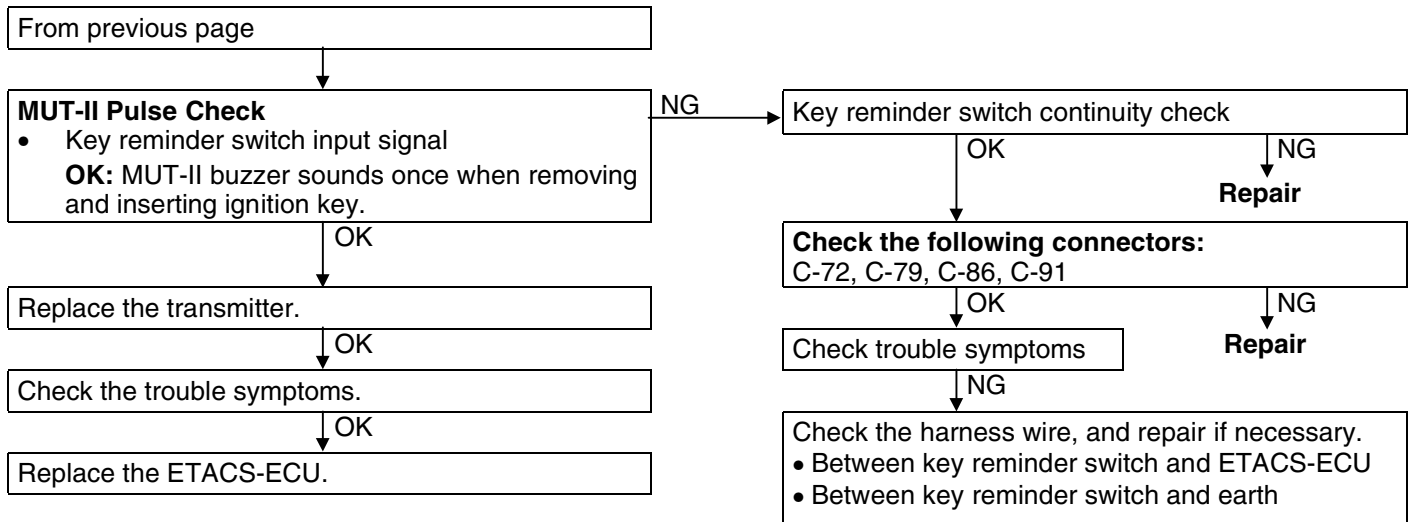
INSPECTION PROCEDURE 1

None of the doors can be locked or unlocked using the transmitter.	Probable cause
The cause may be a malfunction of the transmitter or ETACS-ECU, defective connection between ETACS-ECU and junction block, defective power supply voltage to ETACS-ECU input line due to commercial equipment, or the lock and unlock signals are not being sent to the ETACS-ECU.	<ul style="list-style-type: none"> • Malfunction of transmitter • Malfunction of ETACS-ECU • Malfunction of key reminder switch • Malfunction of wiring harness or connector • Malfunction of door switch • Defective connection between ETACS-ECU and junction block • Defective power supply voltage to ETACS-ECU input line due to commercial equipment

*: This should be done if a transmitter, receiver or ETACS-ECU has been replaced, and if a secret cod has not been registered properly

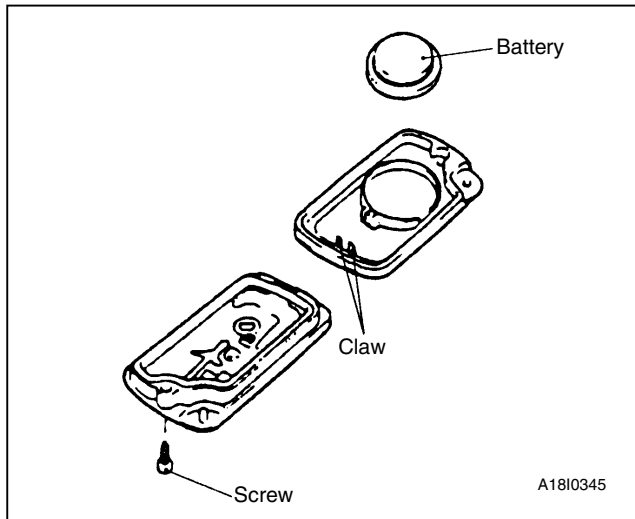
ON – VEHICLE SERVICE HOW TO REPLACE A BATTERY OF THE TRANSMITTER

1. Remove the set screw to remove the battery from the transmitter.

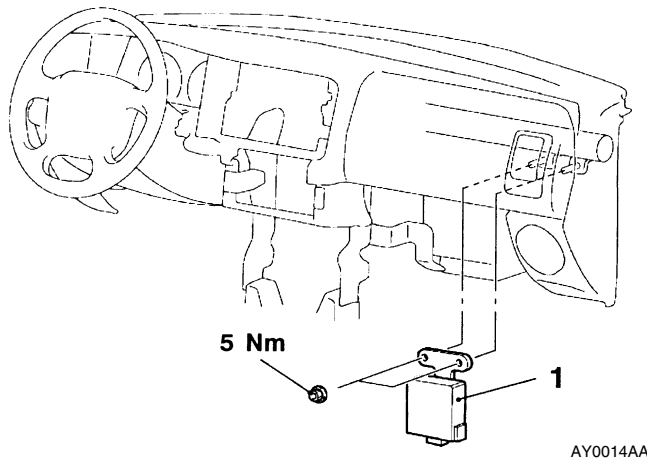
Keyless entry receiver-ECU removal steps

- Glove box assembly (Refer to GROUP 52A*.)
1. Keyless entry receiver-ECU

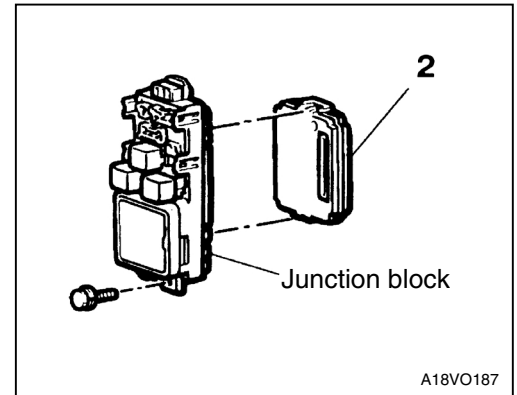
ETACS-ECU removal

2. ETACS-ECU

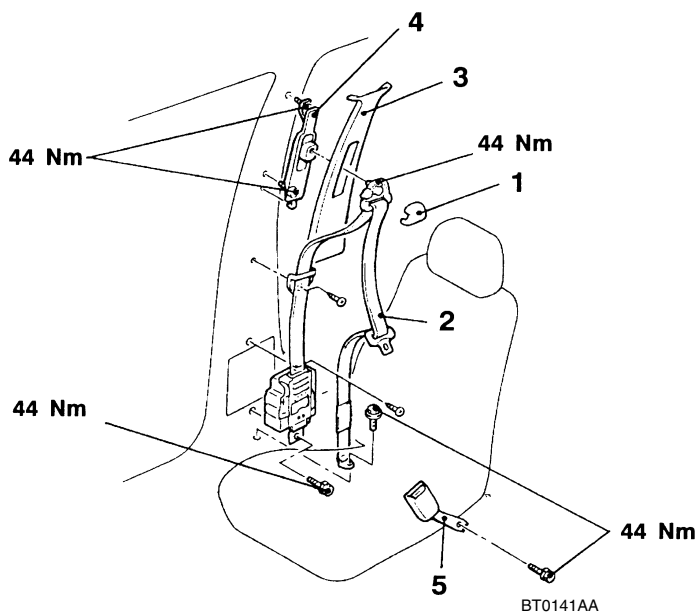
Outer seat belt removal steps

- Center pillar trim, lower or quarter trim, lower (refer to P.52A*.)
1. Sash guide cover
 2. Outer seat belt
 3. Center pillar trim, upper or quarter trim, upper (refer to P.52A*.)
 4. Adjustable seat belt anchor.

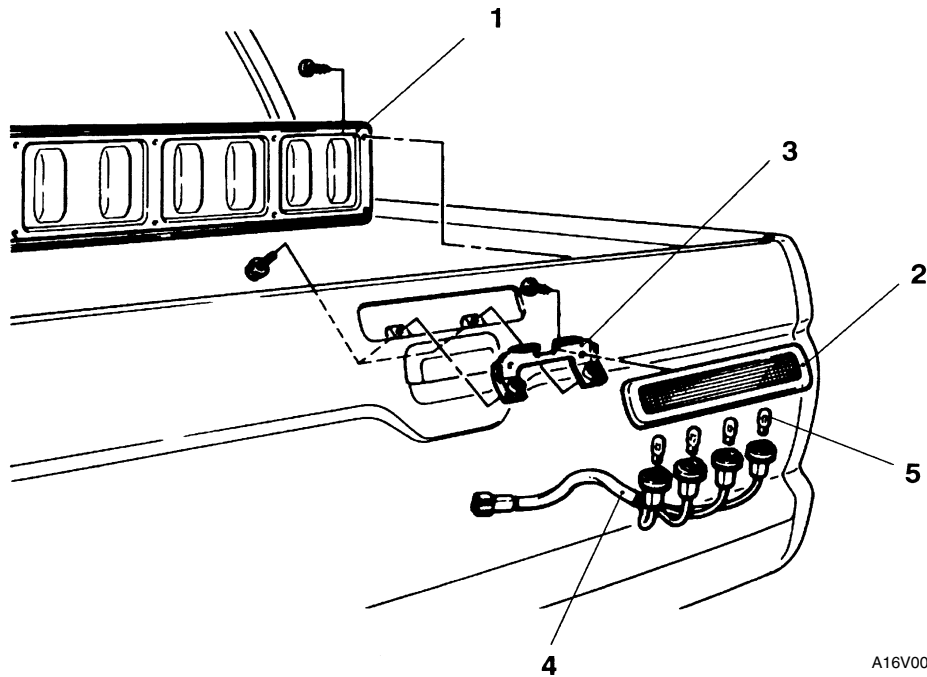
A16V0088

HIGH-MOUNTED STOP LAMP REMOVAL AND INSTALLATION

Removal steps

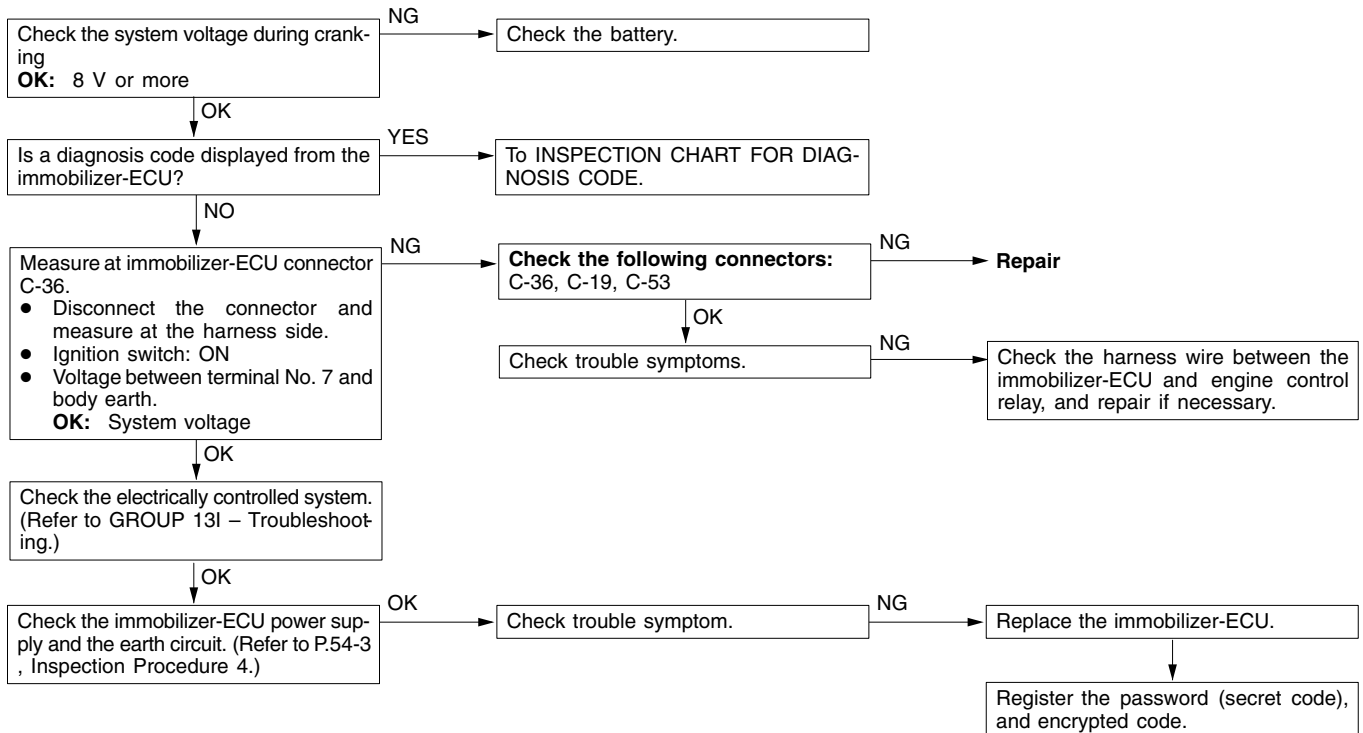
Inspection Procedure 3

Engine does not start (Cranking but no initial combustion).	Probable cause
If no fuel injection, there might be a problem with the fuel injection system in addition to a malfunction of the immobilizer system. It is normal for this to occur if an attempt is made to start the engine using a key that has not been properly registered.	<ul style="list-style-type: none"> • Malfunction of diesel fuel injection system • Malfunction of immobilizer-ECU
