www.discovery2.co.uk

Faults and Fixes - Wheel Hub / Front Bearing

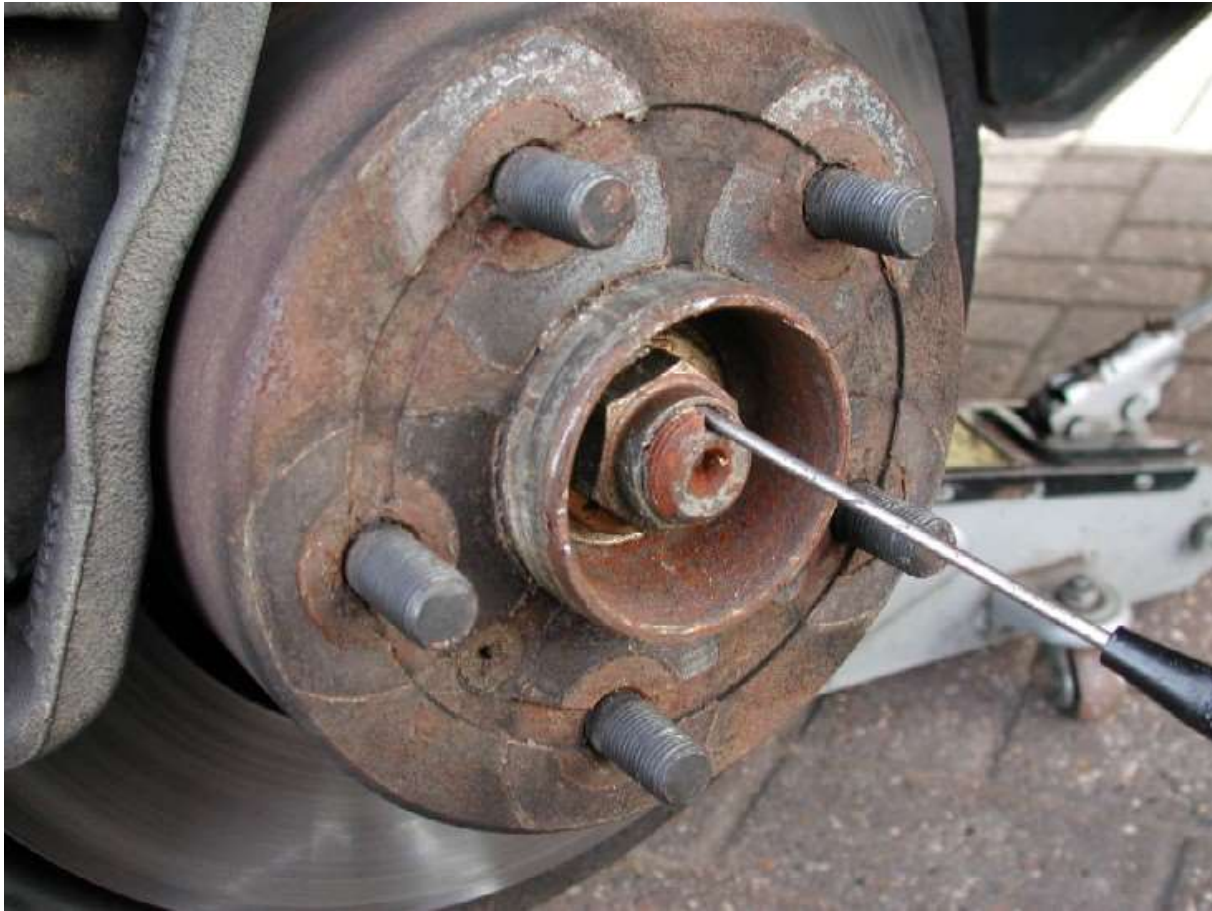
So first off, crack the wheel nuts loose then jack up and support the side your doing on an axle stand. Remove the road wheel and that will show you the Hub stake nut. Its called a stake nut as once its finally fitted, a punch or similar is used to "stake" a section of the nut into the slot in the drive shaft as a way of "locking" the nut on. A NEW nut must be used on reinstallation.

So to remove the stake, simply use a small punch or old screwdriver and hammer / knock the stake out so you can undo the nut.

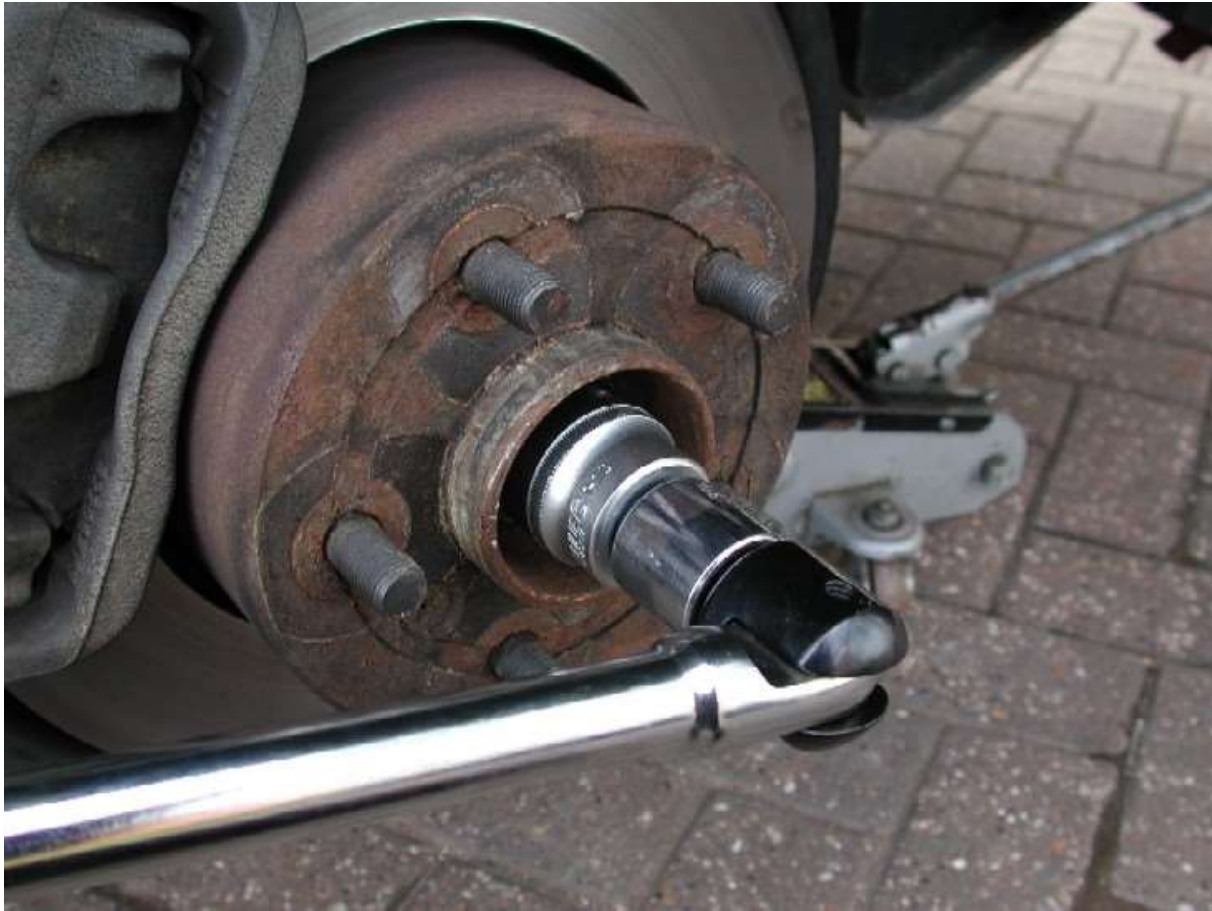
Here lies the first issue, you need to "break" the torque on the nut. I m pretty sure its supposed to be 32mm, how ever I found that size just a little to "sloppy" for my liking with such a high torque, so I used an 1-1/4" AF 6 point socket as it just fitted better. Its about 0.025" smaller than 32mm and that seems to make all the difference. I would HIGHLY recommend you use a 6 point socket as to avoid the possibility of "rounding" the nut off.

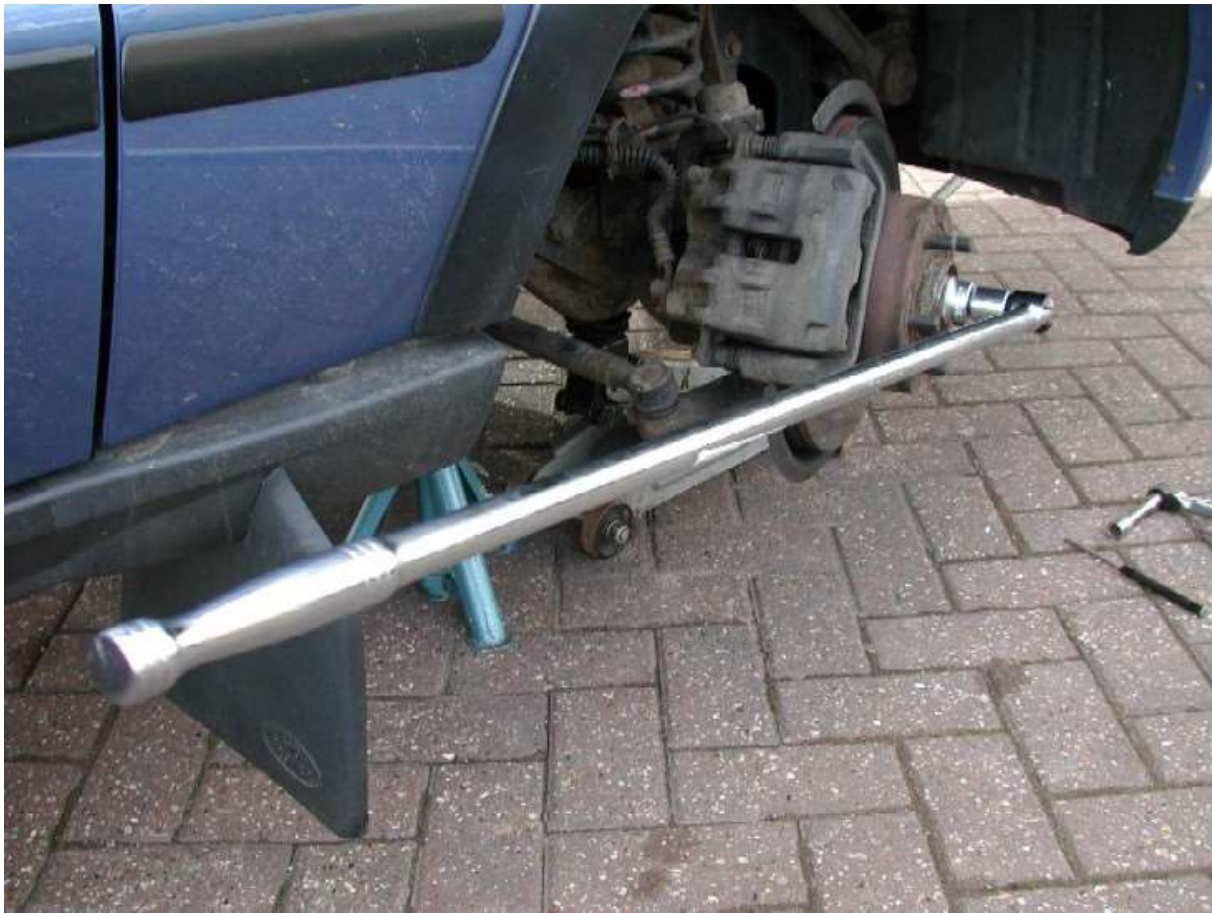
As well as a big torque wrench for refit, you really need a good breaker bar to undo it in the first place. I used a 3/4 drive 1.2m bar and even then it had some force applied before the nut come undone. Turn the wheel so it brings you away from the car when undoing the nut.

I engaged my CDL and left the auto box in park and transfer box in LOW range to assist in holding the hub still and that was enough, you could also start the car and have a second person apply the brakes to also help hold it if need be.

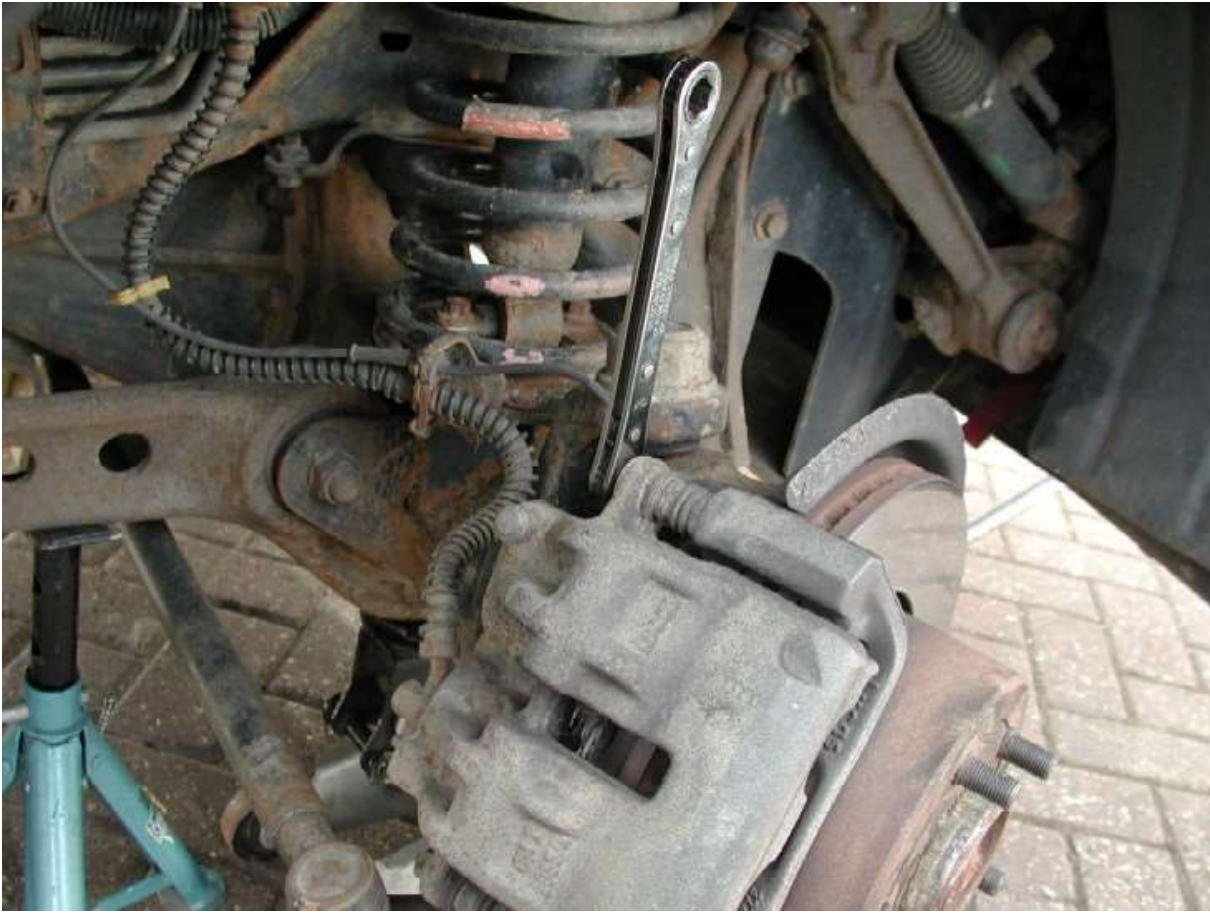
You just need to "break" the torque for now and undo 1 or 2 turns. Now you need to remove the brake calipers and brake disc as well. For "full" info on that check [front disc / pad](#) replacement article. For a quick guide, you need to first remove the pad carrying part of the caliper, undo the 2 bolts at the caliper sliders.

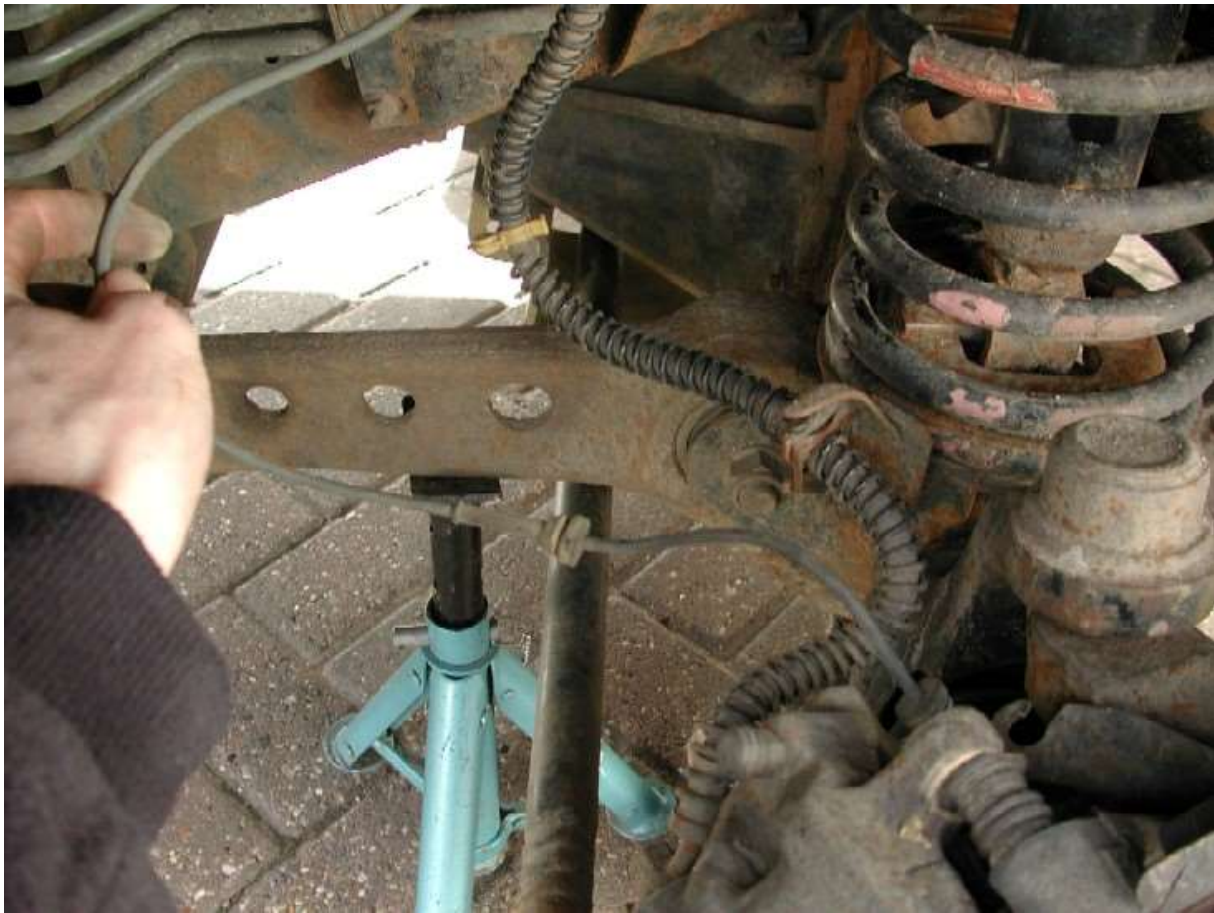
Then before you lift the caliper away, unclip the ABS sensor loom from all the points up to the inner wheel arch. Then go into the engine bay and follow the loom to the connector on the inner wheel arch. It is just below the brake master cylinder on my TD5 (UK car). Feed the loom back out under the wheel arch and leave it there for now.

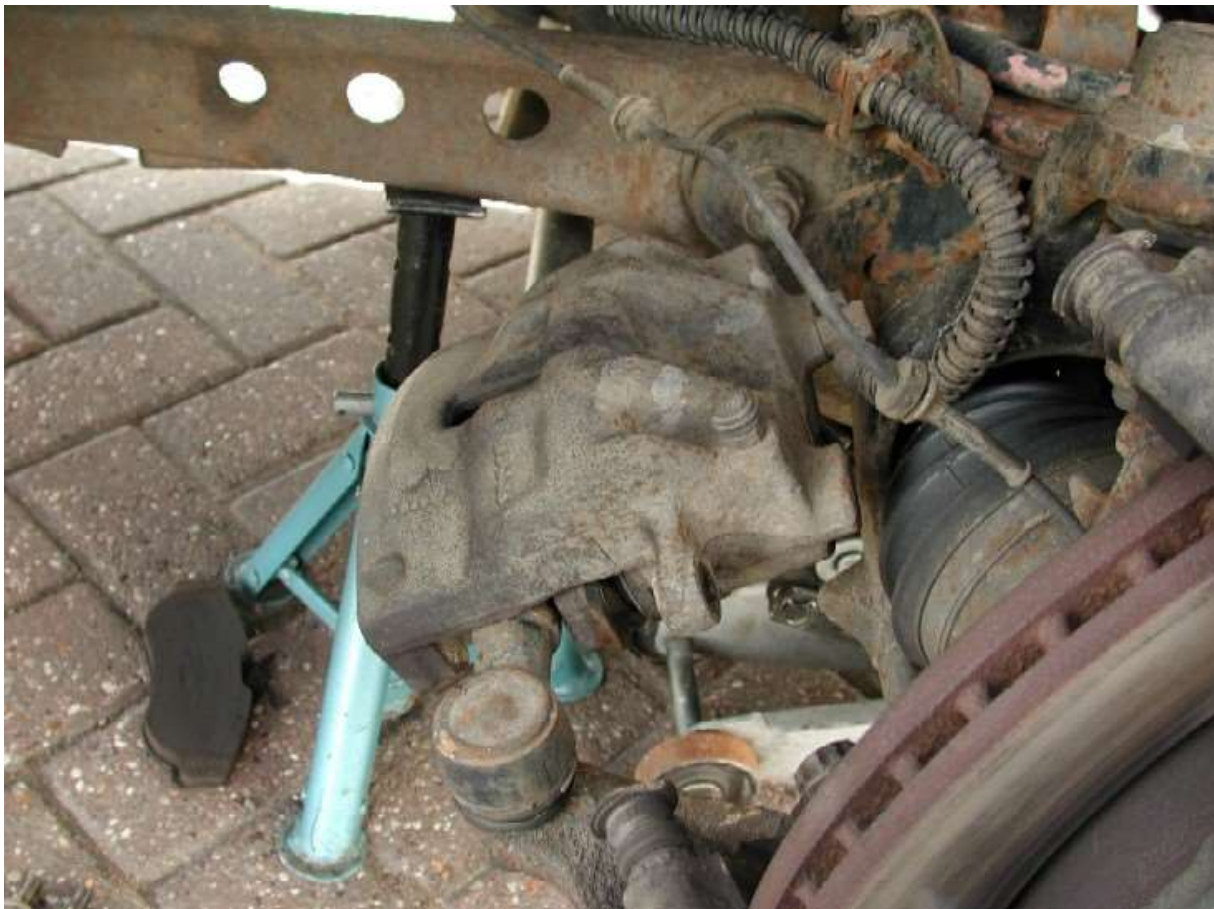
Then lift the caliper away and rest it on the radius arm, take care not to kink or damage the brake pipe. You may need to remove the brake pads and store them safely out the way.

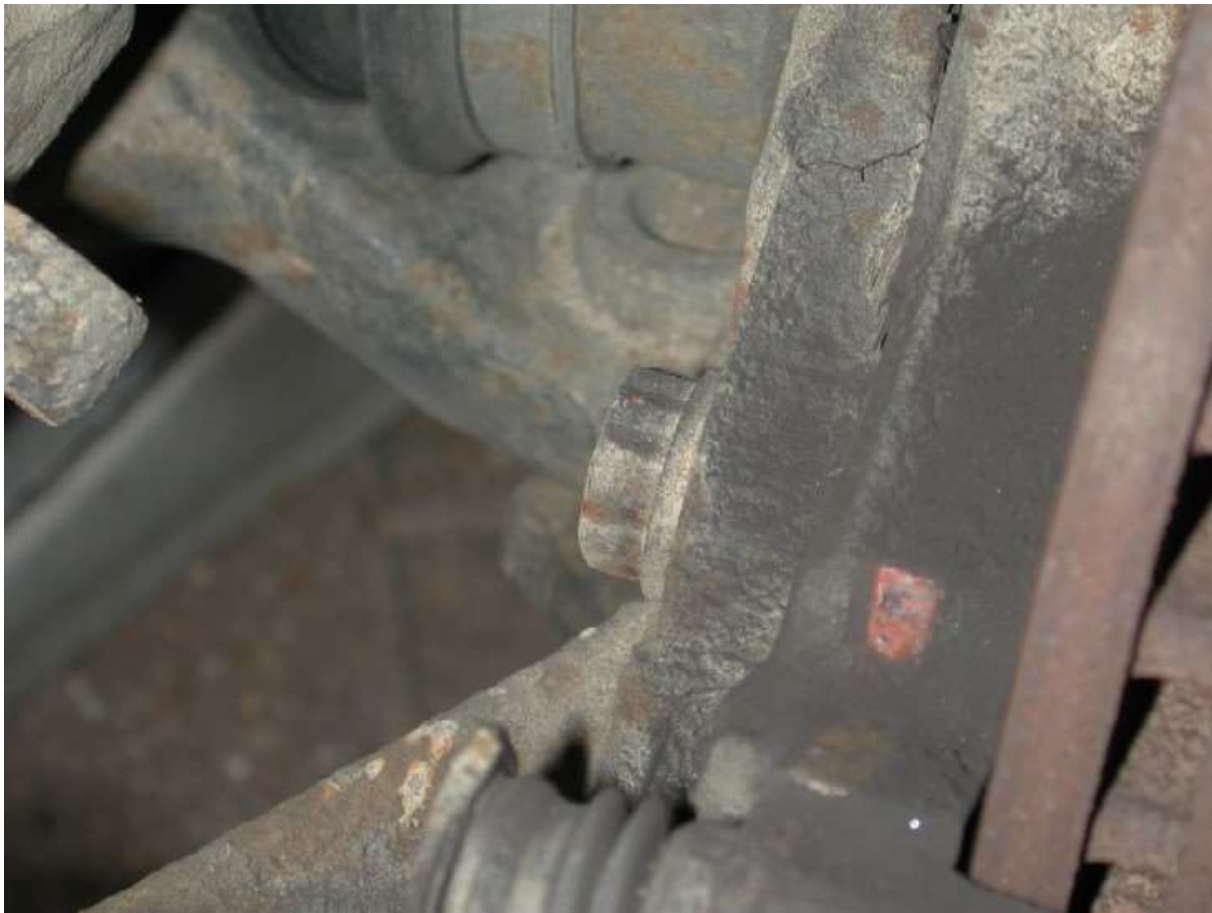
Next you have to remove the inner part of the caliper, that's held on by the 2 12 point bolts that you can now see at the back of the hub.

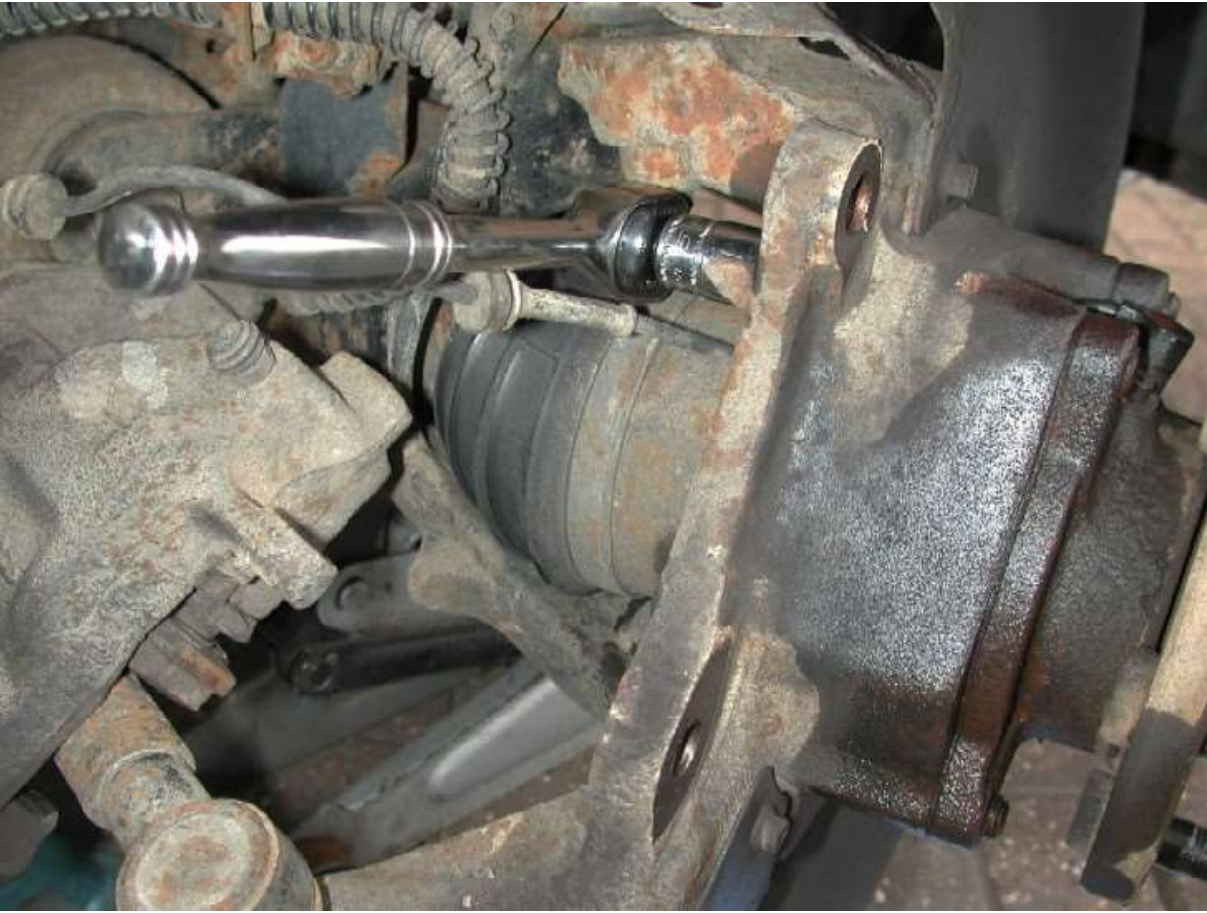
The Hub is held on by 4 15mm bolts from the back, they should not be that tight. Applying a little penetrating / dis-assembly oil is always a good idea. Whilst your undoing those bolts, apply some oil to where the hub meets the steering knuckle as its been in there a long time!.

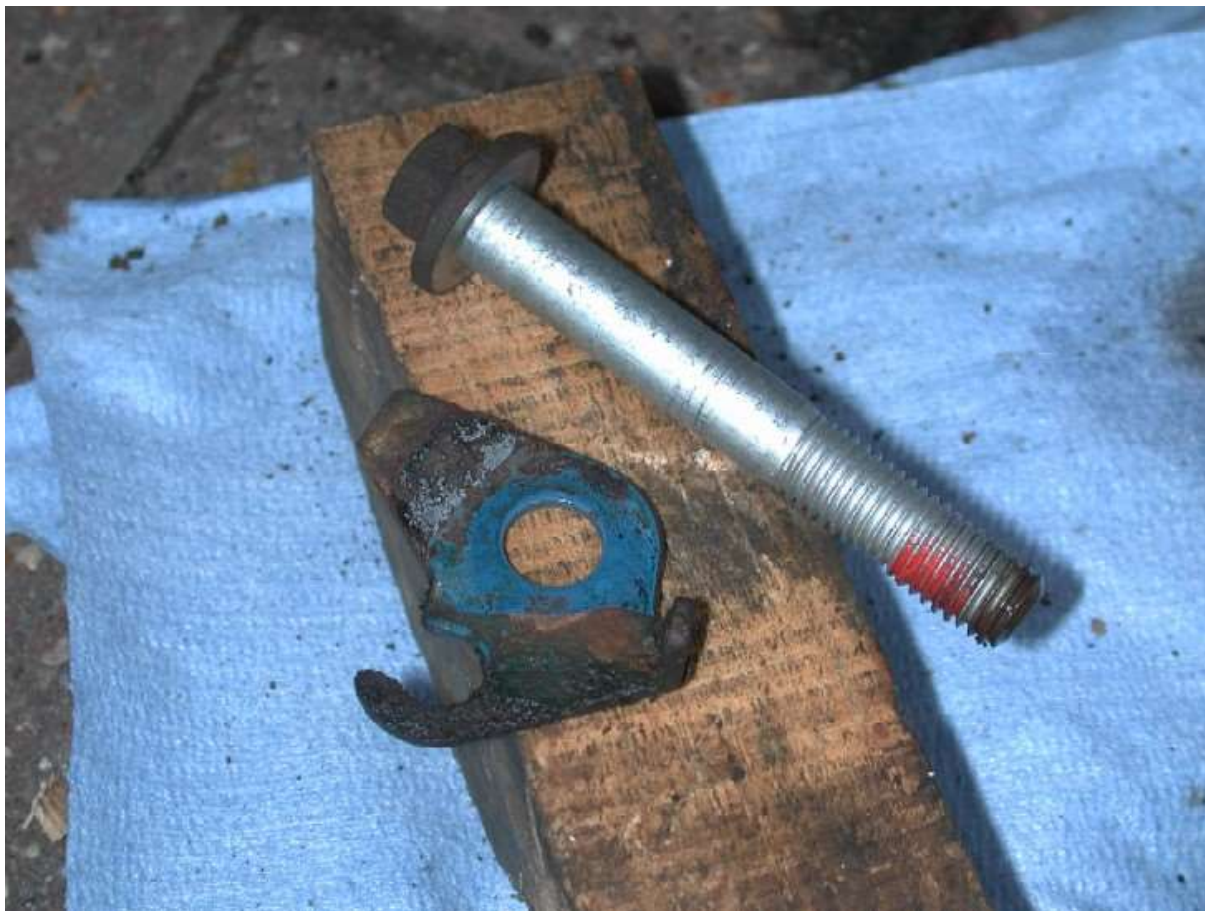
You will need to turn the wheel each way to get access to either the front or rear bolts, be careful of the brake caliper resting on the steering arm when doing this. As with the Hub nut, 6 pointed sockets are always advisable on items like brakes as they get treated to all the elements and are usually rather tight / corroded to come undone.

NOTE the top rear bolt also holds on the bracket for the ABS sensor loom closest to the Hub.

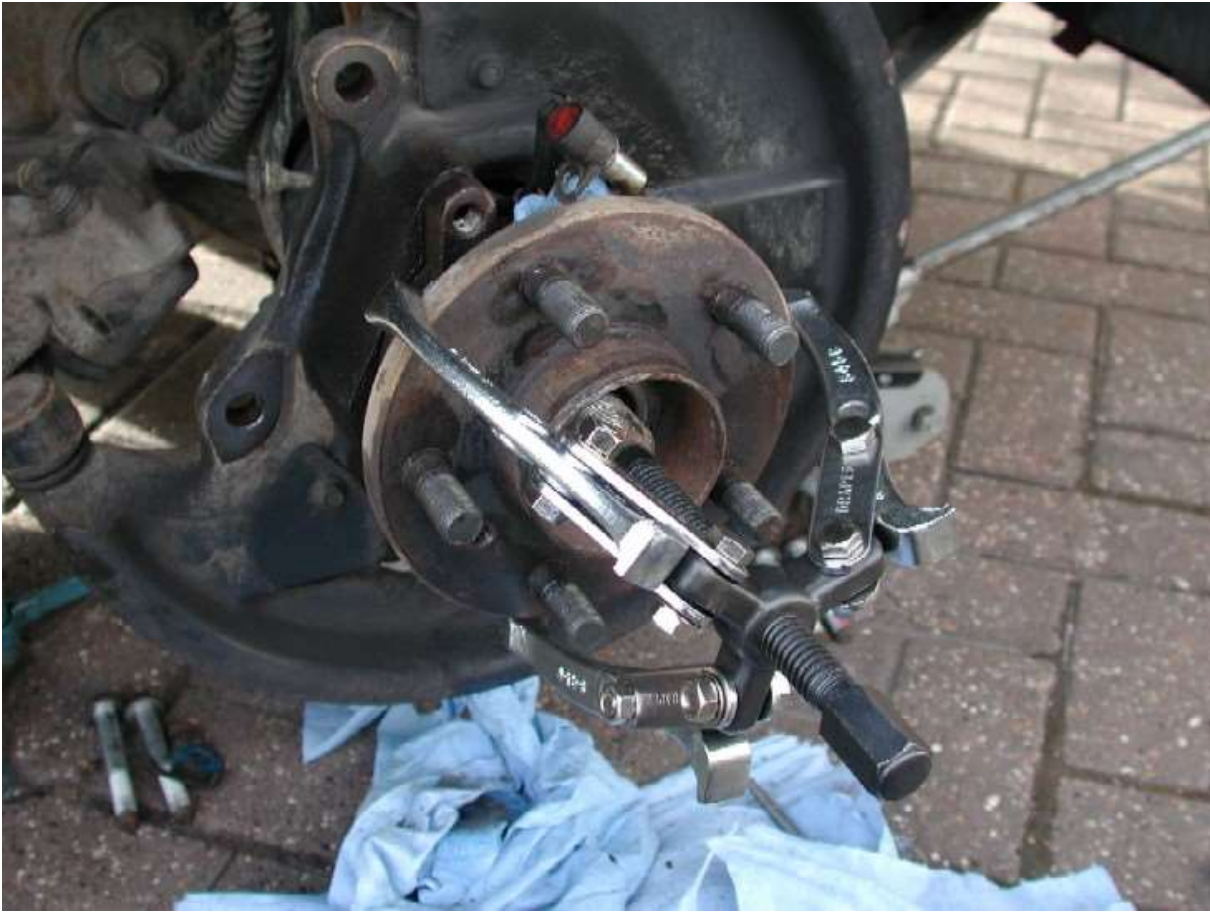
I loosely re-fitted 2 bolts back into the Hub and then used a standard 3 legged puller on the Hub itself and after a few turns it simply began to come free from the driveshaft

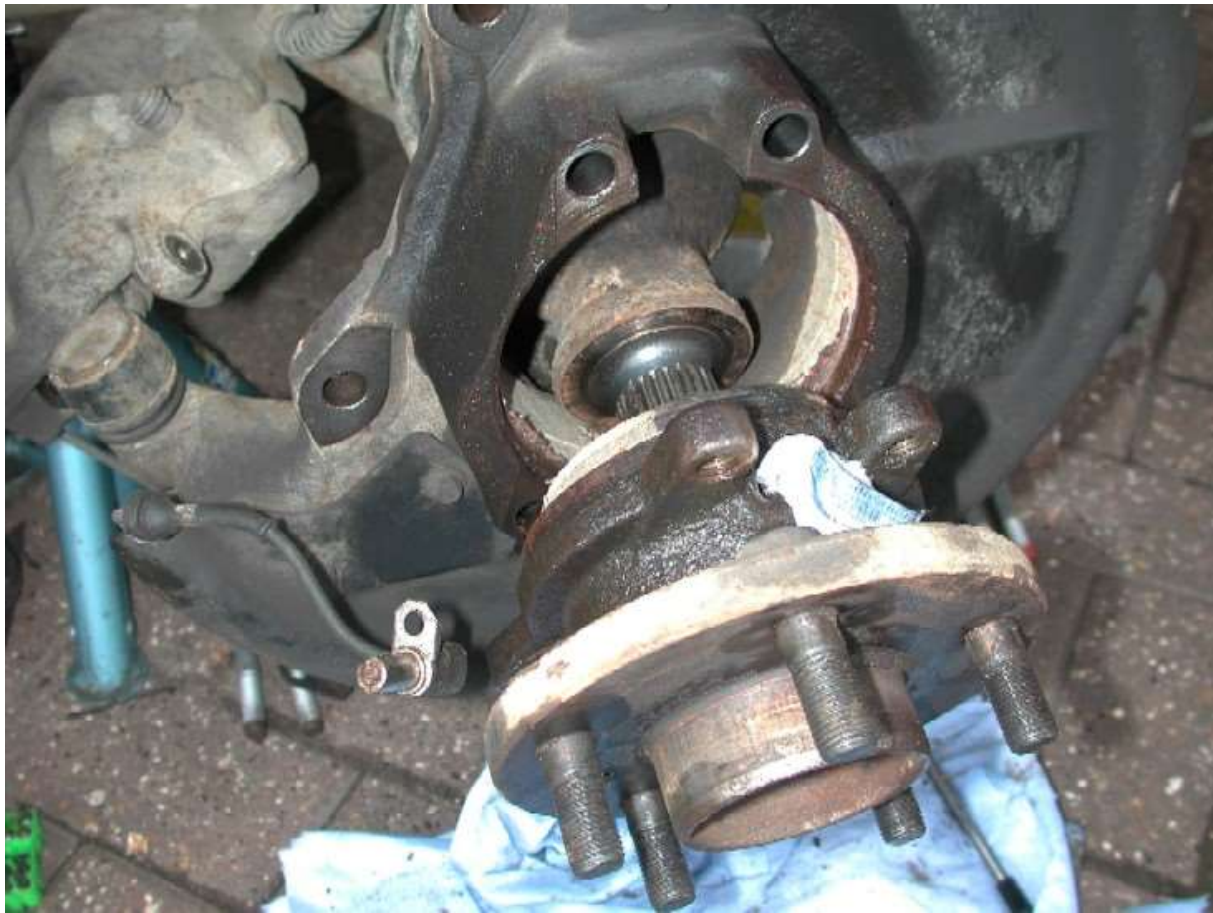
So with a combination of the hammer on the rear of the hub, and the puller, the hub assy came away nicely both from the steering knuckle and the drive shaft and there is no need to replace / disturb any oil seals etc ;o)

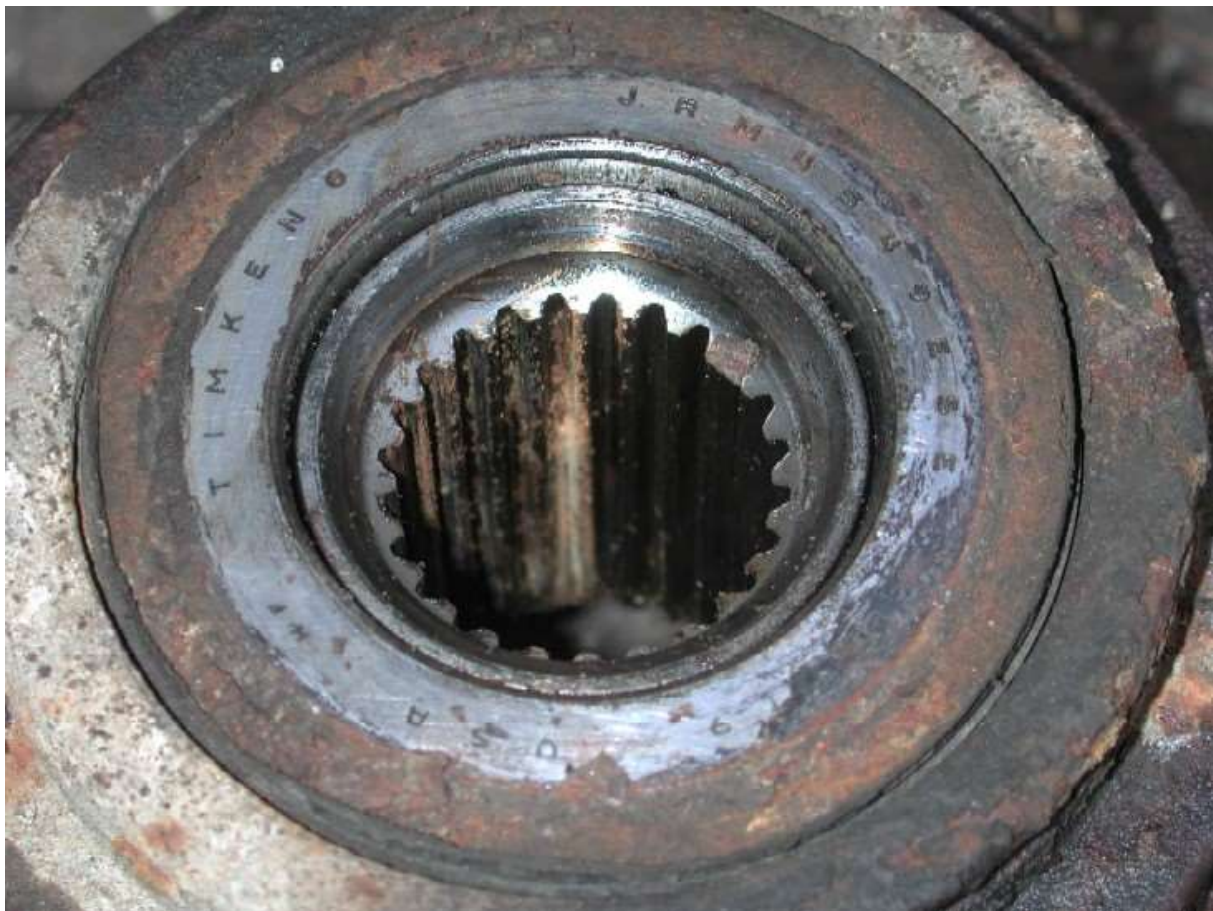
Heres the back of the hub showing the bearing etc, looks a little worse for wear!!.

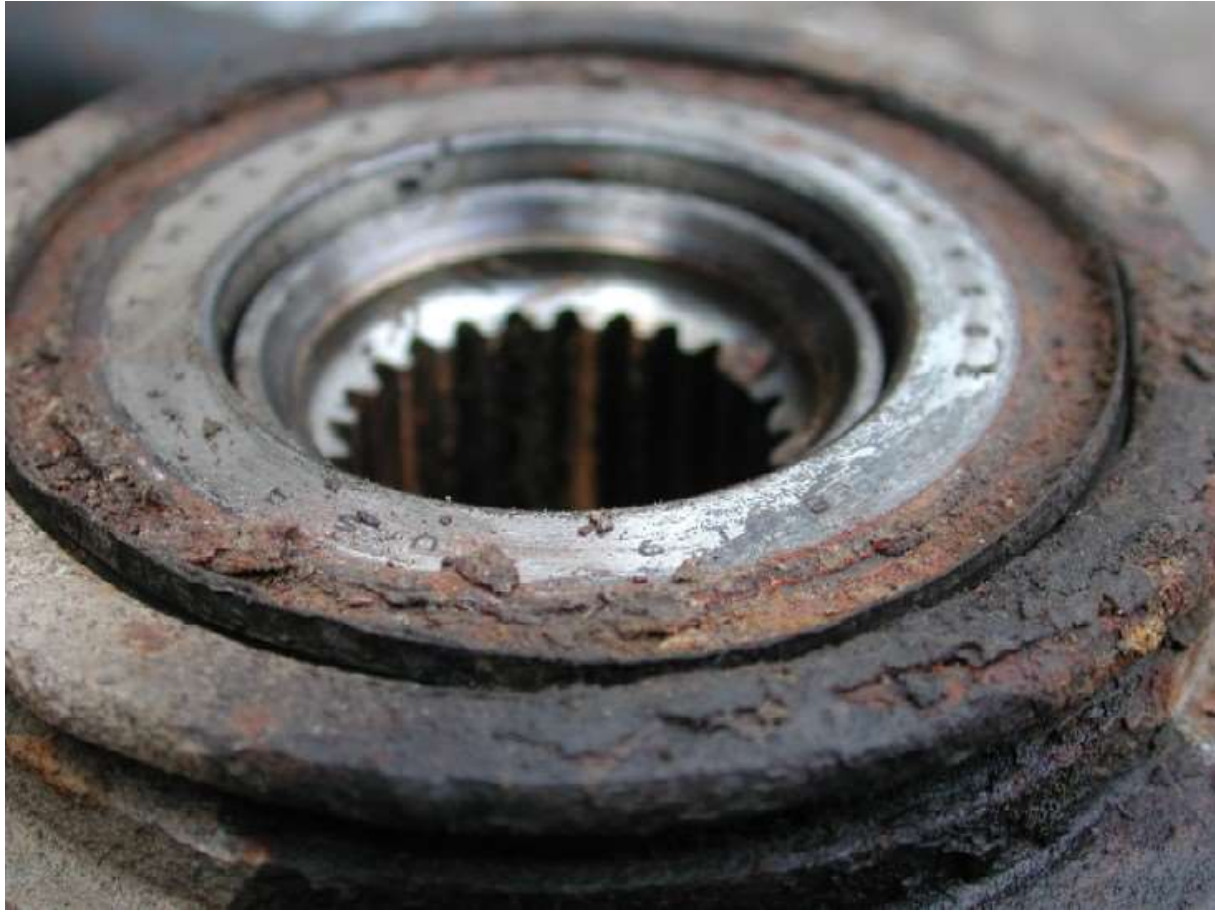
The movement in the bearing was very minimal when off the car, but obviously when you hang a large wheel off it, the movement is "magnified" and it feels a lot worse.

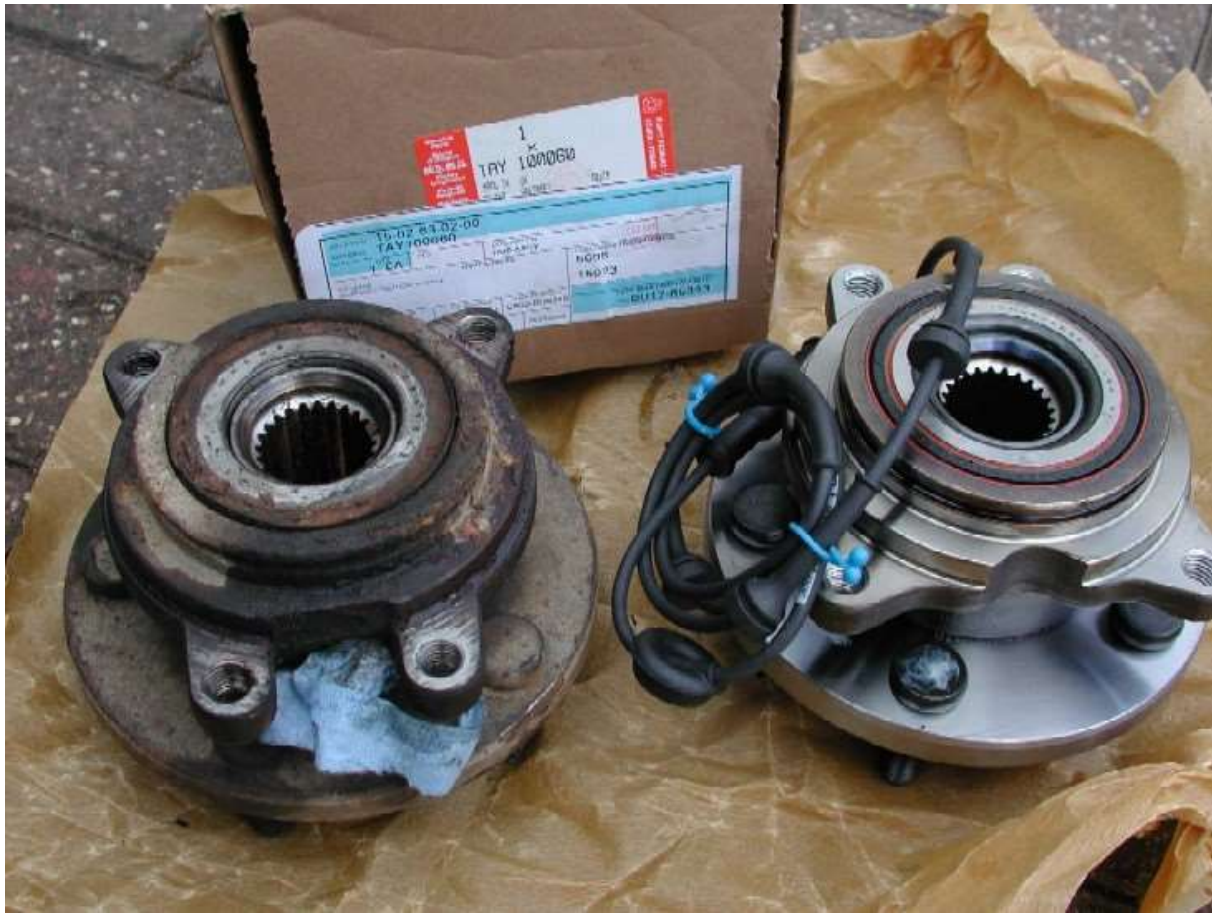
Old v New, I know which one I prefer!!.

As you can see the new Hub assy comes complete with a new ABS sensor and wiring loom already installed. DO NOT disturb / remove the sensor!!!

You will probably have noticed that my old hub has no ABS sensor installed. There is a reason for this and I will explain why at the end of the article.

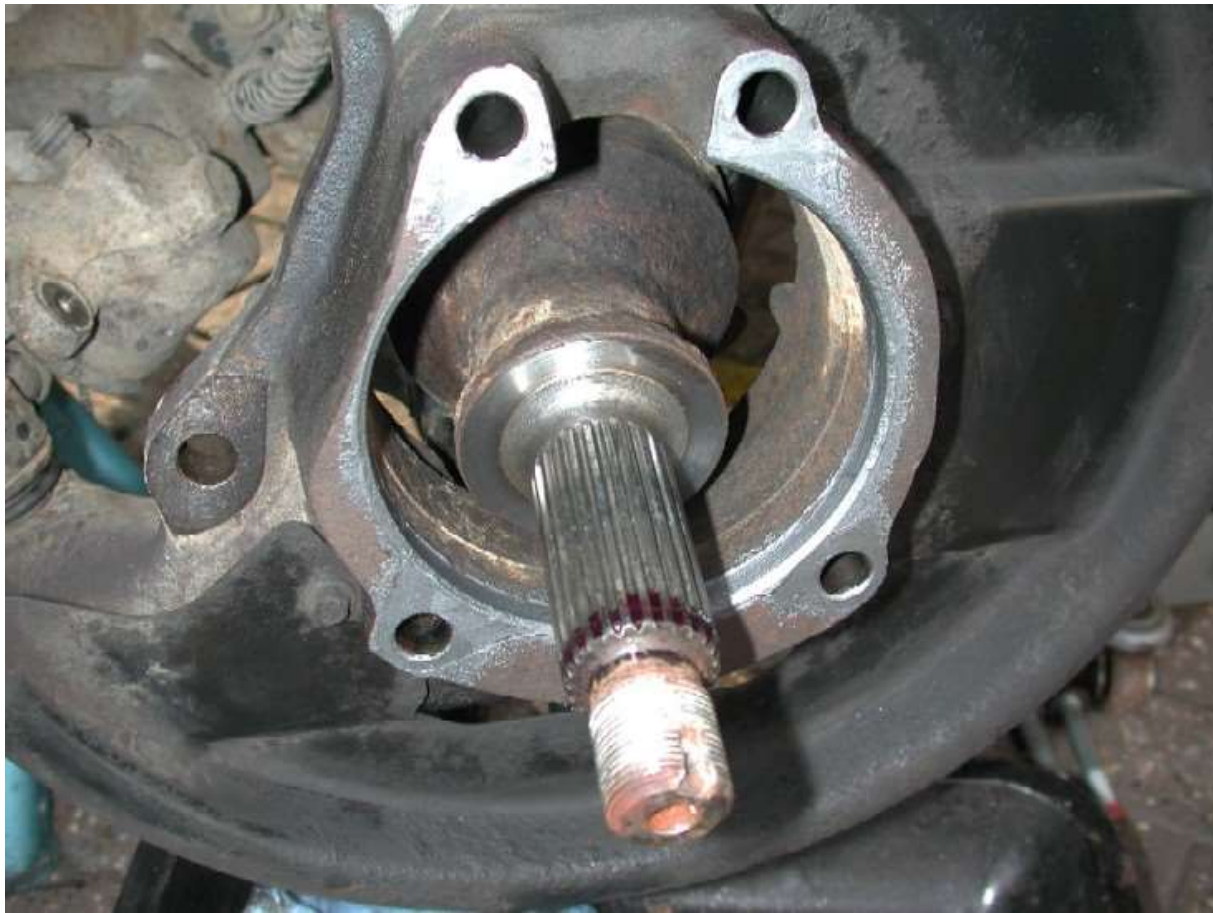
Now its time to get it all cleaned up and ready for the shiny new one!!. First of clean the drive shaft splines carefully of any dust / dirt / oil and old loctite etc. Then clean mating face of the steering knuckle where the hub sits and apply a smear of anti-seize compound to it.

When your ready to start the re-assembly, you need to apply a 3mm wide bead of loctite 640 (or threadlock) as above to the very end of the driveshaft. This will then be smeared down to the splines as you push the new hub assy on. Make sure your have all your tools and bits ready at hand as the Hub assy must be refitted and finally torqued up BEFORE the Loctite goes off!!

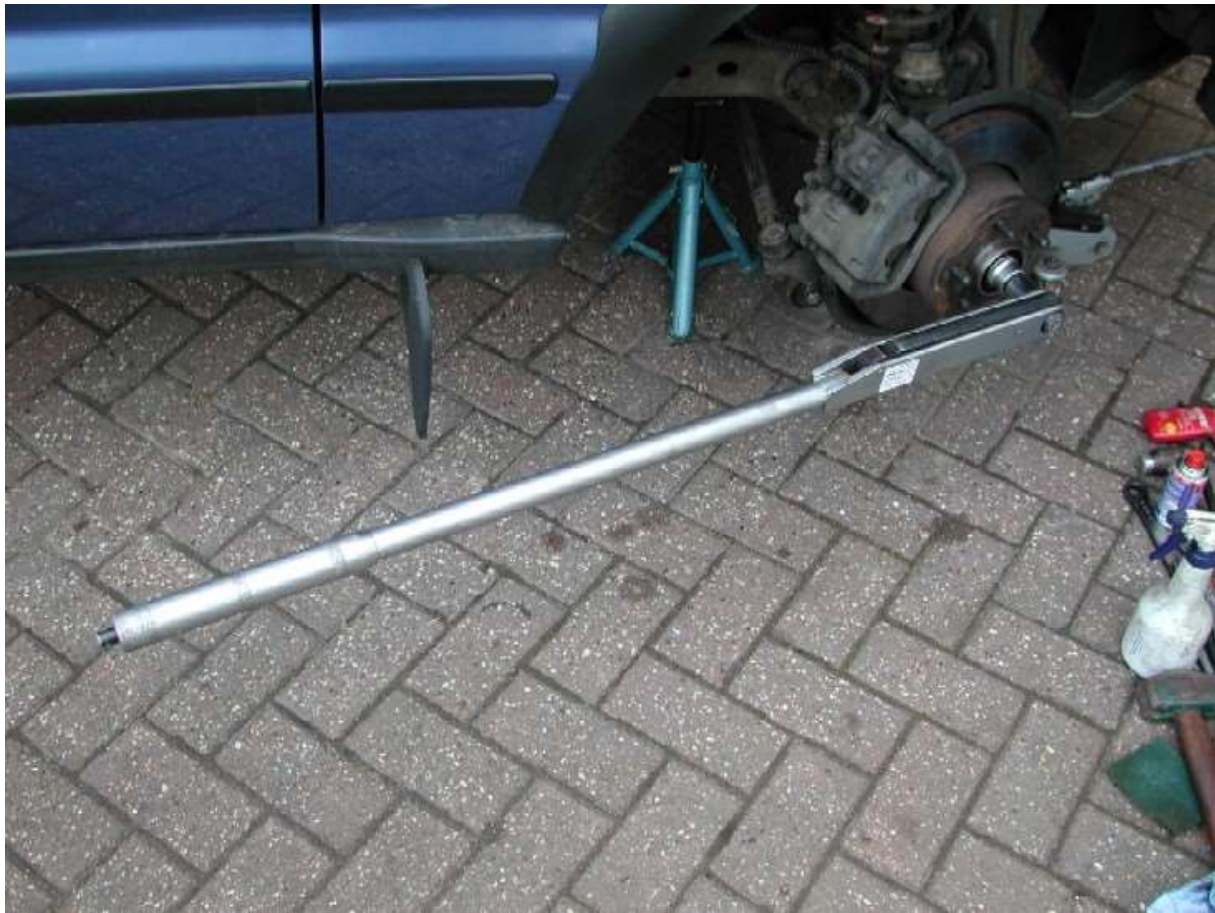
Once the Hub / Brake Disc / Pads / Caliper is all back on, its time for the Big torque wrench to earn its money. Torque the drive shaft nut up to 360Lbs Ft or 490 NM

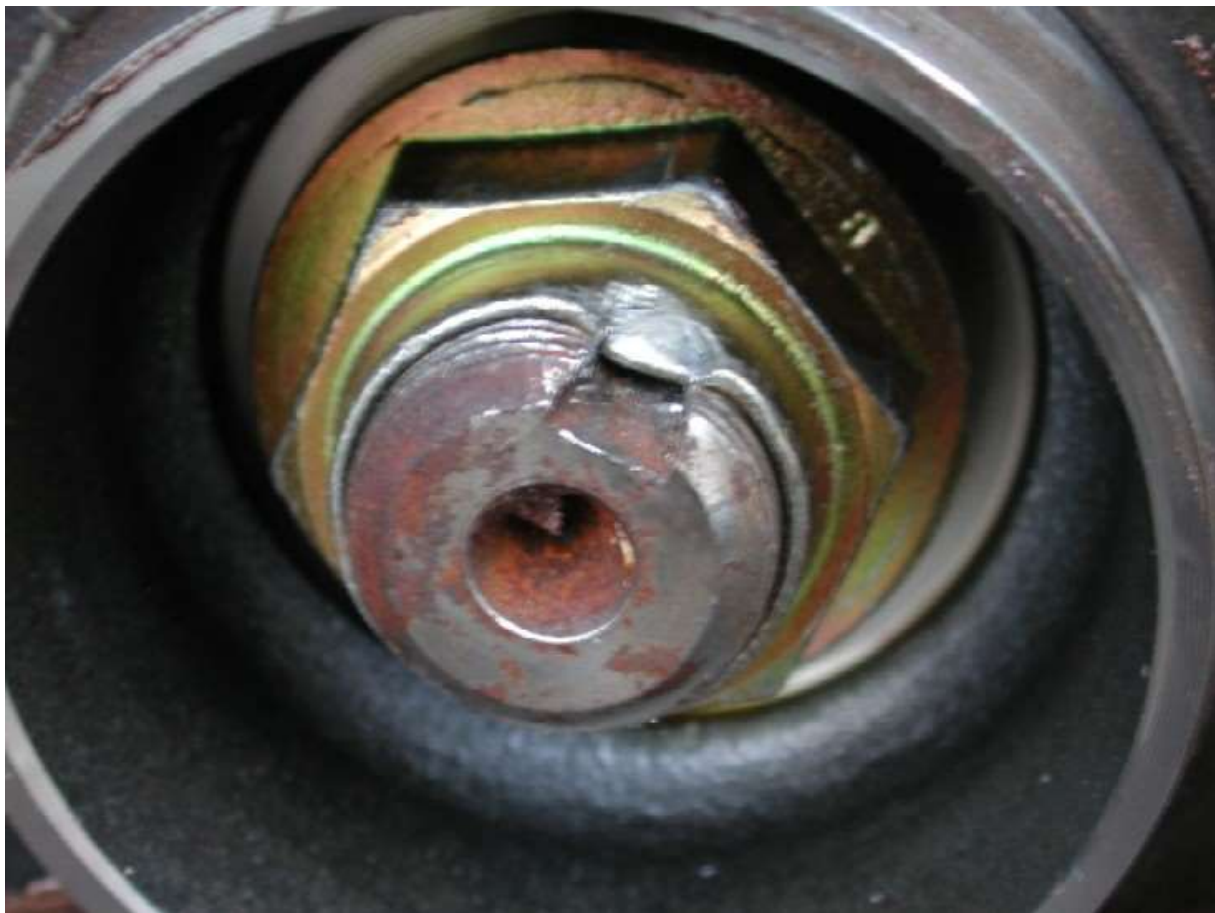
Then, using a punch or similar, re-do the stake on the NEW drive shaft nut to lock it on.

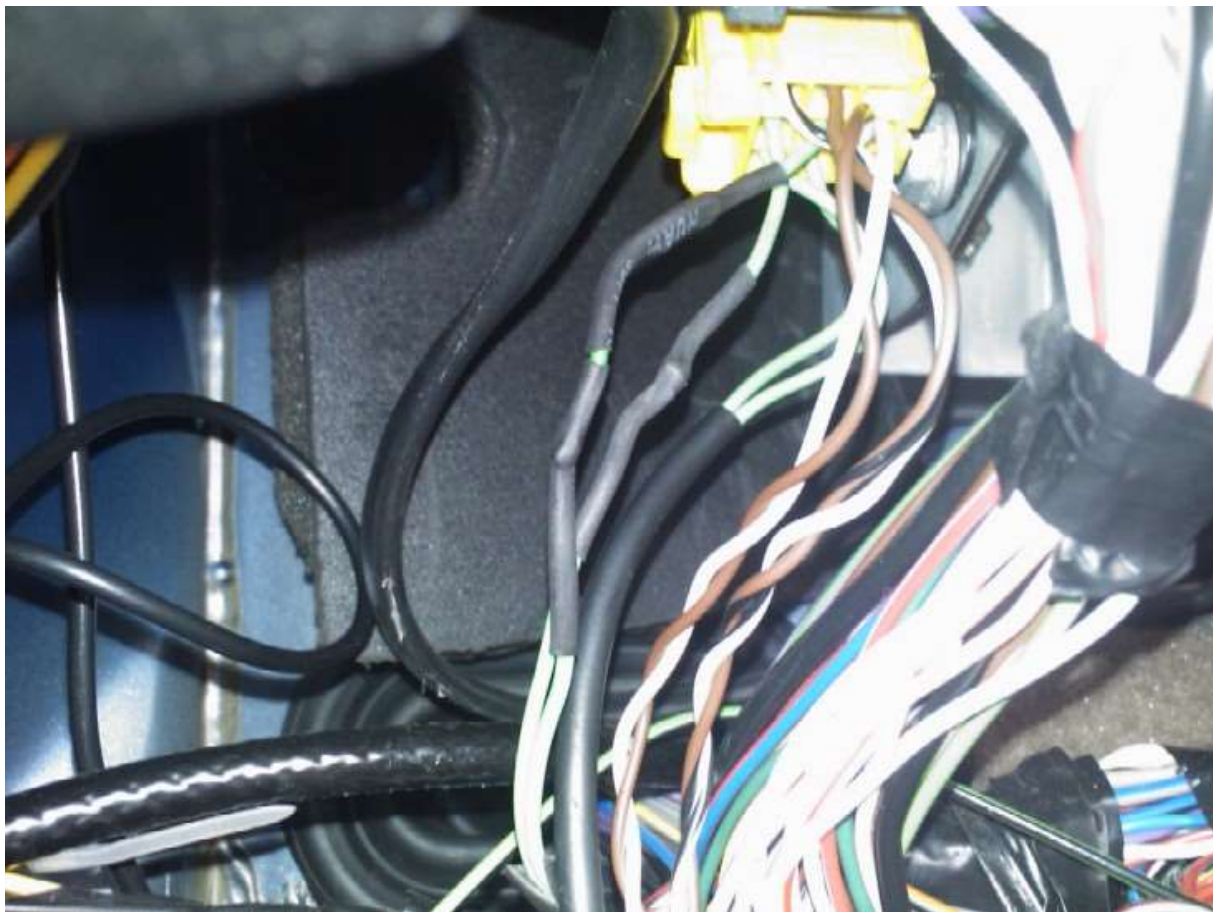
What I will say is this, that the wiring was a complete mess / abortion at the SLABS Ecu and I hope it was not a dealer who did it !!, its a good thing that its now tidied up and back to how its supposed to be from the factory ;o)

here's a picture of the loom / plug at the SLABS ECU, you can see where I had to re-solder the loom back together and then I covered them in heat shrink to protect them.
